Technical Journal

Panoramic sunroof, sealing strip has a gap

REF NO: TJ 35503.3.0	ISSUING DEPARTMENT: Technical Service	CAR MARKET: United States and Canada	
PARTNER: 3 US 7510 Volvo Car USA		ISSUE DATE: 2022-02-01	STATUS DATE: 2022-02-07
FUNC GROUP: 8363	FUNC DESC: Sealing	Page 1 of 3

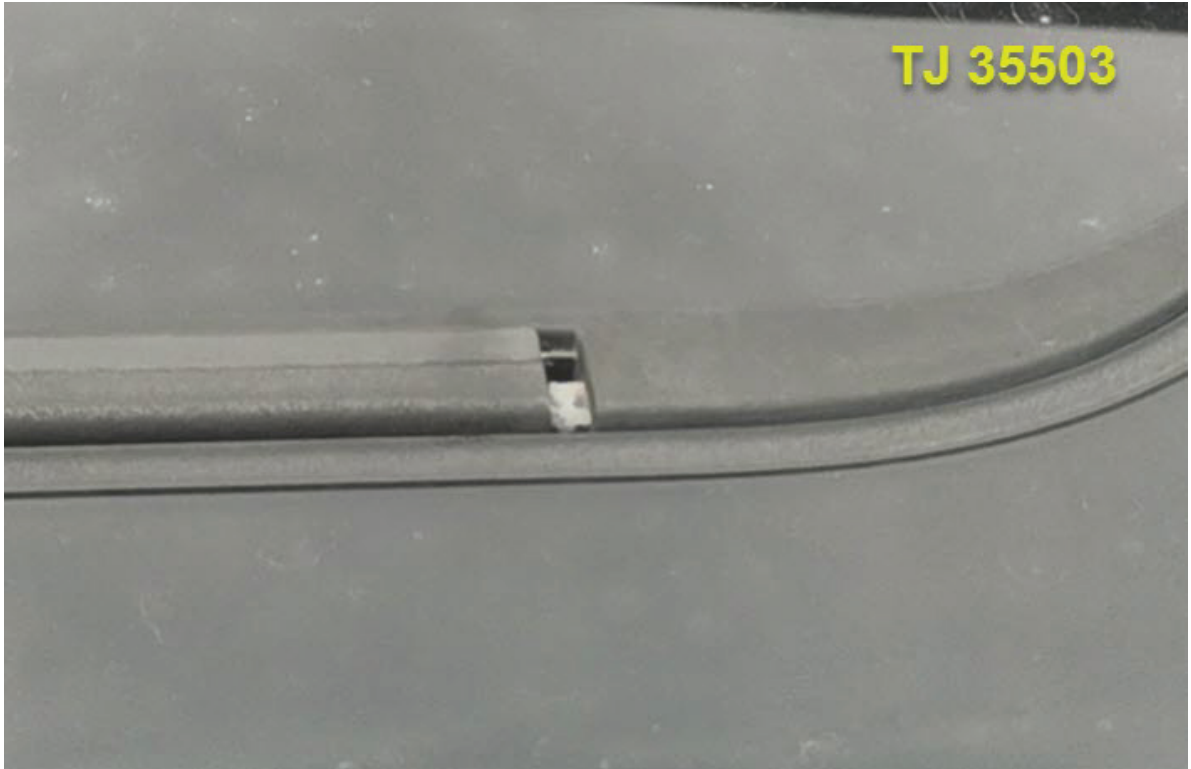
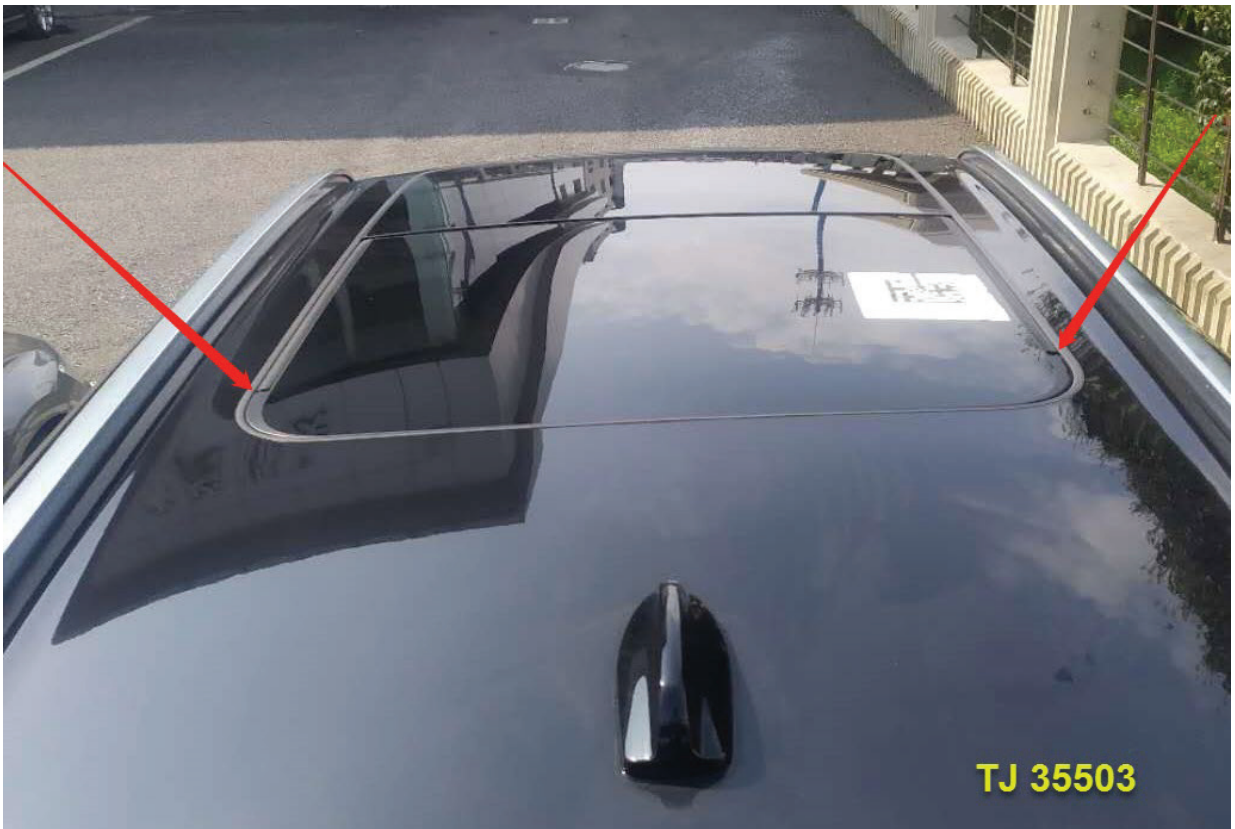
If the customer complain about that the sealing strip in rear end of panoramic sunroof is too short, or if the short sealing strip cause water leaks into the car, please follow advice under Service.

In normal conditions, even if there is a gap in the sealing trim, incoming rain water will be avacuated thru the sunroof drainage hoses.

In rare conditions, an extensive gap may lead to water leak from the sunroof frame but only if extensive amount of dirt and debris have accumulated in the gutter, or if any of the water drainage hoses is blocked due to dirt and debris. If the customer has reported water leakage in combination of a large gap in the sealing strip, please replace the sealing strip but also check the sunroof drainage function and clean if necessary. If any of the drainage hoses is found deformed (kinked), then replace that hose as well. Official cleaning method for this add-on repair is not yet developed, in the meantime use General Operation and send a Vehicle Report with photos (Support Not Needed).

Replace the sealing strip and glue it in each end it according to the method in VIDA, search for VCC ID: VCC-508558-1 or VST Op.No 83684-2

Glue PN: Würth catalogue PN 0893092

Sealing strip PN: 31484660
