# Service Bulletin

Bulletin No.: 21-NA-149

**Subject: Engine Wire Harness Chafing / IPC Gauges Sweep / IPC Warning Message / SES/Check Engine/MIL / No Start / No Crank / Runs Rough / Stalls / Reduced Engine Power / Various DTCs**

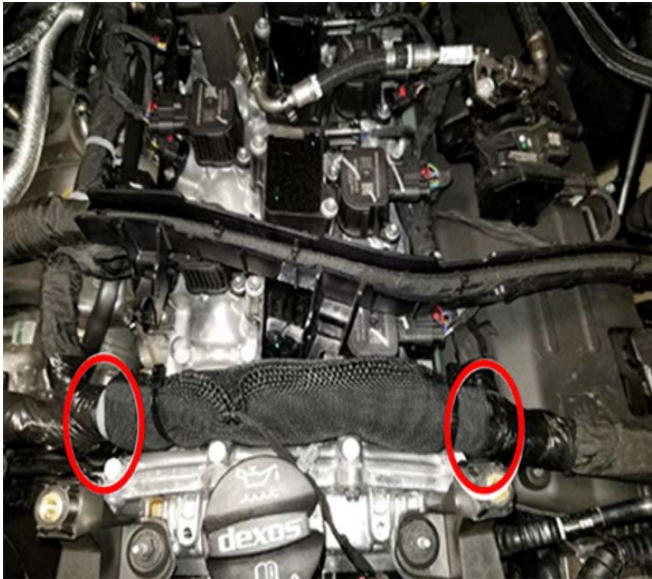
<p>5394681</p>

<p><b>Cause 1</b></p>	<p><b>This Cause pertains to vehicles equipped with engine 2.7L, L3B only.</b></p> <p>These concerns may be caused by engine harness contact with under hood components.</p> <p><b>Caution:</b> This Document Only Applies To VINs NOT Covered by Customer Satisfaction Program N192219370 Please Verify In VIS Before Proceeding</p> <p>Shown below are areas that should be inspected for this concern.</p> <p>Inspect the engine harness as it crosses over top of the Camshaft Carrier Cover. Harness damage can occur at any point across the Camshaft Carrier Cover. Typical inspection locations shown below.</p>

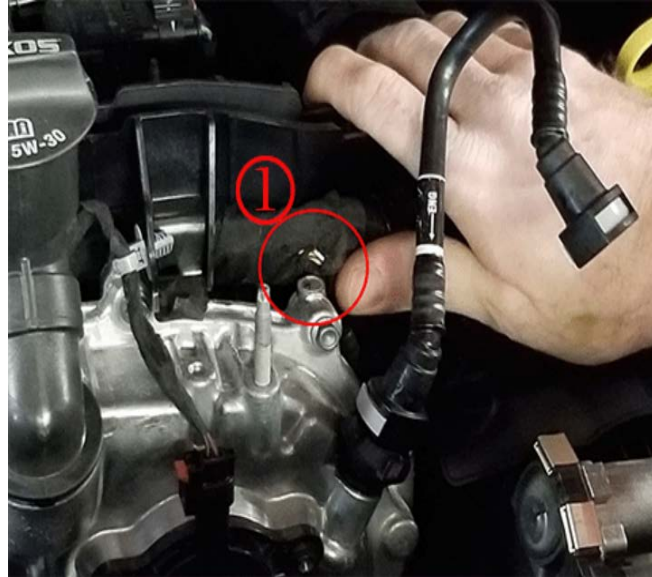
5324748

Example of engine wiring harness damage at Camshaft Carrier Cover shown below.

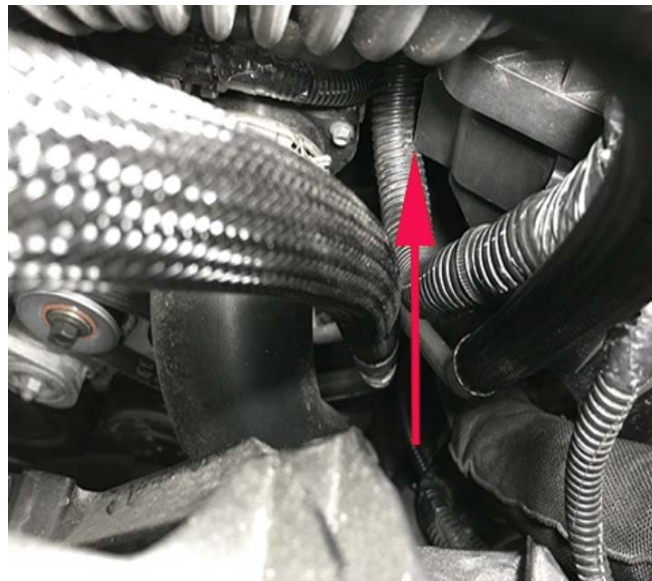
5394683

Inspect the engine harness at the Lower Air Cleaner Housing as shown below.

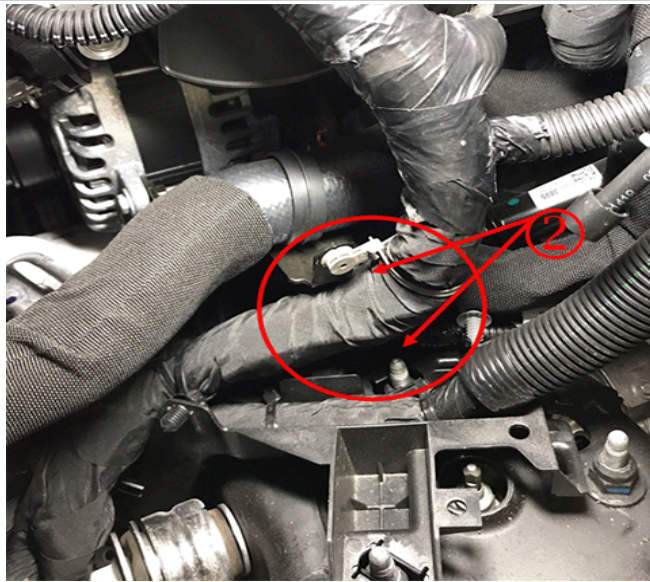
5324752

Example of engine harness damage, Lower Air Cleaner Housing removed shown below. Inspect the engine harness at the Generator Bracket and Left Front Coil Spring stud as shown below.

**Note:** Under normal driving conditions, the engine will rock back and forth in its mounts.

This may result in harness contact with this bracket that may not be present during engine off inspections.

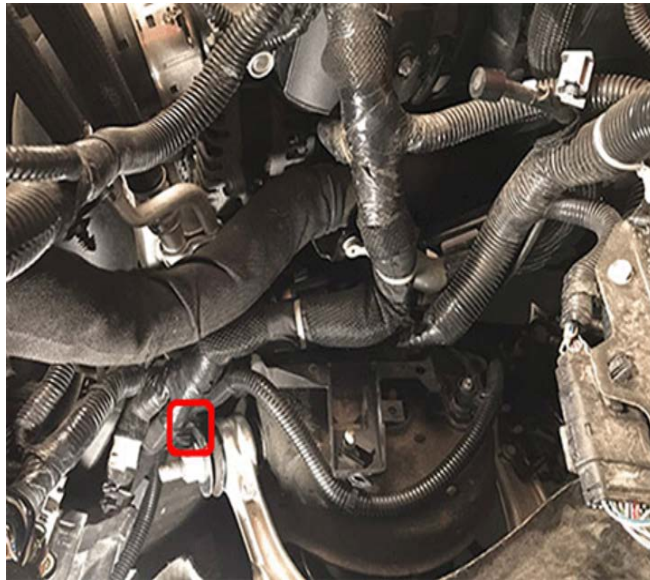
5394677

Inspect the engine harness at the Left Front Upper Control Arm Bushing as shown below.

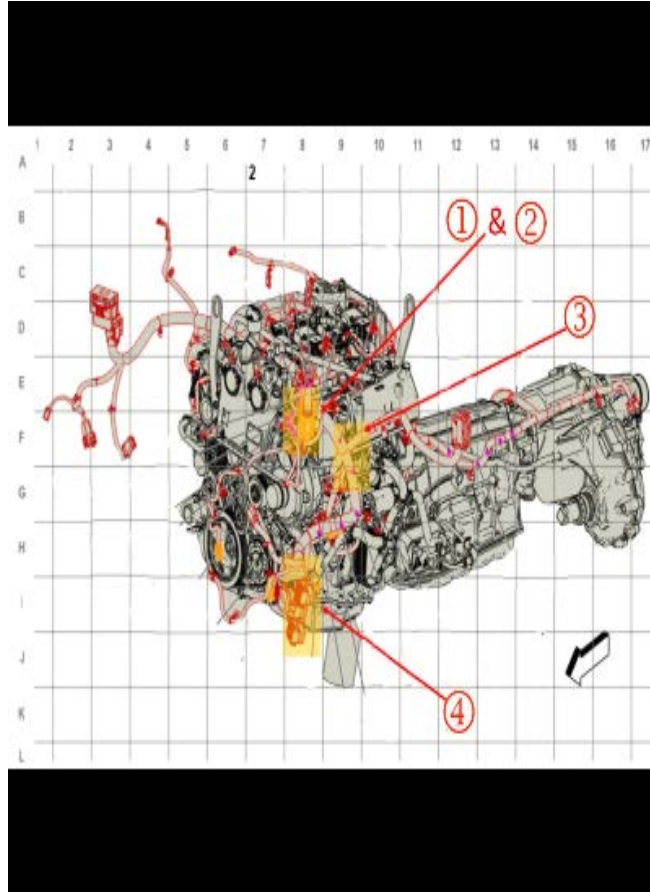
5911724

These concerns could be caused by engine wiring harness chafe on underhood components at various locations:

- Front corner of the left hand cylinder head (1)
- Drive belt idler pulley bracket (2)
- Oil Dipstick bracket (3)
- ECM/TCM bracket (4)

<p>This harness chaffing could cause shorting of any number of circuits to ground. Due to the number of circuits in the harness, there is a wide variety of different symptoms that could occur depending on which circuit(s) are damaged.</p>
<p>Cause 3</p>	<p><b>This Cause pertains to vehicles equipped with engine 3.0L, LM2 only.</b>  <u>For any of the DTC's listed above inspect the following areas</u></p> <ol style="list-style-type: none"> <li>1. The engine harness pinched/shorted/chaffed at grid coordinates G-8, as shown below. This location is approximately 18 inches from the ECM connectors (1) and on top of the generator (2), as shown below. Due to the number of circuits in the harness, there is a wide variety of different symptoms that could occur, depending on which circuit(s) are damaged.</li> <li>2. The engine harness shorted/chaffed at grid coordinates C-9, as shown below. The engine harness could be shorted out on the PVC hose clamp at the crankcase pressure regulator, as shown below (6). This is located approximately 4 inches from the crankcase sensor connector pigtail harness breakout.</li> </ol> <p><u>For DTC's: P0201, P0202, P0203, P0204, P0205, P0206, and/or P0216 inspect the following 3 areas:</u></p>

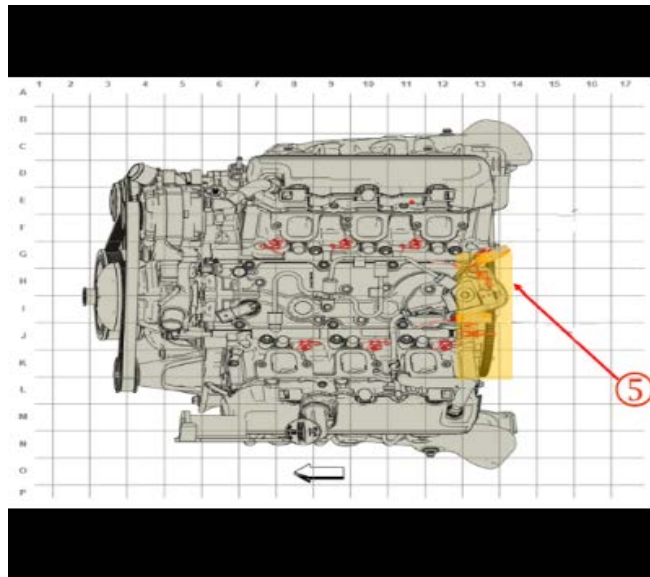
5911725

- Fuel Rail (5)

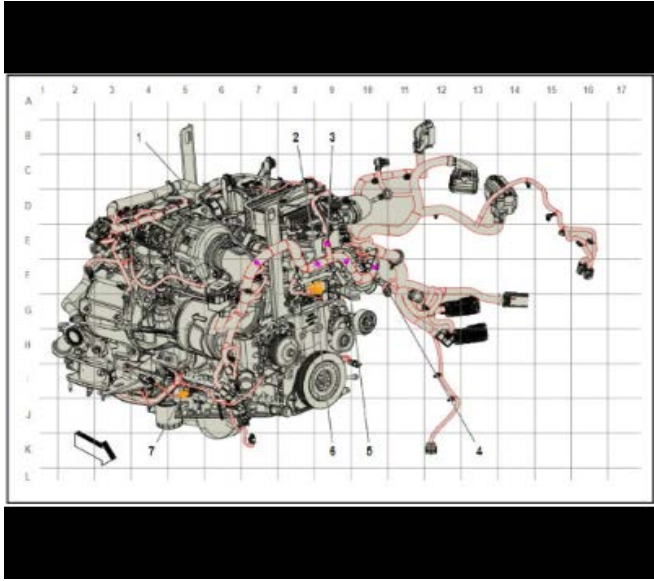
<p style="text-align: right;">5949730</p> <ol style="list-style-type: none"> <li>1. Inspect for poor terminal tension at connector X160, shown above, as callout 6. While inspecting X160 make sure the terminal locking feature (4) is not missing.</li> <li>2. Inspect the fuel injector connectors to make sure they are fully connected/seated.</li> <li>3. Inspect the fuel injector wiring harness near the X160 connector (3) for being pinched/shorted/chaffed, as shown below (5).</li> </ol> <p><u>For DTC's: P2382, P2383, P11CC, P11D5, P1488, P14D9, and/or P23AF inspect the following area:</u></p> <p><b>Note:</b></p> <ol style="list-style-type: none"> <li>1. Inspect the exhaust pressure differential sensor harness at the connector. The circuits may appear good, and test within a proper reading.</li> <li>2. Gently pull on the individual wires. This will sometimes cause 1 or 2 wires to break at the connector.</li> <li>3. After installing the new connector, we advise adding extra tape to limit the movement/vibration of the harness at the connector.</li> </ol>

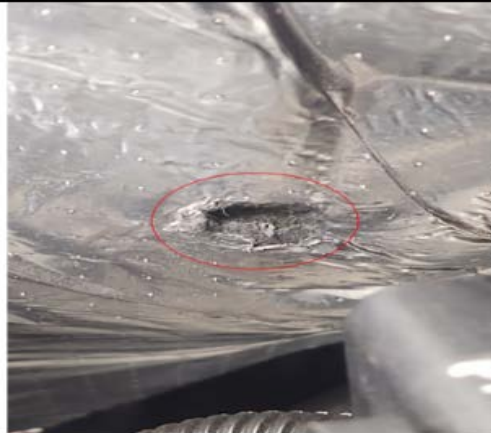
5949751

An example of firewall insulator chaffing

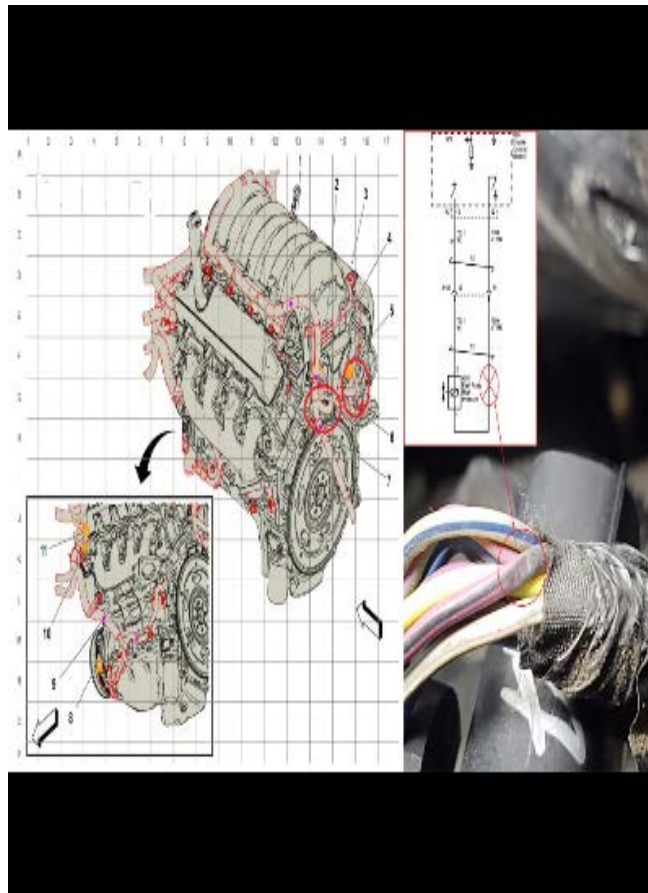
5949755

Other areas of concern.

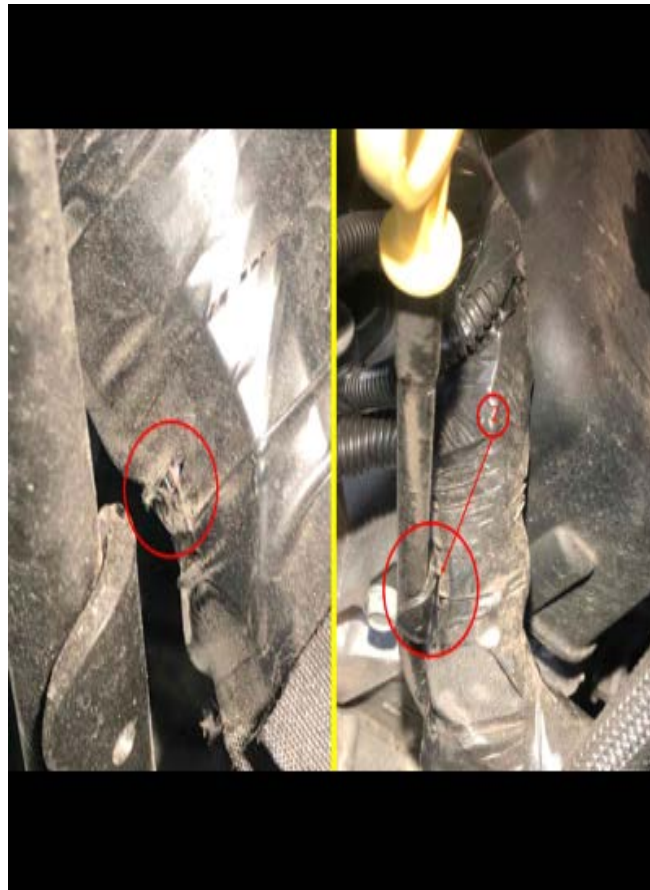
5911722

**This Correction pertains to vehicles equipped with engine 4.3L, LV3 only.**  
**Note:** The first graphic below is a before, and after (2), repair example of harness chaffing at the Oil Dipstick bracket.

To correct this concern, repair the damaged wiring following the SI wire-to-wire repair procedures. Once repaired, protect and reposition the engine wiring harness to prevent future harness damage.

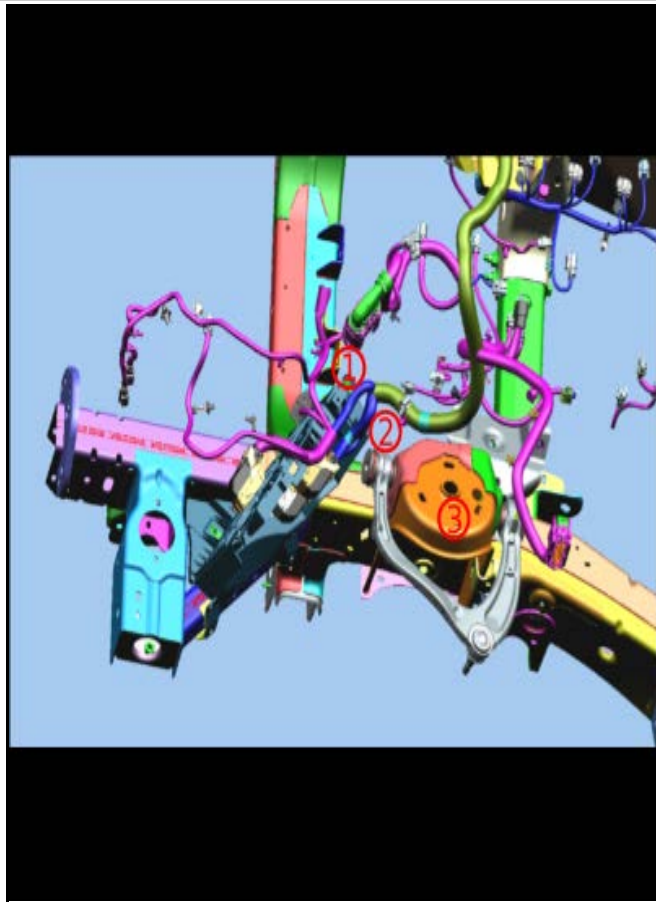
5868341

3. Locate the three contact points where the wire harness is chaffing, the ECM/TCM black bracket (1), the upper control arm (2), and the shock tower bolt (3).

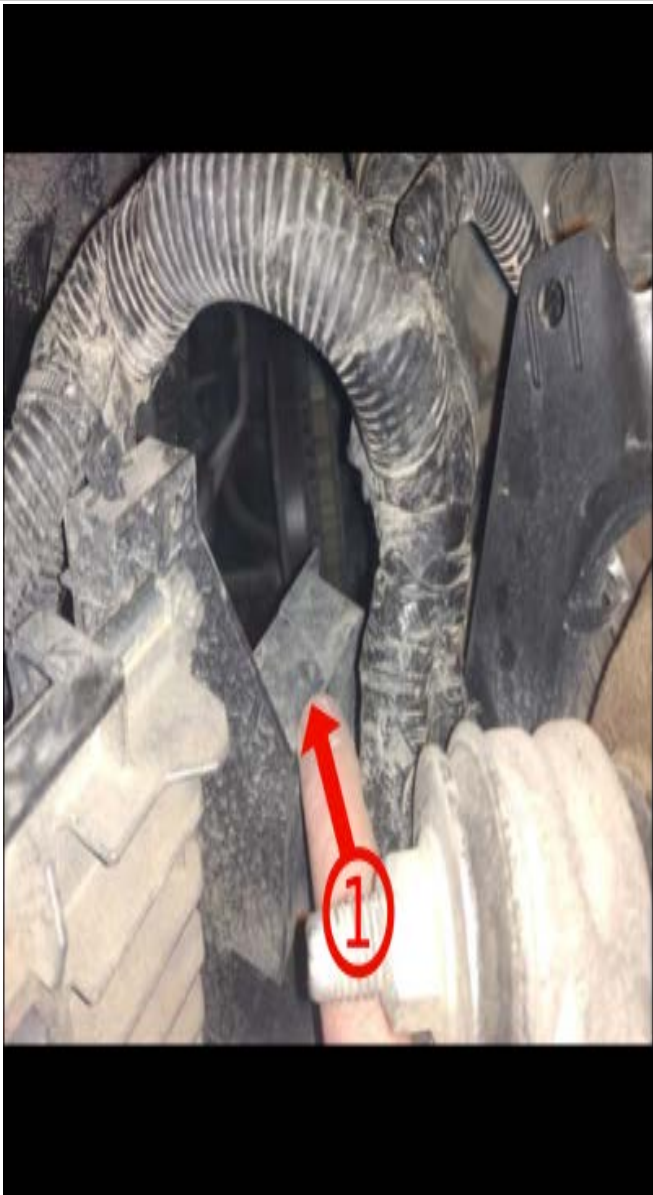
5868349

4. At the ECM/TCM bracket, locate the wire harness laying against the ledge (1).
