Service Bulletin

Bulletin No.: 22-NA-101

Subject: PTO (Power Take-Off) Kicks Out or Intermittently Disengages Unwanted

Ī	Brand:	Model:	Model Year:		VIN:		Engine:	Transmission:
L			from	to	from	to	Engine.	ITAIISIIIISSIOII.
	Chevrolet	Silverado 4500HD, 5500HD, 6500HD	2019	2022

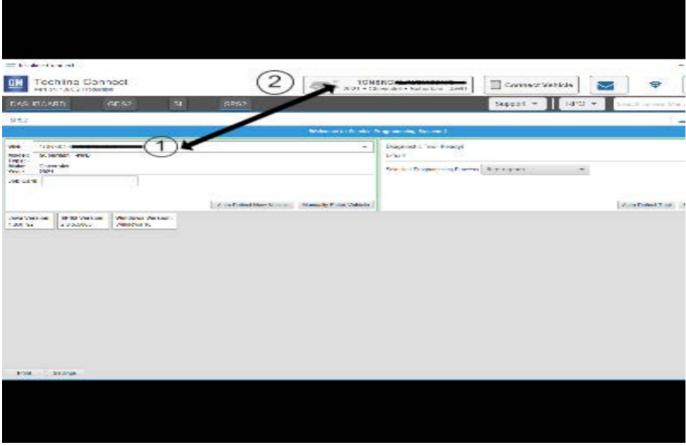
Caution: Be sure the VIN selected in the drop down menu (1) is the same as the vehicle connected (2) before beginning programming.

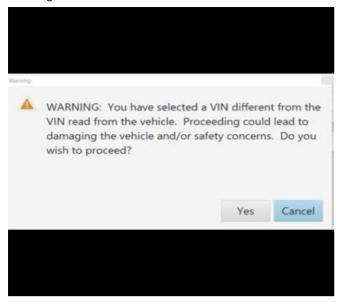
5877000

Important: If the vehicle VIN DOES NOT match, the message below will be shown

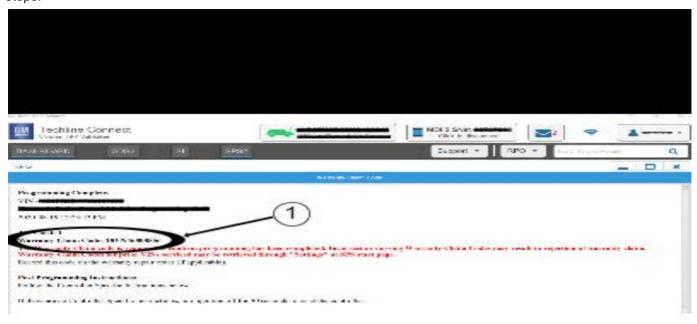
5644478

Important: To avoid warranty transaction rejections, you **MUST** record the warranty claim code provided on the Warranty Claim Code (WCC) screen shown above on the job card. Refer to callout 1 above for the location of the WCC on the screen.

2. Record Warranty Claim Code on job card for warranty transaction submission.
