Macan E-box Water Intrusion Causes Electrical Errors

Models	Model Year	Model Type	VIN Range	Vehicle-Specific Equipment
Macan	As of 2019 up to 2022	95B	N/A	N/A

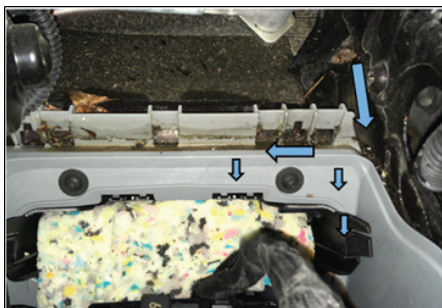
Figure 1

This condition may be the result of water entering the e-box and causing corrosion on the contacts or splices. When investigating, open the e-box and look for evidence of water intrusion.

Note the object area of the blue arrows (in figure 1) and note if there are traces of water related residue on the bottom of the e-box (like in figure 2).

Remove existing corrosion from the splices and wiring and reattach to the e-box. Follow instructions in the attached document. Please note: it is necessary to replace the cover for the e-box.

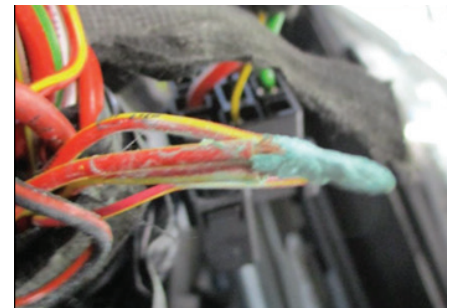
Figure 3

Also, look for corrosion on the contacts or splices (Figure 3).
