Technical product information

Topic	Clicking noises from the left and/or right front corner(s)
Market area	Bentley: worldwide (2WBE),Hongkong-Macau (5HK)
Brand	Bentley
Transaction No.	2052853/9
Level	EH
Status	Approval
Release date

Bentayga series

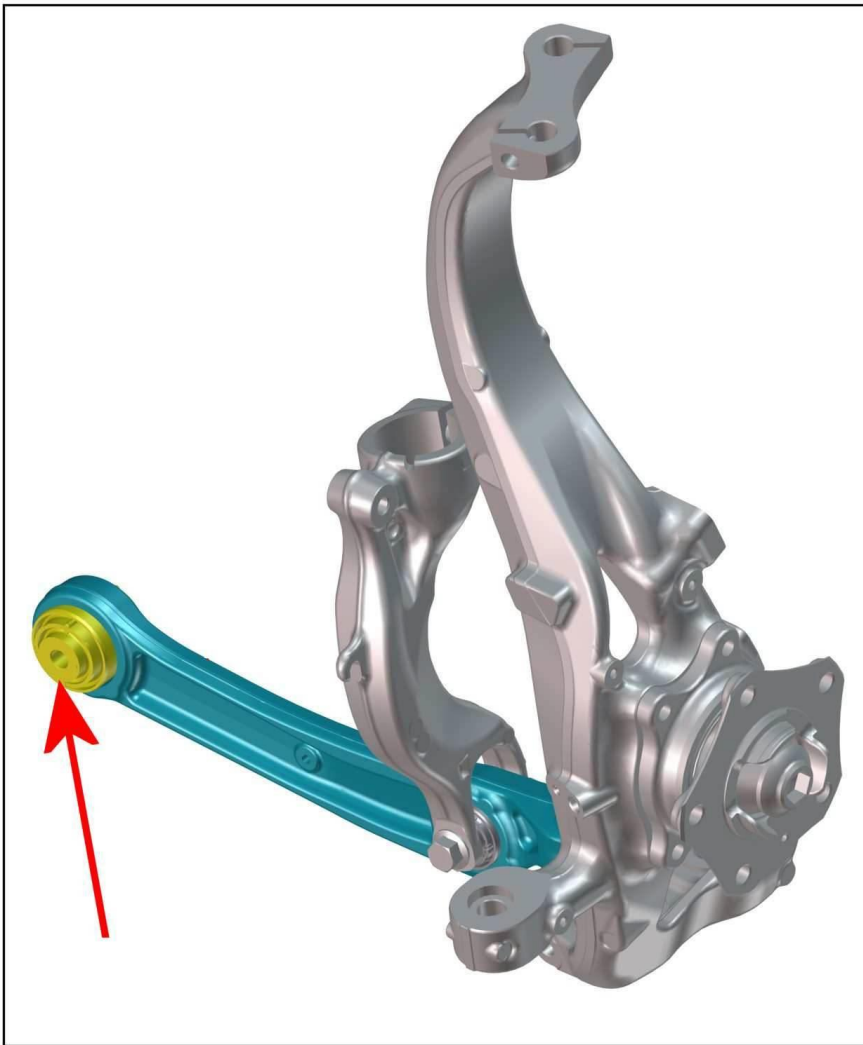
Figure 1

Single click from the front wheel corner(s) when the steering is moved from lock to lock whilst stationary

- If so then replace both front lower inner control arm bushes (Figure 1)

IMPORTANT: Please check the vehicle Repair History to confirm the inner bushes have not been previously replaced, if they have been replaced once before, You must then replace the complete arm, Do Not carry out the bush replacement procedure more than once (per lever)

IMPORTANT: Prior to starting this procedure ensure you have assembly lubricant part number G 052 566 A2 this must be used when fitting the new replacement bushes, the lubricant should only be used when the bushes are replaced as per the instructions within TPI 2052853/-

Each bush should have 5ml of lubricant applied prior to fitment within the bush, the grease should remain present throughout the fitting/pressing in procedure as the grease aids the fitting process and is also crucial once fitted to eliminate any further noise issues *Please Note that x1 – 100 ml tube will be sufficient for use on 20 bushes (10 vehicles) – Do not order x1 tube of lubricant per each individual vehicle complaint*

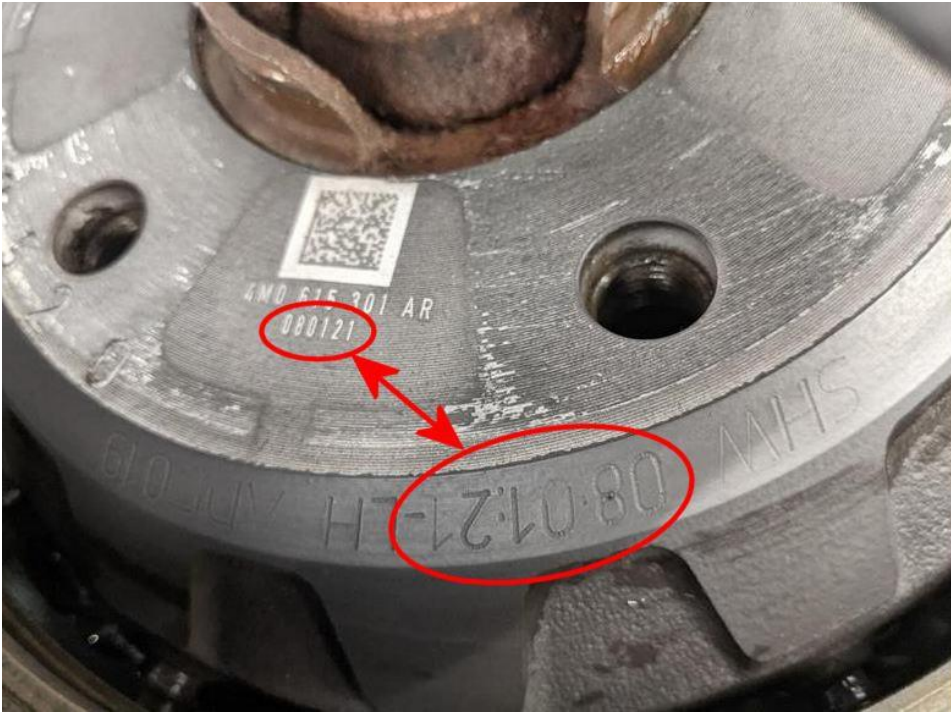
NOTE: The date shown in Figure 2 is 08-01-21

- Clear video of the issue must be attached
- Photographs of the left and right hand front brake disc date of manufacture stamp as shown in Figure 2
- Await feedback via DISS before conducting any further work
