Panamera E-Hybrid – Thermal Management Control Unit Fault P26B100 Causes Check Engine Light

Vehicles Affected

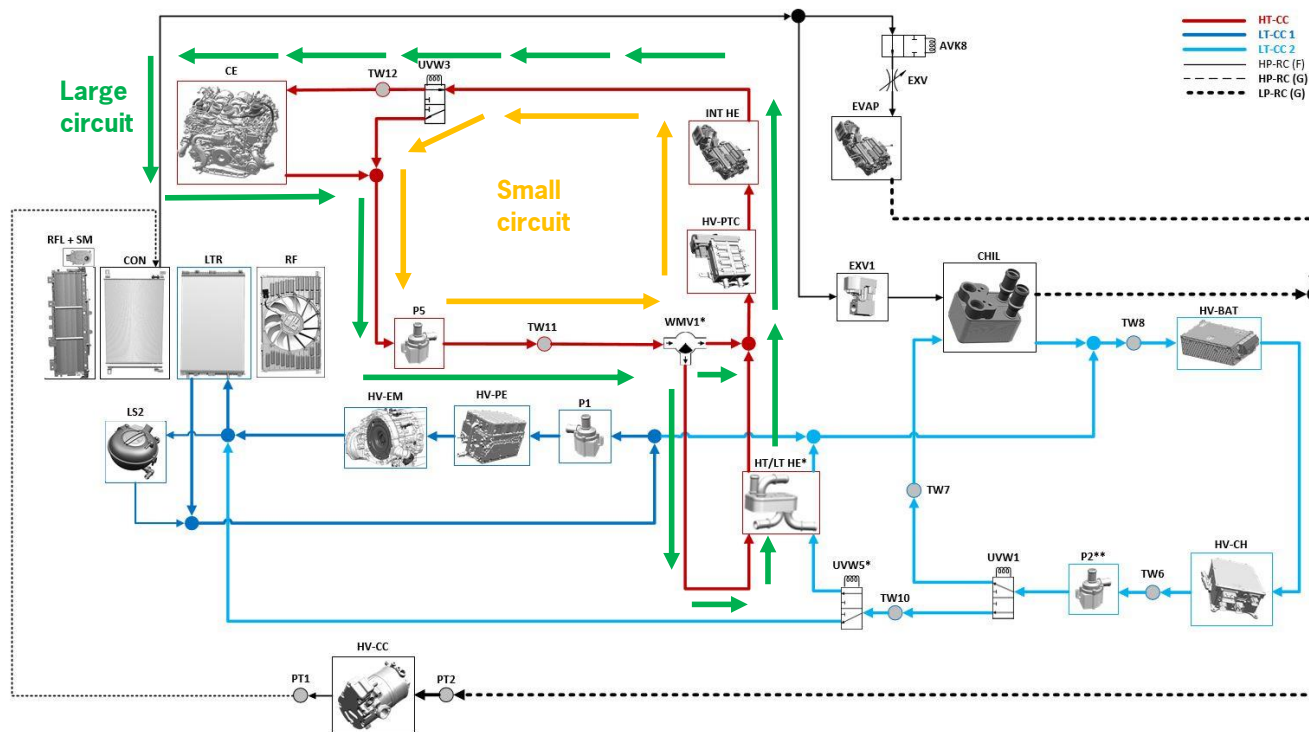
Figure 1: Panamera E-Hybrid Cooling Circuit

While the combustion engine temperature is $< 40\text{ }^{\circ}\text{C}$ ($104\text{ }^{\circ}\text{F}$), the changeover valve UVW3 will remain closed such that the passenger compartment is heated via the HV interior heater on the small coolant circuit. During small circuit operation, the absolute value of the temperature difference between temperature sensors TW11 and TW12 should be $> 7\text{ K}$ ($> 7\text{ }^{\circ}\text{C}$).

Once the combustion engine temperature is within the range of $40\text{ to }60\text{ }^{\circ}\text{C}$ ($104\text{ to }140\text{ }^{\circ}\text{F}$), the valve UVW3 opens and the coolant circuit is operating on the large circuit that includes the combustion engine circuit. During large circuit operation, the absolute value of the temperature difference between temperature sensors TW11 and TW12 should be $< 7\text{ K}$ ($< 7\text{ }^{\circ}\text{C}$).

During short operation of the combustion engine after cold start, the coolant temperature may rise to the range of $40\text{ to }60\text{ }^{\circ}\text{C}$ ($104\text{ to }140\text{ }^{\circ}\text{F}$) and valve UVW3 may or may not open. There is a possibility that the valve remains closed and waste heat from the engine continues to heat up temperature sensor TW12. If the valve is closed and sufficient waste heat exists, the absolute value of the temperature difference between sensors TW11 and TW12 may fall below the 7 K ($7\text{ }^{\circ}\text{C}$) threshold. Such conditions may cause the TME to believe valve UVW3 is stuck in an

incorrect position (e.g., closed when it should be open), despite the system functioning properly. This misdiagnosis may set fault code P26B100 in the TME.

1. Open a PCSS job and create a VAL.
2. In the VAL, find TME fault P26B100 and open the fault information. Check the value of 13_Fault display in the instrument cluster. If this value is "on", this fault is the cause of the check engine light.

3. Find the Thermal management control unit (TME) in the "Overview" tab in the PIWIS Tester and select it.
4. Navigate to the "Extended Identifications" tab to view the control unit information. Check the current software level in the TME. The current SW level should correspond to one of the two Factory SW Levels given in Table 1 below.
5. Please navigate to the Overview tab in the PIWIS Tester and select "Additional menu" on the bottom toolbar. Select "Campaign" from the list and use the Programming Code given in Table 1 below.

6. After programming is complete, navigate to the "Extended identifications" tab for the TME. Verify that the control unit successfully updated to the Final SW Level given in Table 1. Please also create an "After repair" VAL.
7. If the fault persists after updating the TME to SW Level 0305, please ensure the coolant system is properly filled and bled and that there are no electrical or mechanical faults with valve UVW3 or with temperature sensors TW11 and TW12. Please also check coolant hoses for proper routing and/or restrictions.
