INFINITI

TECHNICAL SERVICE BULLETIN

Classification: AN22-007	Reference: ITB22-017	Date: April 12, 2022
-----------------------------	-------------------------	-------------------------

B2E01-96 (INTERNAL BATTERY) DTC STORED AS CURRENT IN IVC

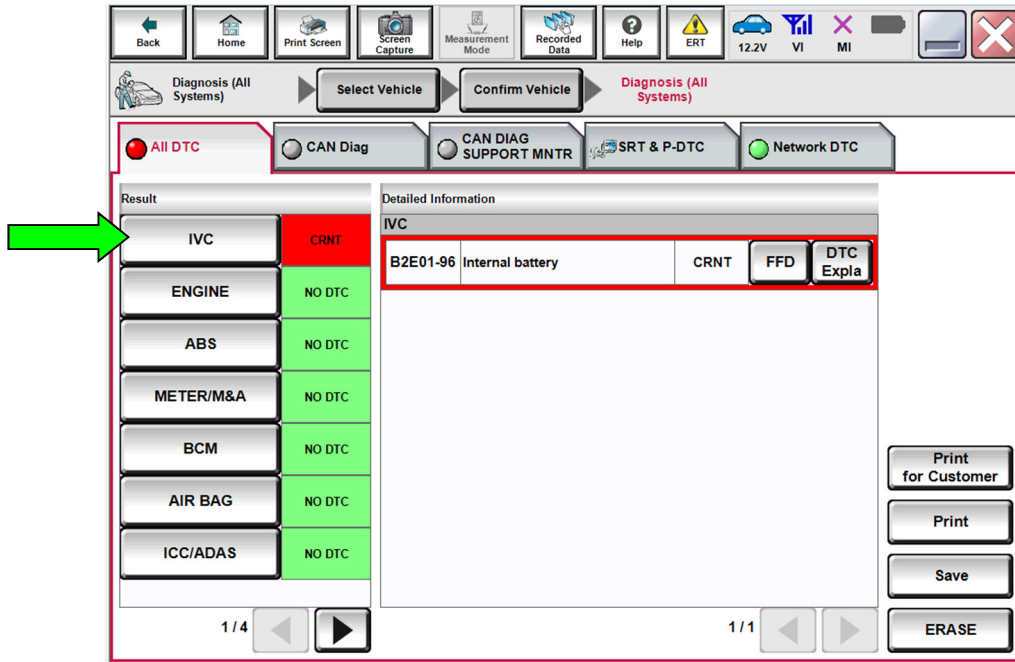
Figure 3

9. Confirm that DTC B2E01-96 for Internal battery is “CRNT” in the **IVC**.
 - If only DTC B2E01-96 is present, select **IVC** (Figure 3) and then proceed to step 10.
 - If additional DTCs, other than B2E01-96, are present in the **IVC**, refer to the ESM for further diagnostic information and repair first, and then proceed to step 10.
