Service Bulletin

SERVICE PARTS CHANGED FOR IMMOBILIZER UNIT

Bulletin No: 09-001/16

2000-2003 MPV 2001-2005 MX-5

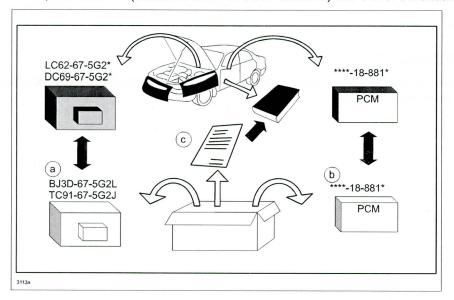
If the immobilizer unit LC62-67-5G2* or DC69-67-5G2* needs to be replaced with a new one, these parts are no longer available. New alternative service parts kits are now available, including alternative immobilizer unit BJ3D-67-5G2L or TC91-67-5G2J. They will require the following additional procedure to be performed in order to work on the vehicle.

1. Replace "a" and "b", and insert "c" (DECLARATION of CONFORMITY) into Owner's Manual.
