© 2016 Mazda Motor of America, Inc.

Subject: CONDENSATION / FOG IN FRONT AND REAR COMBINATION LIGHTS	Bulletin No: 09-003/16
	Last Issued: 01/25/2016

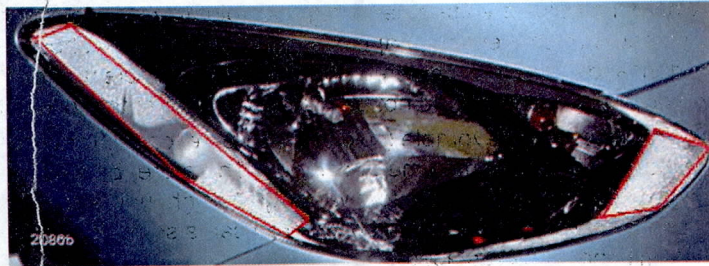
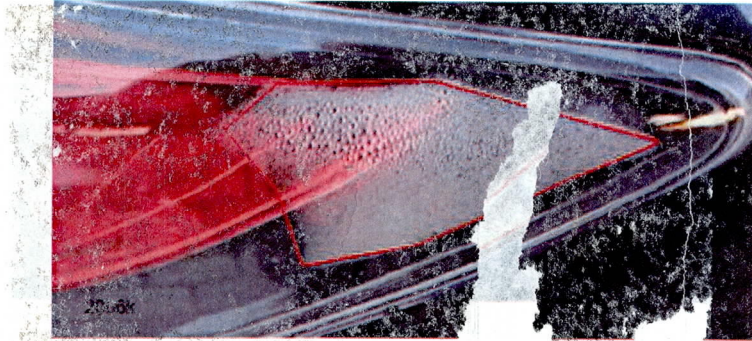
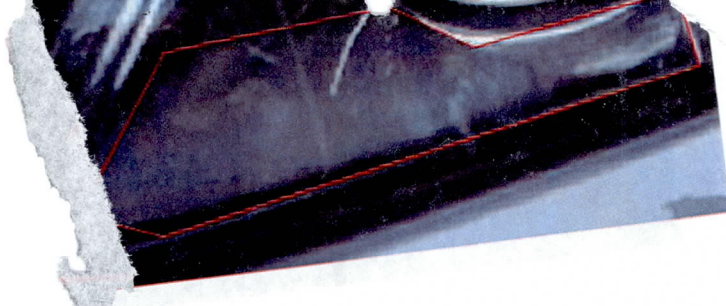
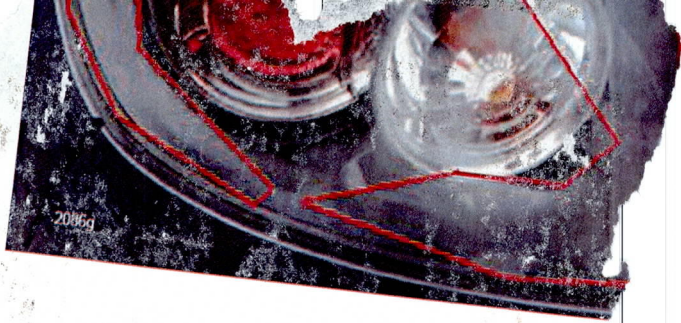
Examples of Light Units With Condensation/Fog That Should NOT Be Replaced

Condensation/fogging along the edges and in the corners is considered normal.

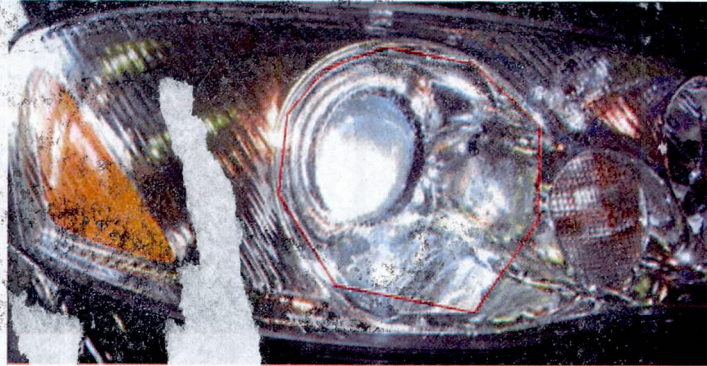
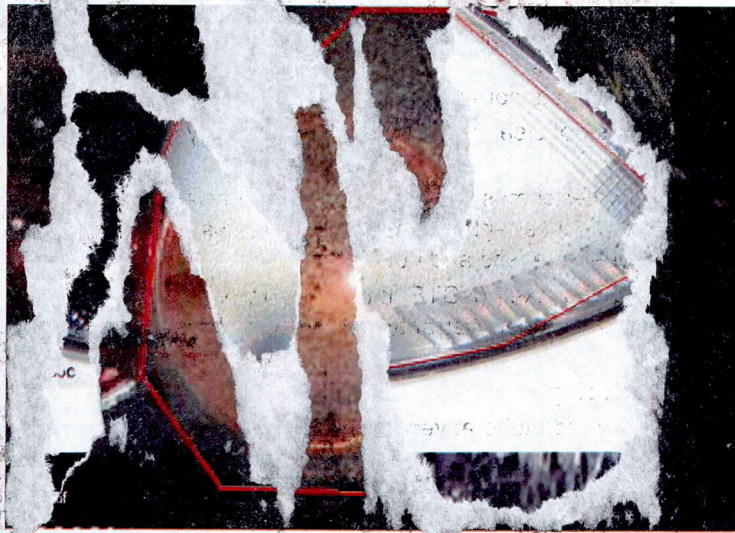
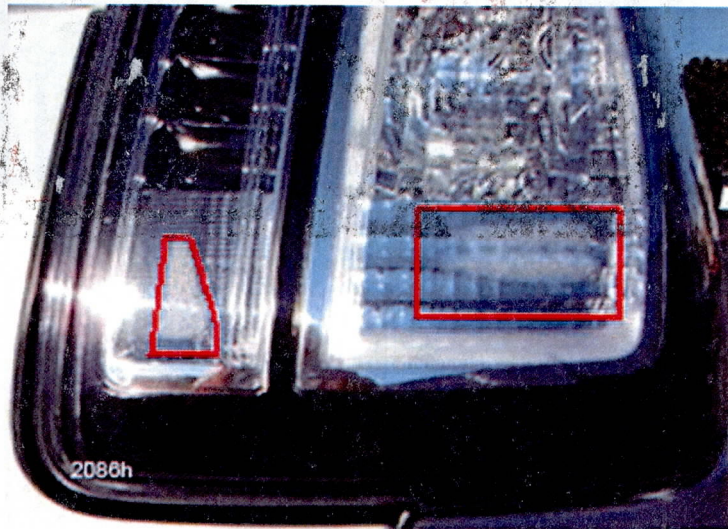
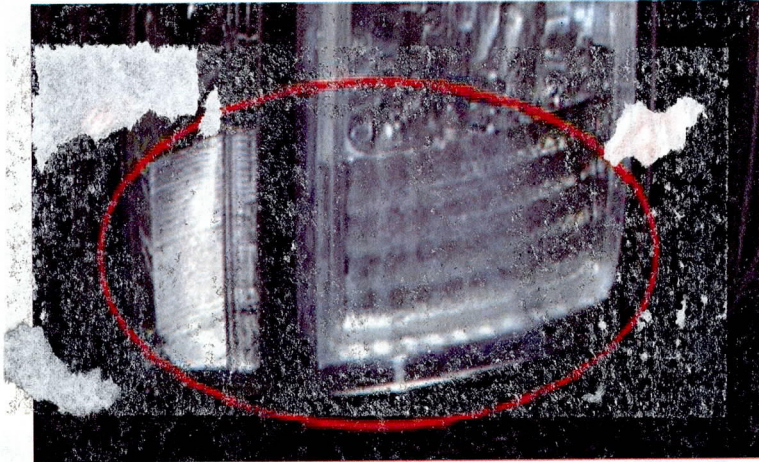
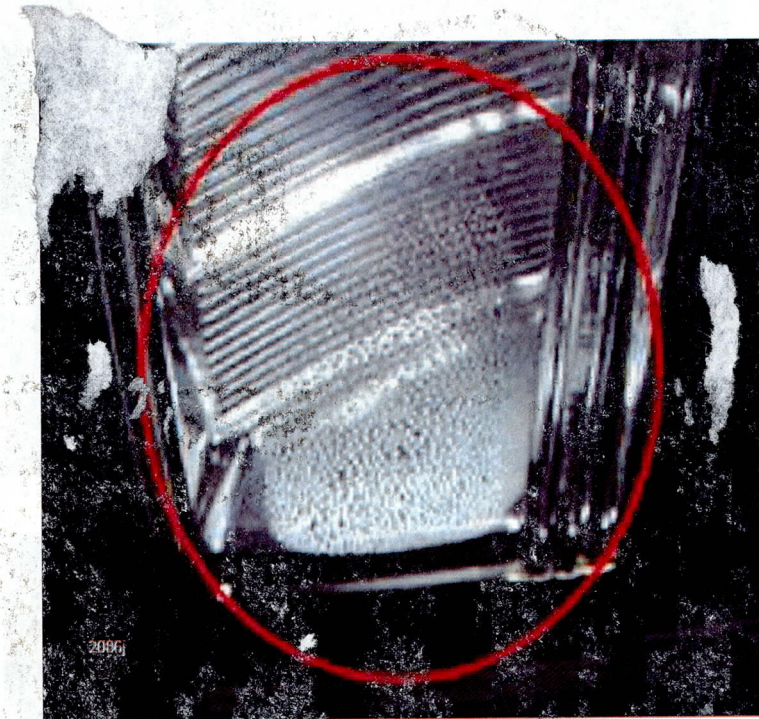
Some condensation/fogging on the lens is considered normal.

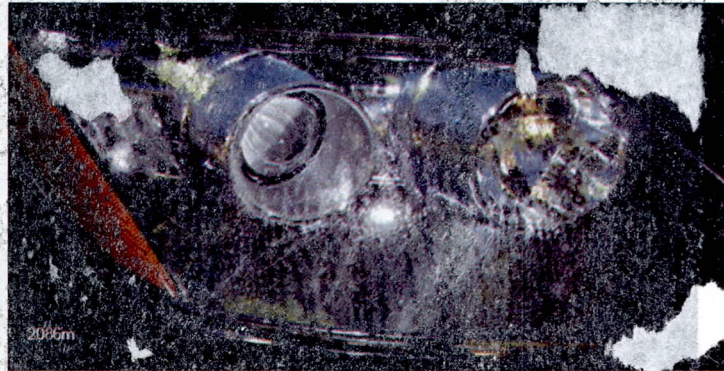
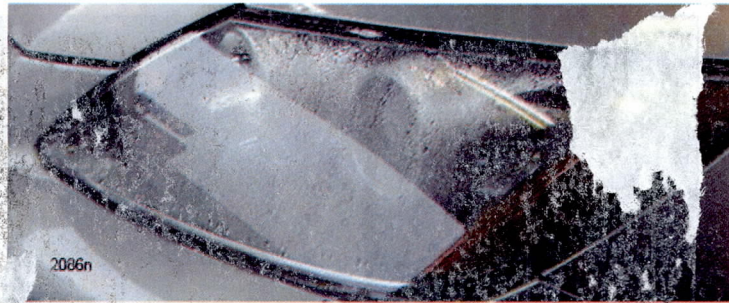
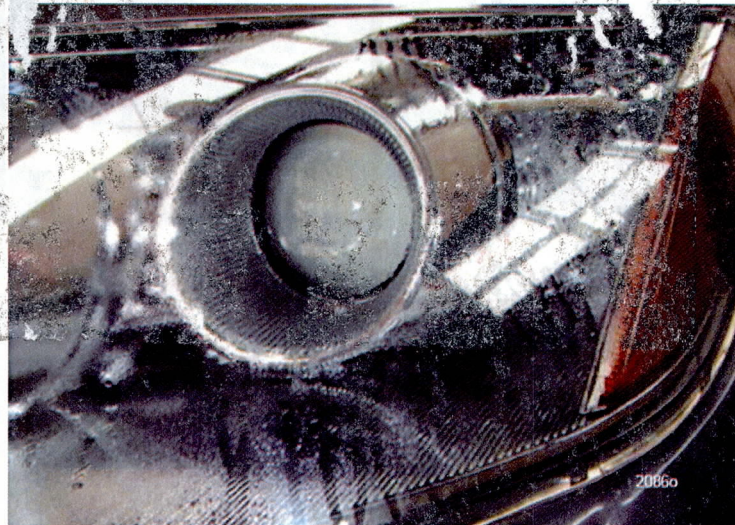
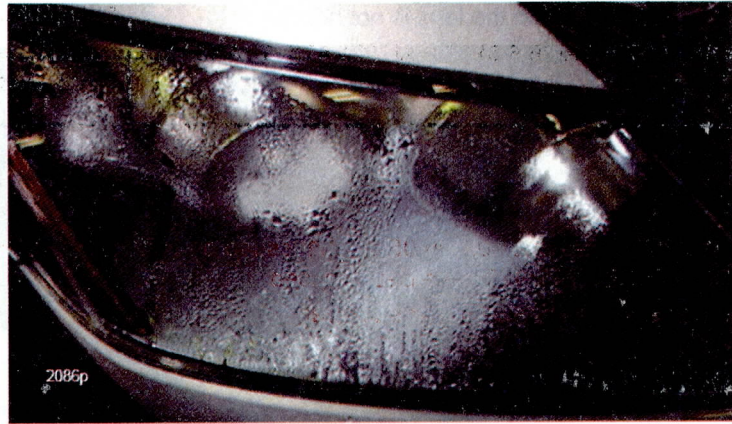
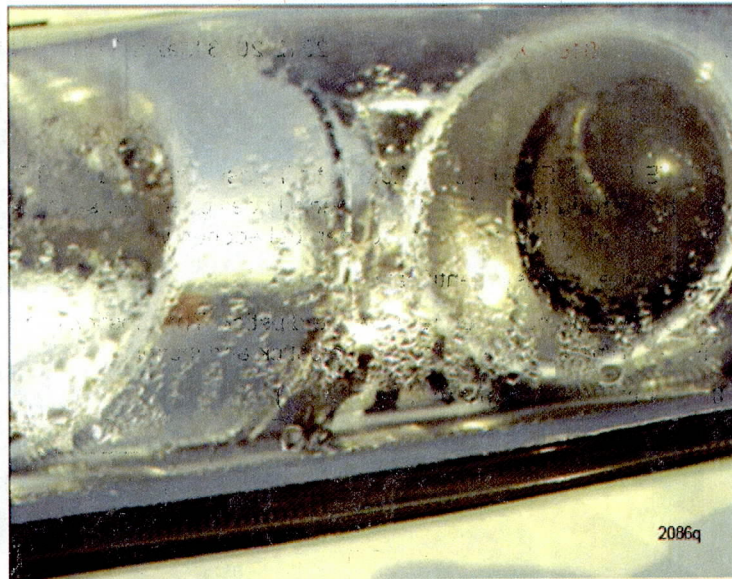
Examples of Light Units With Condensation/Fog That Should Be Replaced

Heavy/large amount of condensation/fog is not normal.

- The location where the bulbs are fitted has a high air volume with good air circulation, therefore, if a large or heavy amount of condensation appears here, the light unit should be replaced. A small amount of condensation here is considered normal and should clear after the lights have been on for some time and the light unit should not be replaced. Refer to the following pictures for examples.

- If the condensation/fog does not clear, it is abnormal (water entry is suspected), and the light unit should be replaced.
