Service Bulletin

Bulletin No.: 18-NA-020

Subject: Malfunction Indicator Lamp Illuminated with DTCs P0300, P0299, P0234 and/or P2227 Set

Brand:	Model:	Model Year:		VIN:		Engine:	Transmission:
		from	to	from	to		
Chevrolet	Equinox	2018	2022	-	-	Equipped with 2.0L or 1.5L Engine (RPOs LTG, LYX)	All
GMC	Terrain

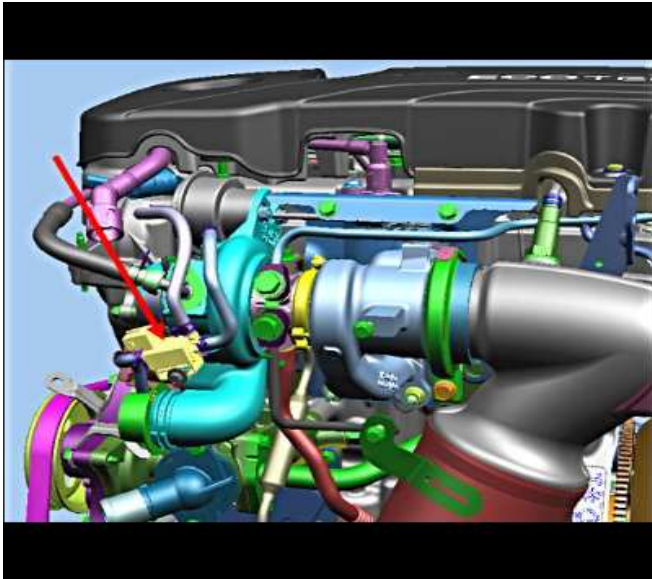
6055063

Inspect the Turbocharger Control Valve (TCV) to ensure it is not frozen.

1. Remove Turbocharger Wastegate Regulator Solenoid Valve.
2. Drain Turbocharger Wastegate Regulator Solenoid Valve (TCV) by turning valve upside down.

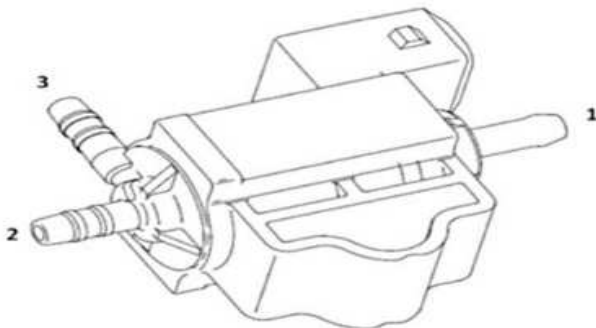
6055068

Note: Check port #2 to assure the spring gets lifted off the seat. This will be determined by the compressed air not dead heading when applied to port #2. When applying air to this port a small amount of air should be observed at port #3 and even less air will be noticed at port #1. If this does not happen, the TCV plunger may have hardened deposits from hot operating conditions which will impede TCV plunger movement, and the Turbocharger Wastegate Regulator Solenoid Valve should be replaced.

3. Using clean shop air regulated to 80-100 PSI (551-689 kPa), blow through all three ports (1, 2 & 3) for 5 seconds each. Repeat this step twice.
