Service Bulletin

Bulletin No.: 22-NA-089

Subject: Intermittent Click Noise at Front of Vehicle, ABS, Traction Control System (TCS)/ Stabilitrak Lamps May Illuminate Intermittently and/or Deactivate for Ignition Cycle - DTC P215B, C0035-C0051 Set

Brand:	Model:	Model Year:		VIN:		Engine:	Transmission:
		from	to	from	to		
Chevrolet	Bolt EV	2017	2019	—	—	—	—

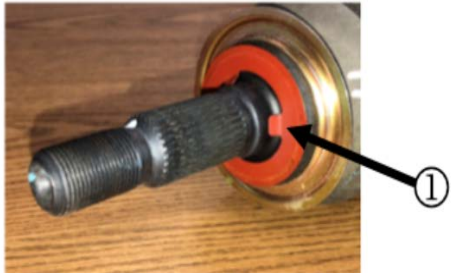
5317523		
Correction	<p>This condition may be caused by fracturing of the front wheel drive shaft anti-click washer and possible collateral damage to the ABS wheel speed sensor (WSS).</p> <p>Note: In cases where the condition is verified on both sides of the vehicle, replace the anti-click washer on BOTH sides.</p> <p>Upon verifying the condition, replace the anti-click washer with new part number shown below on the affected half shaft(s), then inspect the wheel speed sensor on that side(s).</p> <p>Note: If DTC P215B ever sets on the vehicle, replace the wheel speed sensor.</p>

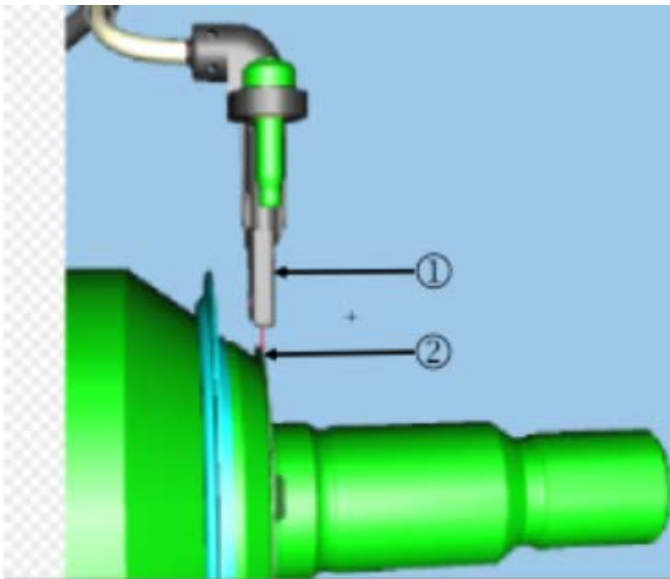
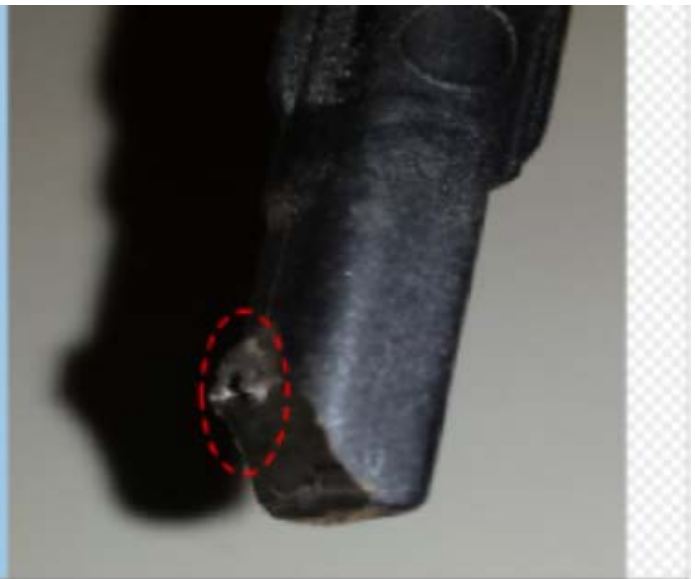
5317529

Note: The example above depicts the wheel speed sensor (WSS) (1) directly in-line with the anti-click washer (2) on the outboard joint of the half shaft.

4. Inspect the WSS on either/both affected side(s) for possible damage. It may be damaged due to contact with the oversized damaged washer.
 - If no damage is found, reinstall the lower control arm to the steering knuckle, and no further repairs are necessary.

- If the WSS is found to be damaged (as shown circled in the graphic above), continue ahead to step # 5.
