Service Bulletin

Bulletin No.: 22-NA-113

Subject: Head Up Display (HUD) Blank, Non-Responsive to Brightness, Aim, or Page Controls, DTC U0158 Set

Brand:	Model:	Model Year:		VIN:		Engine:	Transmission:
		from	to	from	to		
Cadillac	CT4	2020	2022	—	—	—	—
	CT5

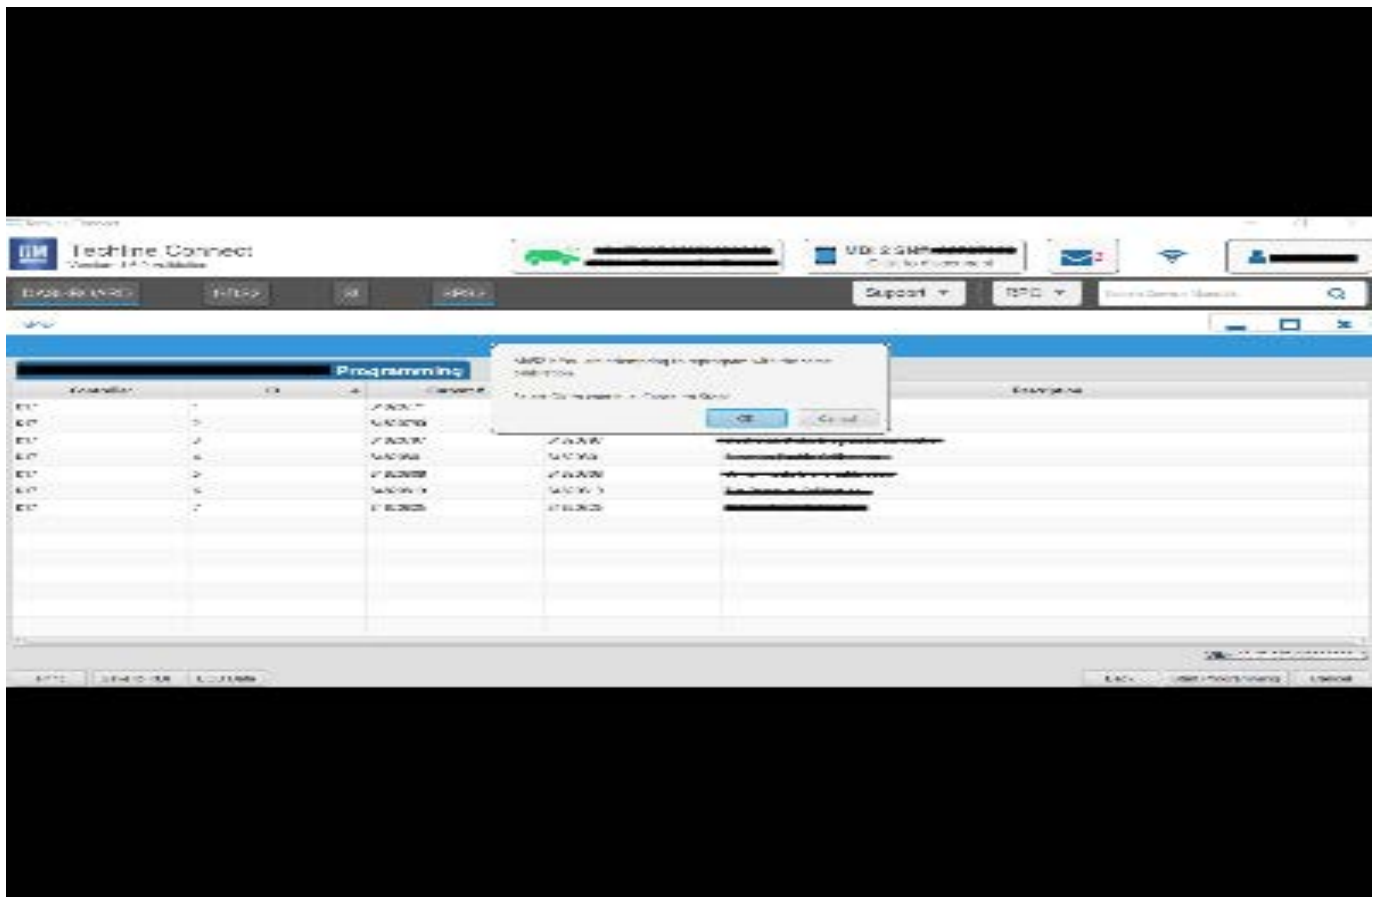
5644477

Important: Techline Connect screen shown above.

Important: If the same calibration/software warning is noted on the TLC or SPS Summary screen, select OK and follow screen instructions. After a successful programming event, the WCC is located in the Service Programming System dialogue box of the SPS

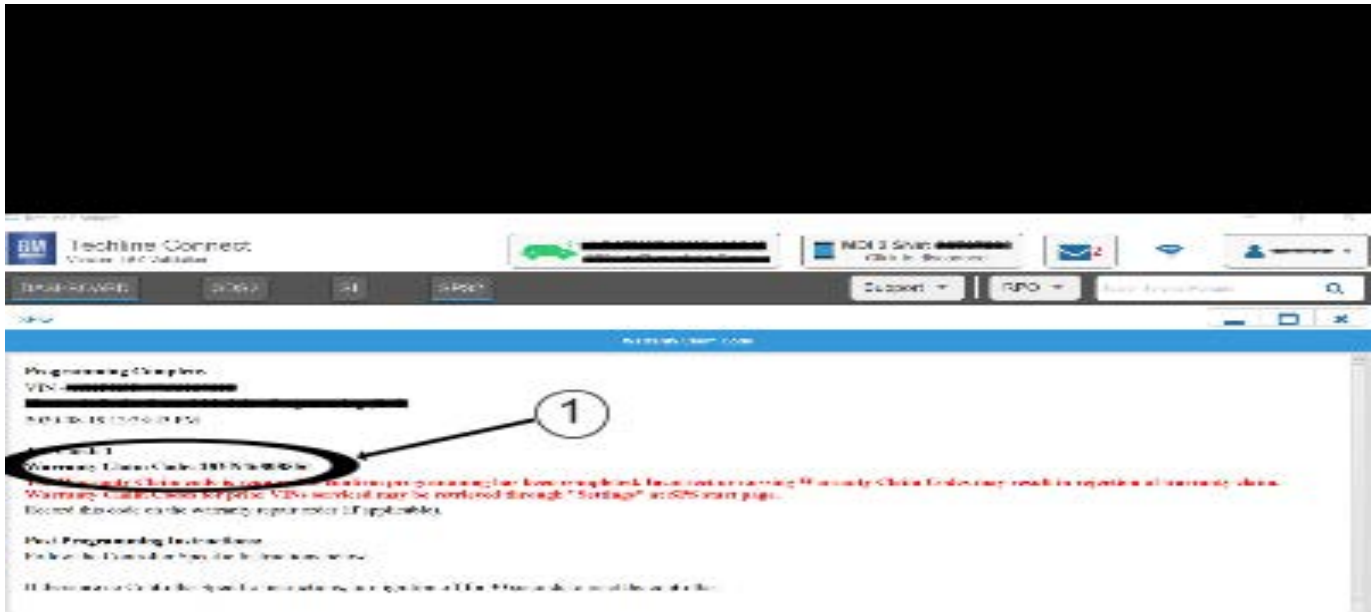
Note: The screenshot above is an example of module programming and may not be indicative of the specific module that is being programmed. Module selection and VIN information have been blacked out.

Important: To avoid warranty transaction rejections, you **MUST** record the warranty claim code provided on the Warranty Claim Code (WCC) screen shown above on the job card. Refer to callout 1 above for the location of the WCC on the screen.
