TECHNICAL SERVICE BULLETIN

AN22-004

NTB22-029

SOFTWARE UPDATE FOR INFOTAINMENT ISSUES

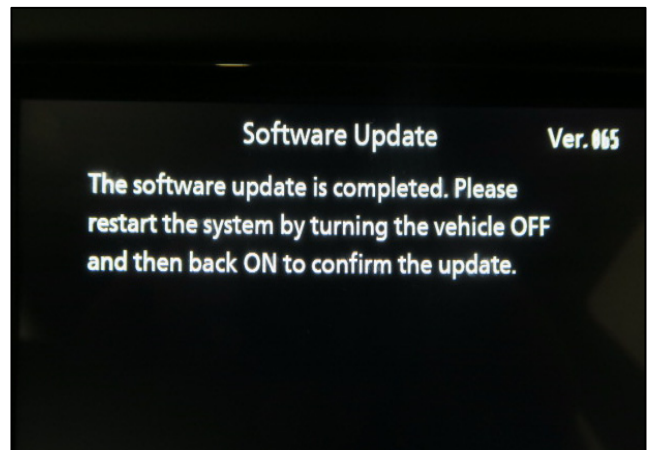
Do not remove the USB drive until the screen in Figure 15 is displayed. If removed prior to this screen being displayed, the AV control unit may be damaged

20. When the message shown in Figure 15 is displayed, remove the USB drive from the USB media port.
