Service Bulletin

Bulletin No.: 22-NA-064

Subject: In-Vehicle MyBrand App Login Error IOK Radio

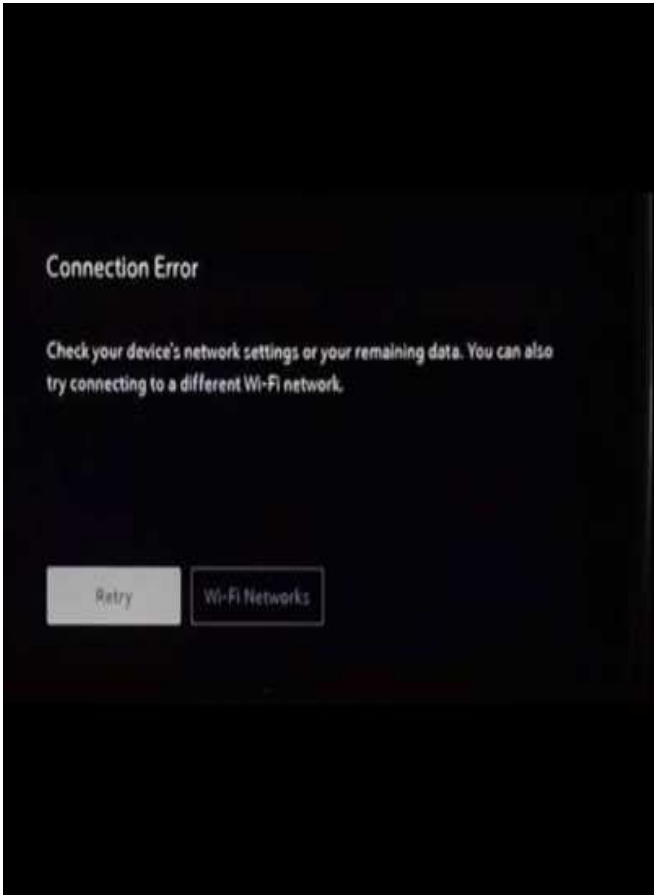
6017552

| Condition | <p>Some customers may comment that they are unable to login to the In-vehicle MyBrand application and will notice a connection error message on the radio display:</p> |

| Cause | The cause of the condition may be a software anomaly in the radio. |

| Correction | Do not replace the radio for this particular concern. Dealers are asked to reprogram the radio with the latest calibration available. |

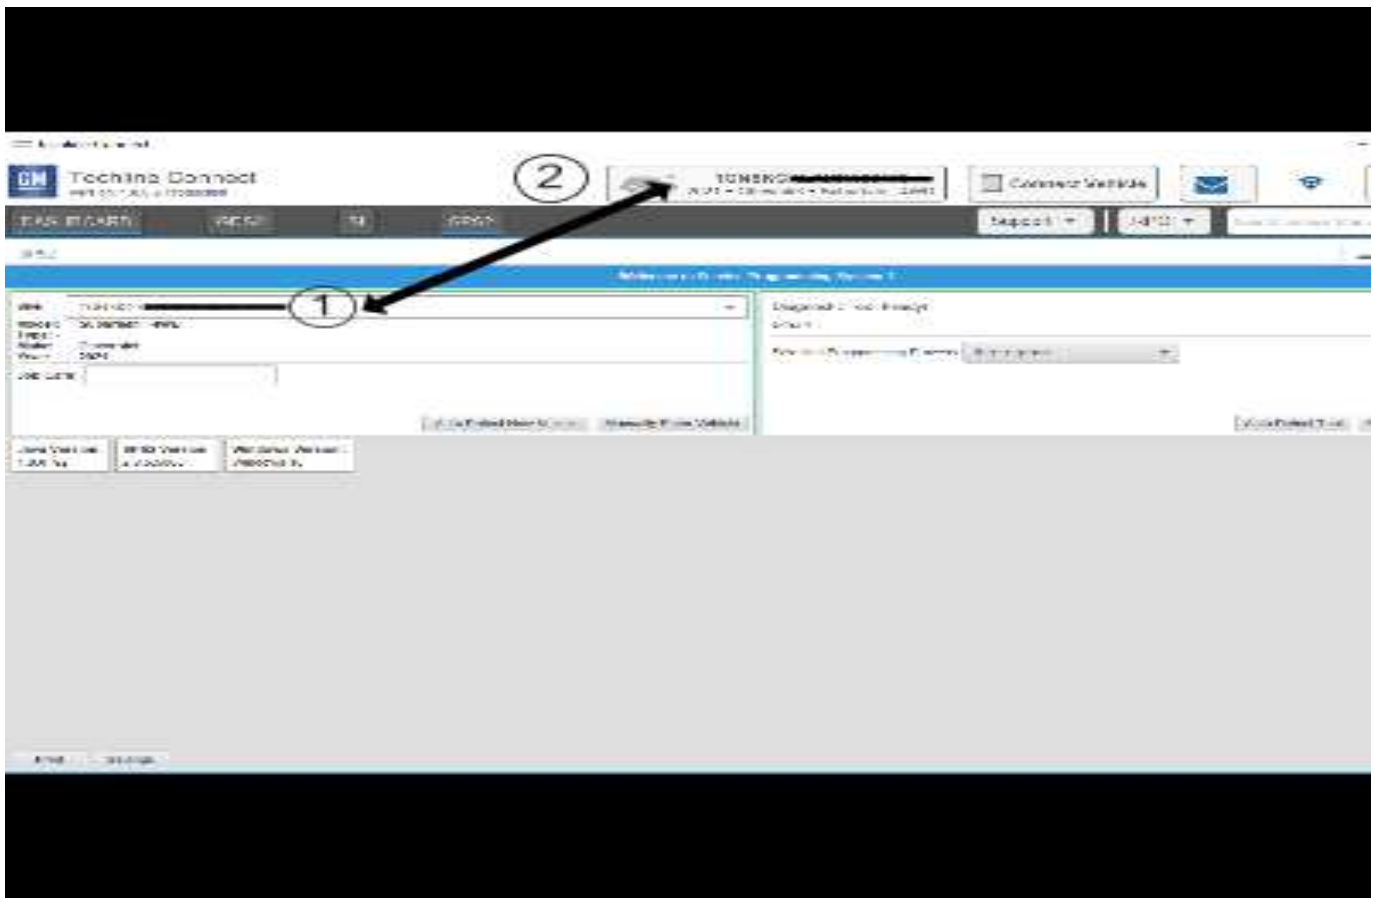
5743643

Caution: Be sure the VIN selected in the drop down menu (1) is the same as the vehicle connected (2) before beginning programming.

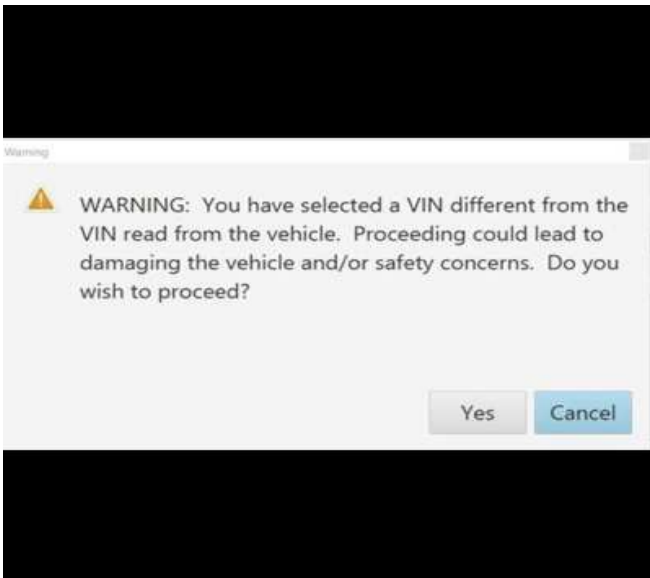
5877000

Important: If the vehicle VIN DOES NOT match, the message below will be shown
