GROUP	NUMBER		
BRAKES	22-BR-001H-1		
DATE	MODEL(S)		
MAY, 2022	GENESIS (BH) EQUUS (VI)

GENESIS (BH) AND EQUUS (VI) HECU (WARRANTY EXTENSION TXXP)

THIS TSB SUPERSEDES 22-BR-001H TO ADD AN OP CODE FOR PART NUMBER 58920-3M0A6

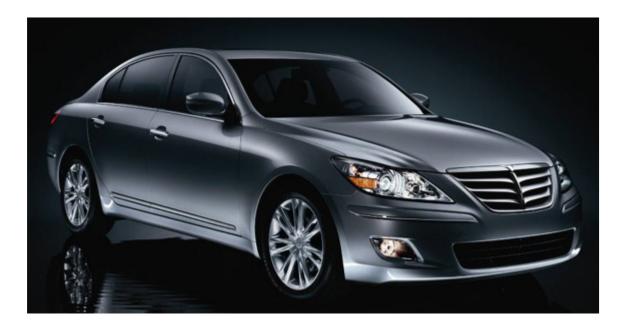
Description: The warranty coverage for the hydraulic electronic control unit (HECU) for certain Genesis (BH) and Equus (VI) vehicles for repairs and replacement has been extended to 15 years with unlimited miles from the date of original retail delivery or date of first use, and is valid for original and subsequent owners.

- If HECU is found to be defective, replace the HECU according to the applicable Service Manual procedures.
- Air bleeding and HECU calibration are required after replacing the HECU.
