Bulletin No.: PIT5915A

## PIT5915A No Crank Due To Dead or Low Battery (N212351590)

Brand:	Model:	Model Years:	VIN:		Engine:	Transmissions:
			from	to		
Chevrolet	Suburban	2022	All	All	All	All
Chevrolet	Tahoe	2022	All	All	All	All
GMC	Yukon Models	2022	All	All	All	All

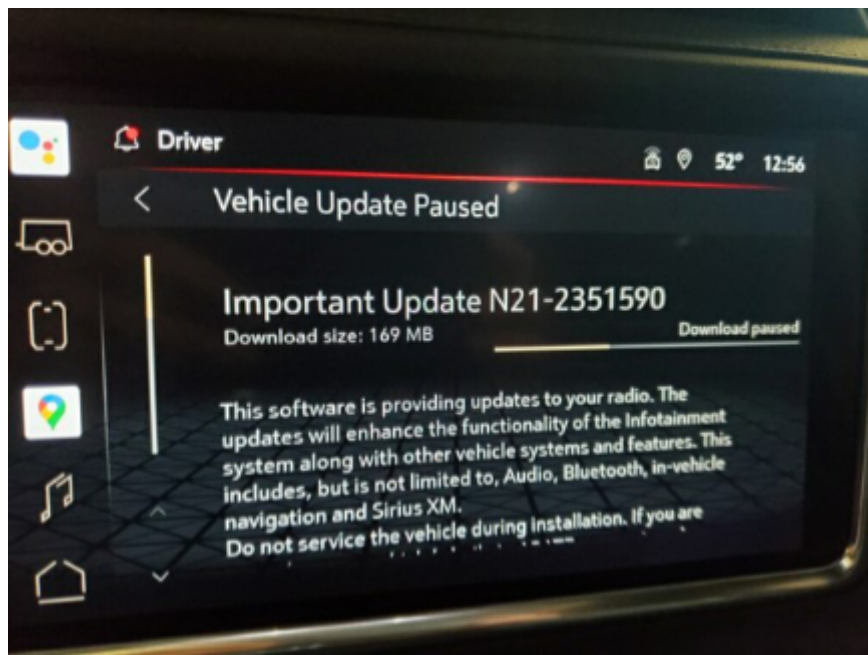
Involved Region or Country	North America
Condition	Some customers may experience a no crank due to a low or dead battery.
Cause	The cause of this concern could be a failed Over The Air (OTA) update.

Charge the battery and test using the GR8 or DCBS to make sure the battery is good. After the battery is recovered, check the radio/infotainment update menu for a pending update. If the update shows download paused, example shown above, then the dead battery was the result of the OTA event failing in the Serial Data Gateway Module (SDGM).

To recover the SDGM: (Read all instructions before starting the procedure)
