Preliminary Information

PIT5915B No Crank Due To Dead or Low Battery (N212351590)

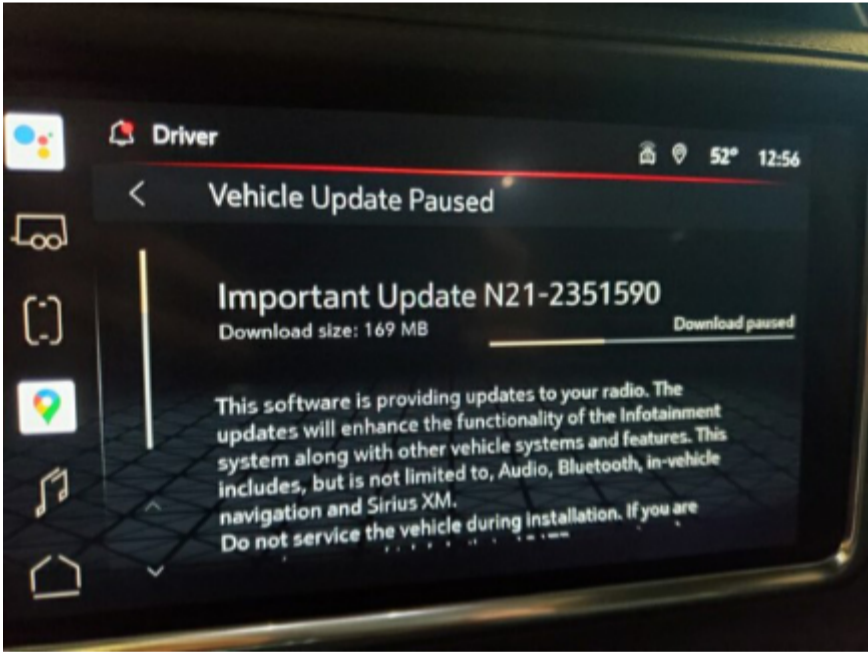
Involved Region or Country	North America
Condition	Some customers may experience a no crank due to a low or dead battery.
Cause	The cause of this concern could be a failed Over The Air (OTA) update.

Charge the battery and test using the GR8 or DCBS to make sure the battery is good. After the battery is recovered, check the radio/infotainment update menu for a pending update. If the update shows download paused, example shown above, then the dead battery was the result of the OTA event failing in the Serial Data Gateway Module (SDGM).

To recover the SDGM: (Read all instructions before starting the procedure)
