# VW Elsa Newsletter

Edition 168: January 11, 2016

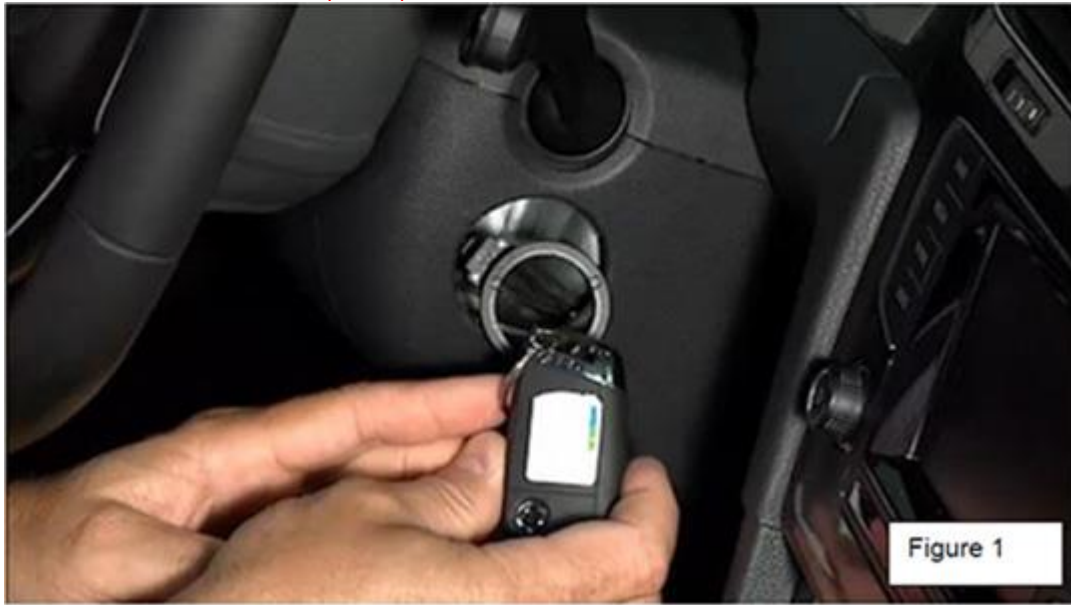
**96-14-05 Immobilizer Key/Key Remote Adaptation**

To adapt keys to a 2015 Golf or Golf GTI, it is necessary to complete the “Adapt Immobilizer” test plan. **Kessy Vehicles:** Verify that the reader coil (figure 1) is removed from the steering column and the key is touching the reader coil during key adaptation. Bladed key vehicle, it is not necessary to remove the reader coil. The test plan can be found under the ODIS Special Functions Tab (figure 2) or by navigating to “Immobilizer functions” under “Elect. Immobilizer 5A” after clicking the “Select self-test” button in the Test Plan tab (figure 3). This procedure adapts both the remote and immobilizer functions of the key.
