# Tech Tips

TT 96-14-05

2015-2016 Golf, GTI, **Golf R, Sportwagen** -Immobilizer Key/Key Remote Adaptation Test Plan

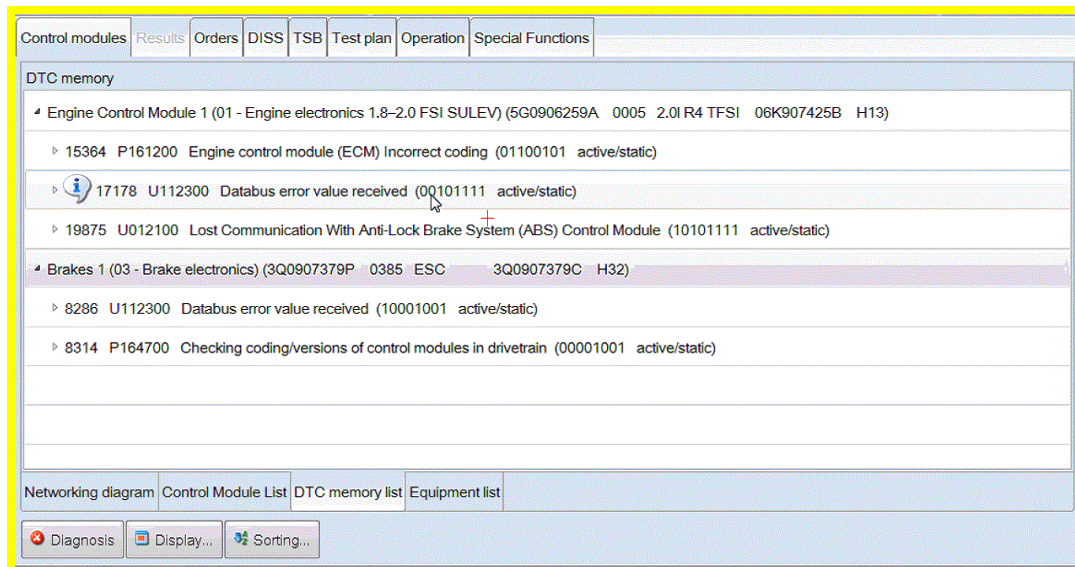
Vehicle doesn't start and or warning lights on after immobilizer / key adaptation. Check for faults related to modules that may no longer be coded.

It will be necessary to recode all modules that are no longer coded. Code modules online under the special functions tab, "Code online control module". Modules may include, but not limited to ECM, ABS, TCM.

Clear all related faults, recheck operation of the vehicle.

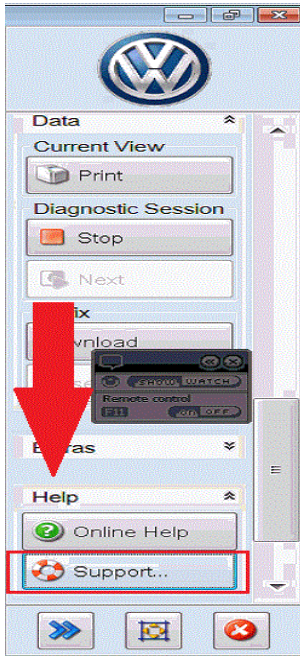
If a control module is no longer coded, the test plan for immobilizer / key adaptation has failed. If the scan tool being used is up to date, please submit feedback for the failed test plan using the Help tab and Support button in the right column of the scan tool.
