Service Bulletin

Bulletin No.: 21-NA-284

Subject: 60% Rear Seat Will Not Fold Down

Brand:	Model:	Model Year:		Date Breakpoints:		Engine:	Transmission:
		from	to	from	to		
Cadillac	Escalade Models	2021	2022			All	All
Chevrolet	Suburban						
	Tahoe						
GMC	Yukon Models

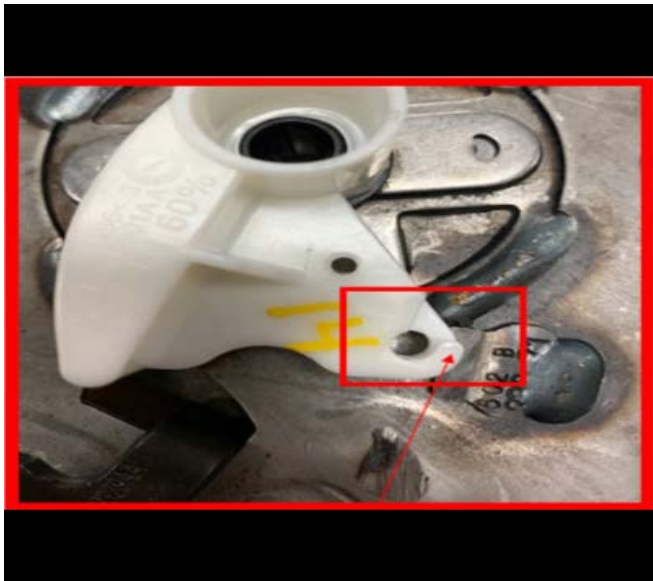
5932660

Note: Inspect outboard white release lever for damage or missing material (1). If damage is found, the entire structure must be replaced.

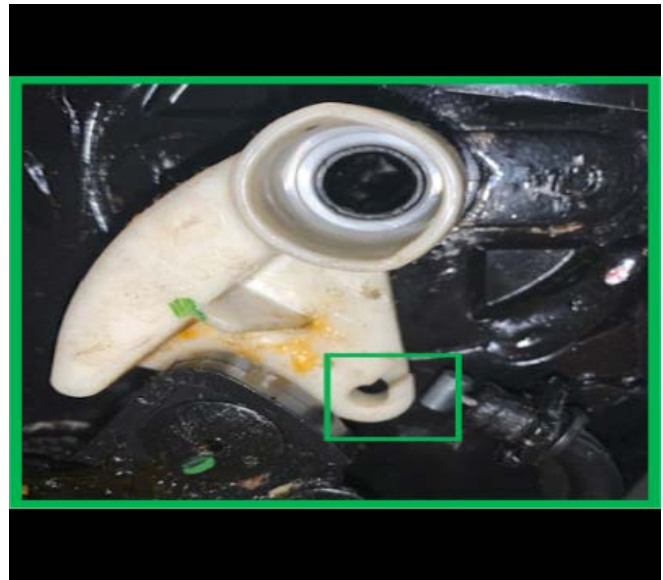
5932661

2. Verify cable is disconnected from the outboard white release lever.
3. Disconnect the outboard cable fitting:
