MIL ON With DTCs P0AA649 and/or P1C8049 or AM Radio Static/Distortion

Service Category Engine/Hybrid System

Section Hybrid/Battery Control System

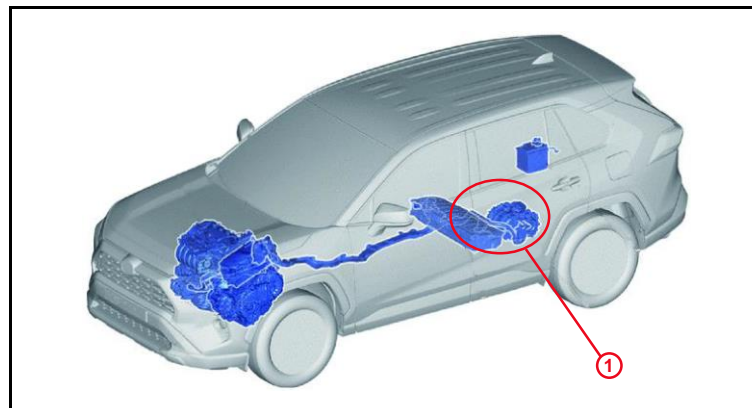
Figure 1. Image of HV Floor Under Wire Pathway Through Vehicle

The vehicle may also exhibit static or distortion when listening to AM radio. These conditions may be caused by corrosion on the high-voltage wire harness below the vehicle at connector Y6 at Motor Generator Rear (MGR) or dirt and debris inside the connector. Follow the Repair Procedure in this bulletin to address these conditions.

1	Area of Concern
----------	------------------------

4. Replace the HV Floor Under Wire.

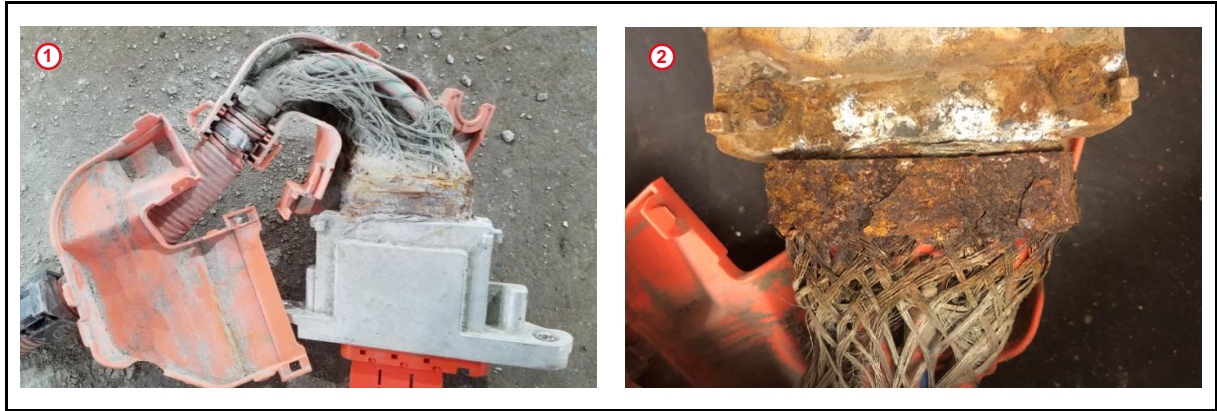
Figure 2.

1	Dirt, Corrosion, and Debris Build-up
2	Corrosion

- B. Disconnect the Y6 connector at the MGR and inspect for corrosion, dirt, or debris. Is dirt, debris, or corrosion present?
 - **YES** — Continue to step 2.
 - **NO** — This bulletin does NOT apply. Continue diagnosis using the applicable Repair Manual.

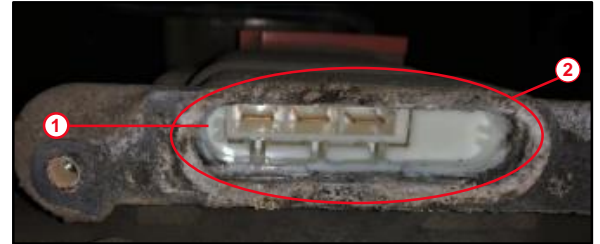
Figure 3.

2. Check connector housing of the MGR.
 - Is the chamfer or a further inner part corroded as shown?
 - **YES** — Continue to step 3.
 - **NO** — Go to step 4.

1	Chamfer
2	Corrosion

3. Replace the Cable, Motor, No. 2.
 - A. Remove Cable, Motor, No. 2 rear traction motor.
 - Refer to TIS, applicable model and model year Repair Manual:
 - [2019](#) / [2020](#) / [2021](#) RAV4 HV:
 - Drivetrain – Hybrid Transmission/Transaxle – “Q610 (Hybrid Transmission / Transaxle): Rear Traction Motor: Removal”*

- B. Install NEW Cable, Motor, No. 2 from rear traction motor.
 - Refer to TIS, applicable model and model year Repair Manual:
 - [2019](#) / [2020](#) / [2021](#) RAV4 HV:
 - Drivetrain – Hybrid Transmission/Transaxle – “Q610 (Hybrid Transmission / Transaxle): Rear Traction Motor: Installation”*
