Technical Service Bulletin

40 Creaking noises from front of the vehicle when driving - Q7, Q8, A8

40 22 41 2058489/5 June 8, 2022. Supersedes Technical Service Bulletin Group 40 number 22-40 dated April 26, 2022, for reasons listed below.

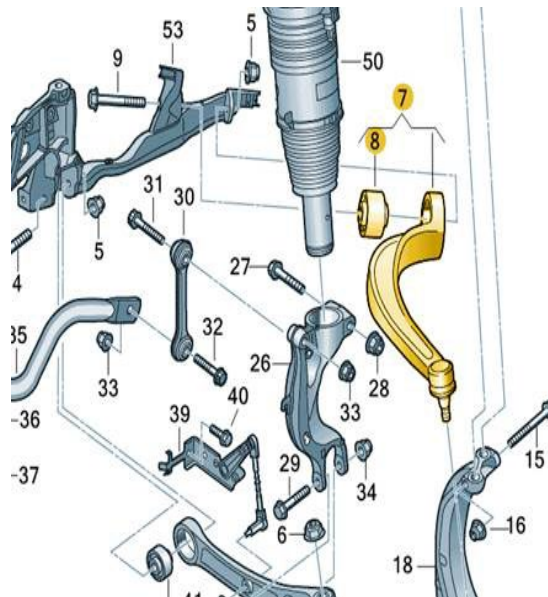
Figure 1. Hydro-bush.

- They can hear squeaking, creaking, or similar noises from the front end when driving on uneven roads. The noises can possibly be heard and felt in the footwell or behind the dash panel.

The noises can be generated on the lower-left guide in the area of the hydro-bushing. (Figure 1, Positions 7 and 8).

1. Replace the hydro-bushing on the guide link in pairs (Figure 1, Position 8) according to the instructions in the ELSA Repair Manual at *Chassis >> Suspension >> Wheels, Steering >> 40 Front Axles >> Lower Control Arm and Ball Joint >> Guide link bonder rubber bushing, Removing and Installing*.
2. If repeat repairs are necessary and the hydro-bushing has already been replaced (pressed out/in), the complete guide link has to be replaced (Figure 1, Position 7). Refer to the instructions in the ELSA Repair Manual at *Chassis >> Suspension >> Wheels, Steering >> 40 Front Axles >> Lower Control Arm and Ball Joint >> Guide link, Removing and Installing*.

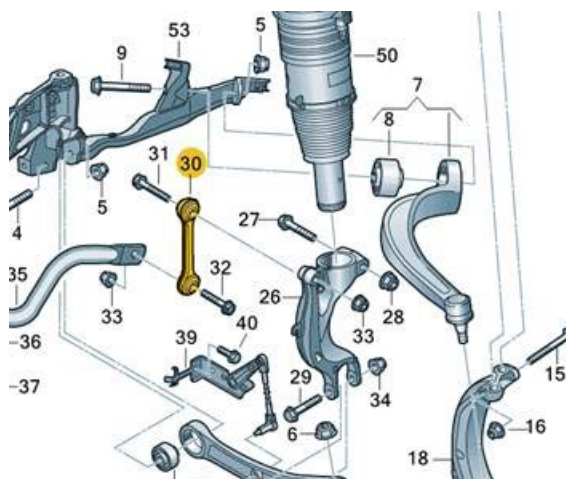
Figure 2. Coupling rod.

Parts such as the coupling rod (Figure 2, Position 30) are usually replaced by mistake, presenting no problems.
