STAR ONLINE PUBLICATION

Case Number: S1925000008 REV. D

Symptom/Vehicle Issue: Malfunction Indicator Lamp (MIL) Illumination. Diagnostic Trouble Codes (DTCs) P208B – Reductant Pump 1 Control Performance, and/or P20E8 – Reductant Pressure Too Low, Set.

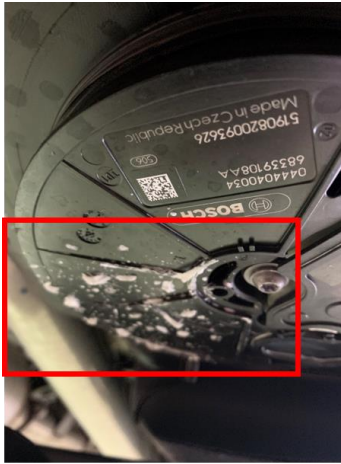
Figure 1.

2. Closely inspect the DEF supply line connections at the pump and injector to ensure there are no leaks. Look for signs of wetness, and/or crystallization around the connections indicating a leak. Please see (Figure 1, and 2.). Repair any leaks before proceeding with the rest of this procedure.
