Subject: N212345440 - Customer Satisfaction Program
Heater Outlet Pipe

Models: 2019 – 2021 Chevrolet Silverado 4500HD/5500HD/6500HD

Customer Satisfaction Program

N212345440 Heater Outlet Pipe

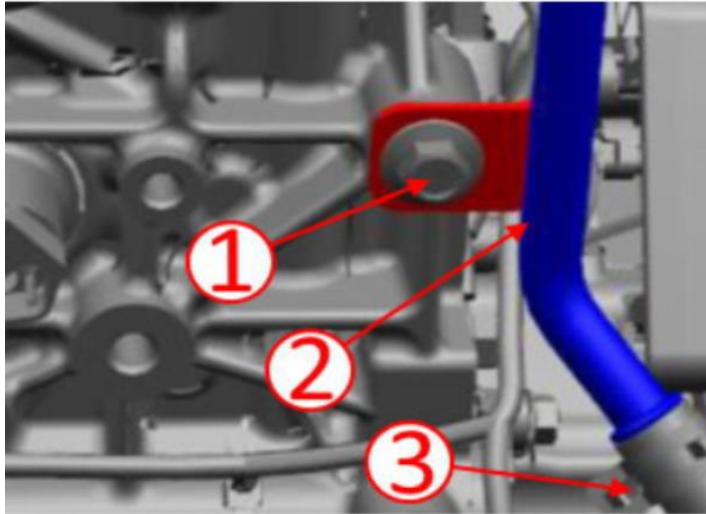
Condition	Certain 2019 - 2021 model year Chevrolet Silverado 4500HD/5500HD/6500HD vehicles, may have a condition where there is a coolant leak from the heater outlet pipe near the lower bracket mounted to the engine.
Correction	Dealers will replace the heater outlet pipe.

3. Remove the lower heater outlet hose and clamp (3) from the heater outlet pipe (2).

4. Remove the bolt (1) that secures the pipe to the block.
5. Remove the intake air box top and lower box.
