GLOBAL SAFETY FIELD INVESTIGATIONS
DCS6006
URGENT - DISTRIBUTE IMMEDIATELY

Subject: REVISION – N212345750-01 - Service Update
High Voltage Battery Software Update
Revised vehicle population added.

Models: 2017-2019 Chevrolet Bolt EV

N212345750 High Voltage Battery Software Update

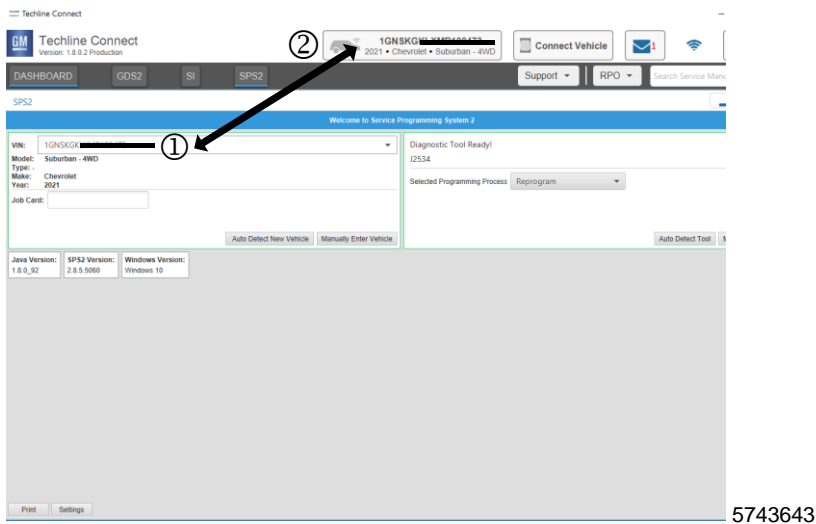
Caution: Be sure the VIN selected in the drop-down menu (1) is the same as the vehicle connected (2) before beginning programming.

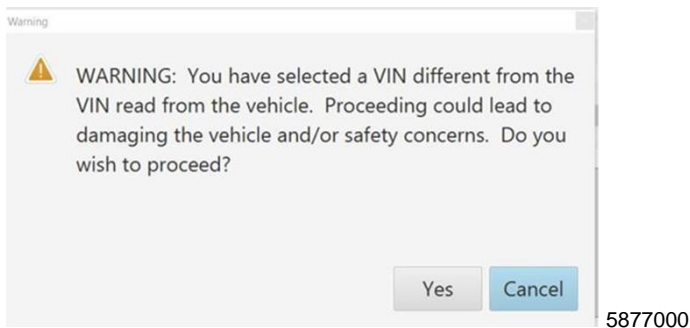
Important: If the vehicle VIN DOES NOT match, the message below will be shown.

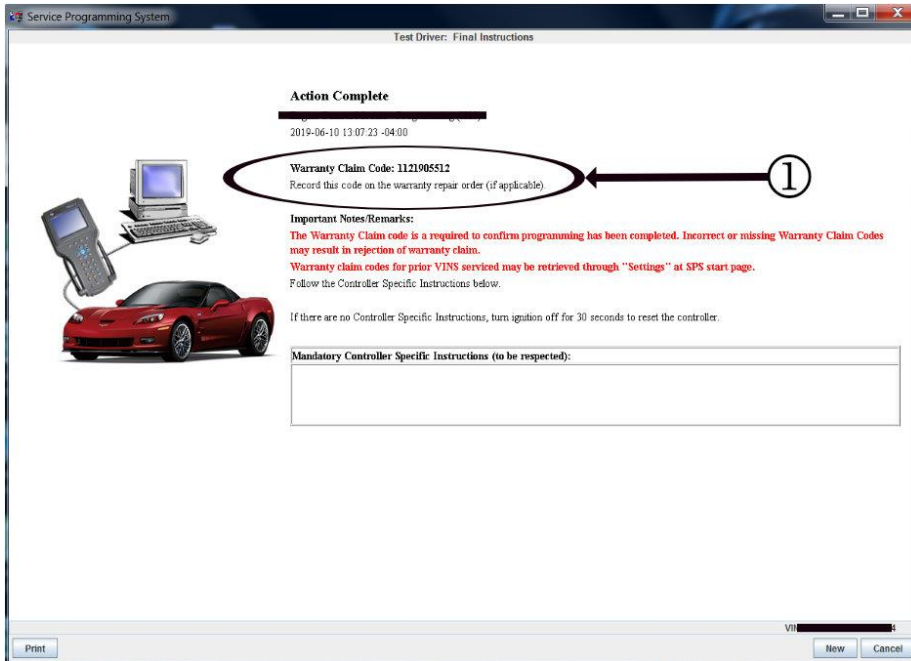
5431209

Important: To avoid warranty transaction rejections, you **MUST** record the warranty claim code provided on the Warranty Claim Code (WCC) screen shown above on the job card. Refer to callout 1 above for the location of the WCC on the screen.

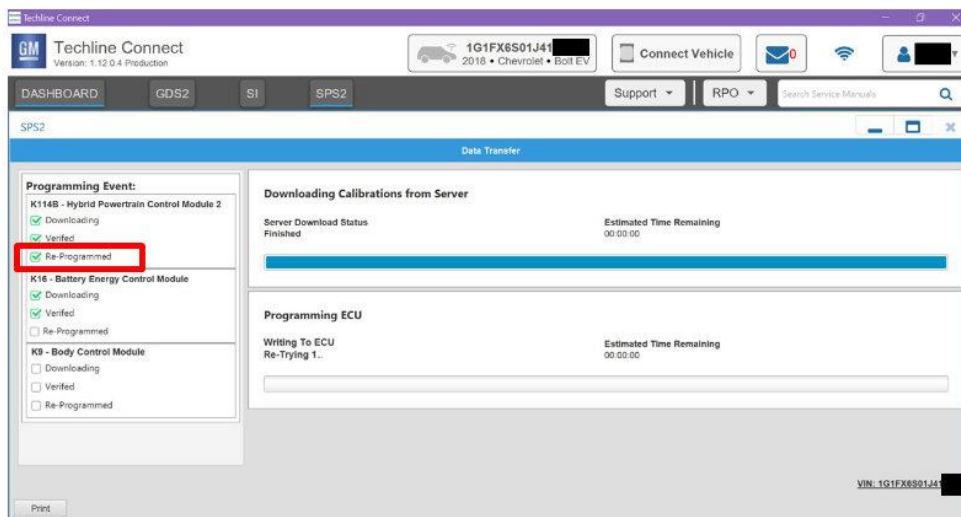
5924567

1. Reprogram the sequential multiple modules through SPS/Techline Connect (SPS and Techline Connect screens shown) by selecting **“ZFA – Field Action Multimodule Coordinated Sequence”** on the select controller screen and select **“Programming”** for the Select Function/Sequence”. Select **“Next”** and follow all on screen instructions. In SPS, scroll down to view all instructions prior to programming.

Note: The first module in the sequence is the K114B HPCM2 which is programmed with Ignition OFF and the brake pedal depressed to keep communications awake. The second module in the sequence is the K16 BECM, which is programmed with Ignition ON/Propulsion OFF. The third module is the K9 BCM is also programmed with Ignition ON/Propulsion OFF.
