# Technical Service Bulletin

## 55 Status of the charging port door(s) is displayed incorrectly

55 22 69 2064953/3 June 13, 2022. Supersedes Technical Service Bulletin Group 55 number 21-64 dated October 31, 2021, for reasons listed below.

Model(s)	Year	VIN Range	Vehicle-Specific Equipment
e-tron GT	2022	000001 – 007101	Not Applicable
RS e-tron GT	2022	900001 – 903527

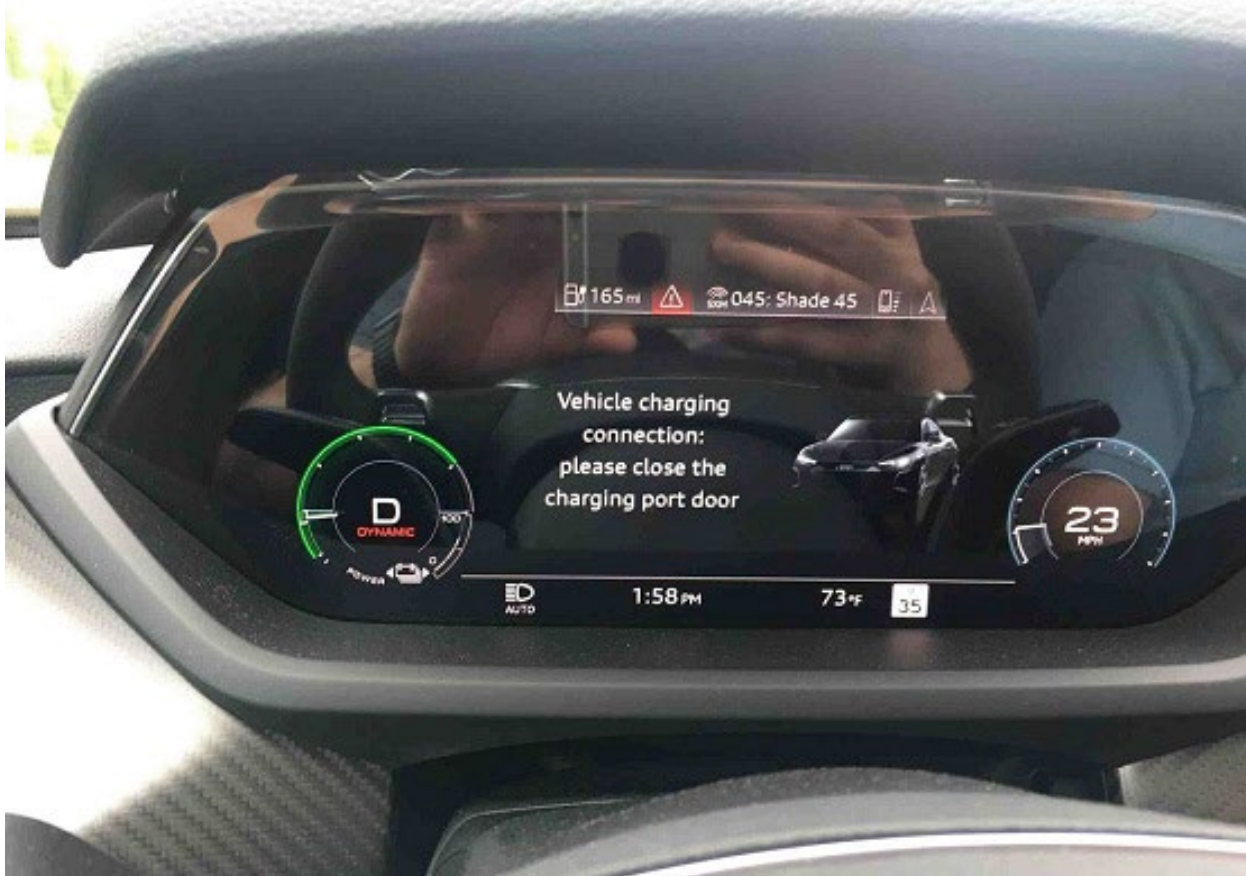
- The status of one or both charging port doors is not detected correctly. The charging port door actuator(s) is defective.

Oxidation and/or contamination of the charging port door actuator can lead to this concern.

The DIS in the Audi virtual cockpit displays the message that the charging port door needs to be closed (Figure 1).

*Figure 1. DIS message incorrectly requesting to close the charging port door.*

Replace both charging port door actuators (left + right) according to the Elsa Repair Manual.
