Technical Service Bulletin

57 Door handle touch sensor does not lock doors or is slow to respond

57 22 92 2067241/1 June 13, 2022.

Model(s)	Year	VIN Range	Vehicle-Specific Equipment
Q5	2021	All	Not Applicable
Q5	2022	000001 - 128757	
Q5 Sportback	2022	000001 – 128748

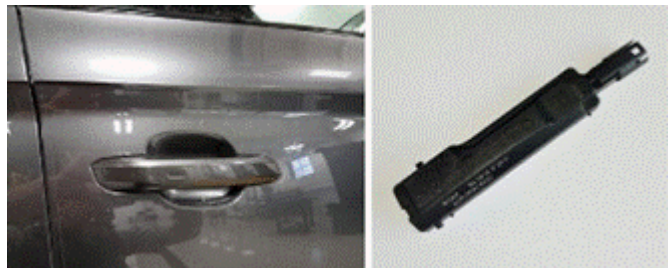
- Lock but only after a significant delay.
- Lock only after several attempts are made.
- or
- Will not lock at all using the touch sensor.

Figure 1. Outer door handle and keyless locking touch sensor.

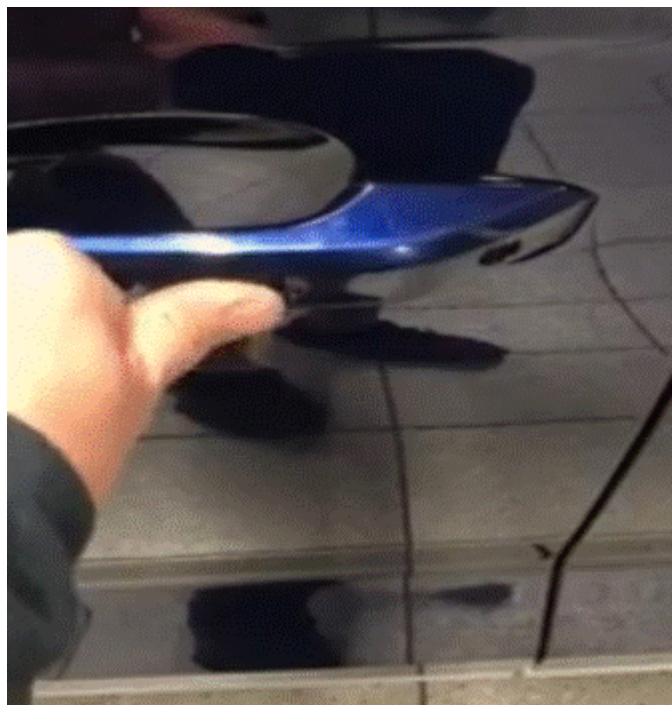
There are no relevant DTCs stored in the Comfort System Central Control Module (Da 0046, BCM 2). When the measuring values are checked during diagnosis the inoperative or delayed response in the lock command is clearly confirmed.

Figure 2. The locking system malfunctions while using the touch sensor.

An error has been identified in the door handle trim conductivity.

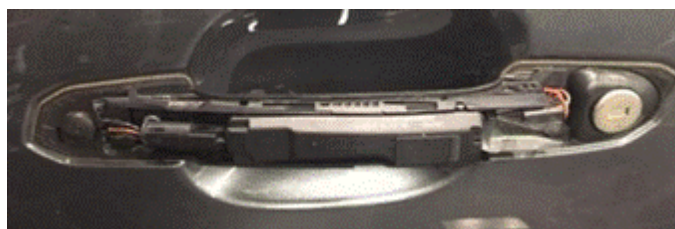
Figure 3. Exposed locking system touch sensor with door handle trim plate removed.

1. If the symptom profile is as described in this TSB and the measuring values confirm an inoperative or delayed response in the lock command, then remove the painted door handle trim plate of the affected door handle.

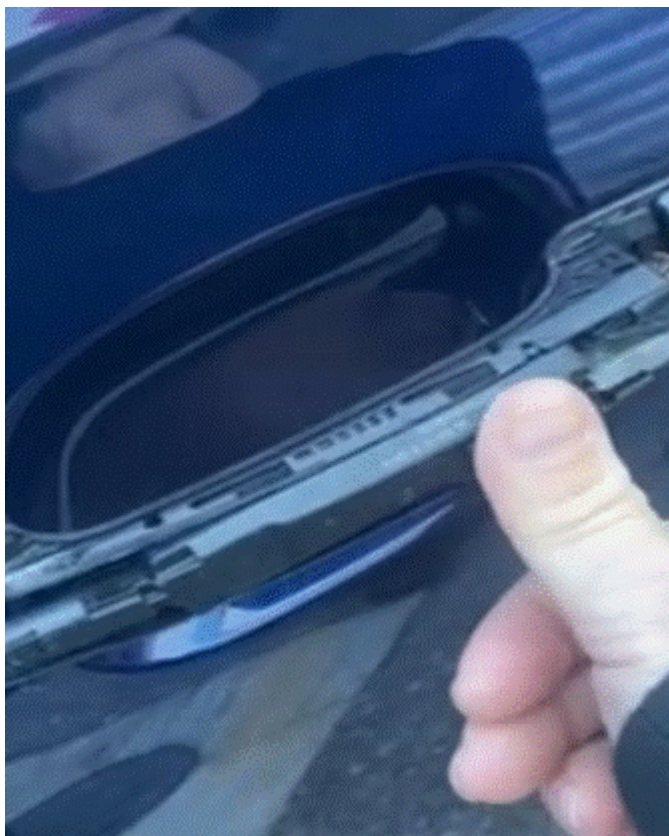
Figure 4. Activating the locking system touch sensor with door handle trim plate removed.

2. If the lock function works properly without the trim plate installed replace the door handle trim plate.
