Service Bulletin

Bulletin No.: 21-NA-155

Subject: Information on Check Trailer Wiring Message and/or Service Trailer Brake Displayed on Driver Information Center (DIC) - DTC C1114 Set

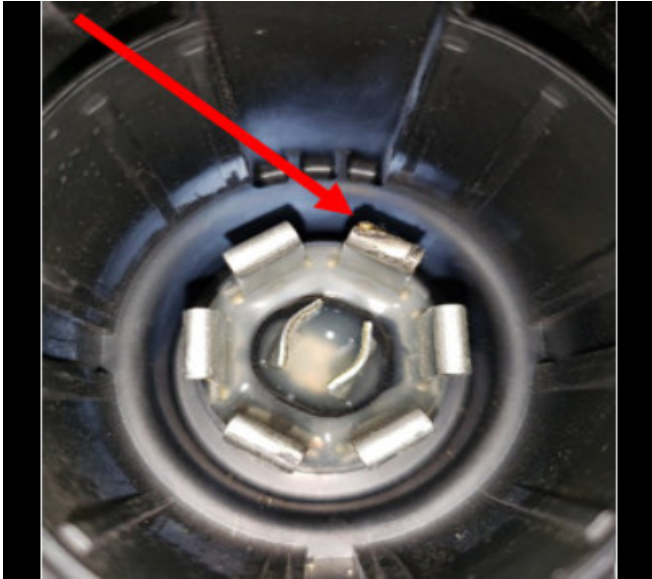
5867917

- 1. Short on trailer side damaged the terminal – Trailer side connector is loose/worn – **Non-Warranty Issue.**

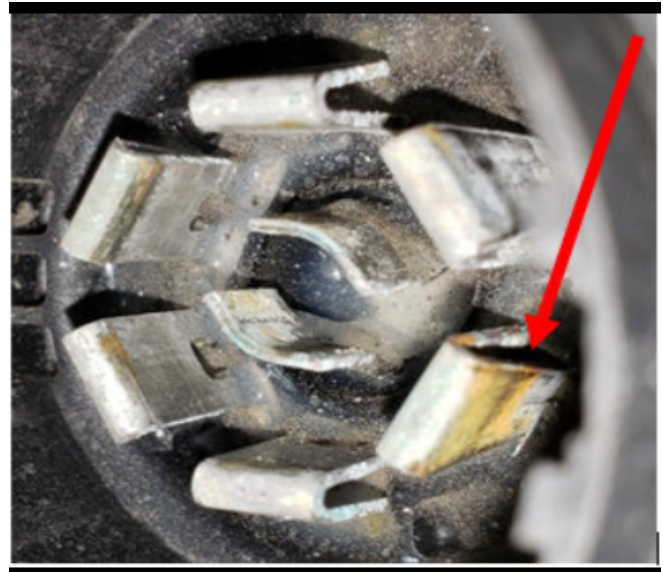
5867995

- 3. Trailer side connector is damaged/deformed causing removal of protective plating. This is the result of the trailer side connector is moving or bouncing when connected (excessively worn connector) – **Non-Warranty Issue.**

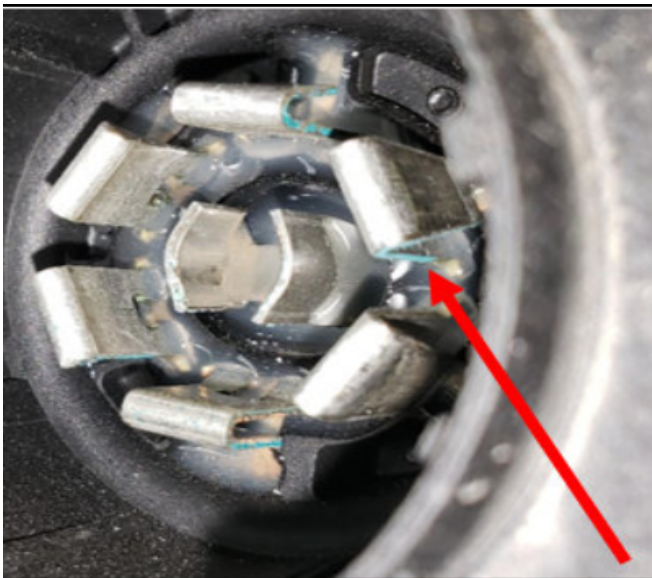
5867994

- 2. The blue/green is expected, and this small amount of corrosion does not impact function of connector – **Non-Warranty Issue.**

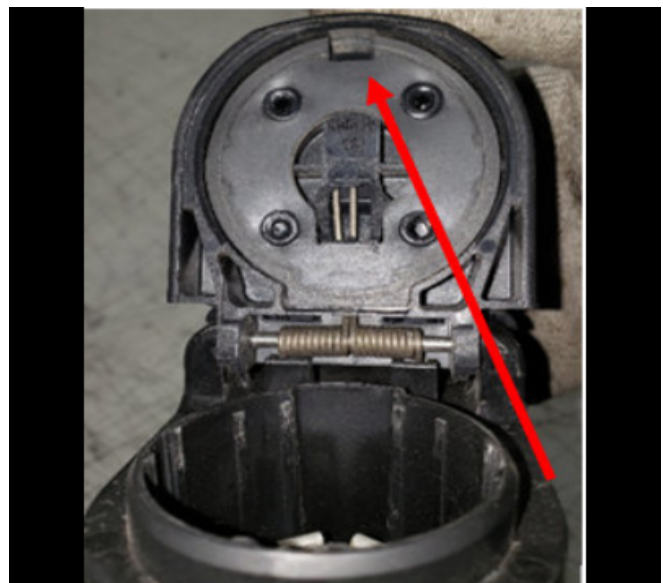
5867997

- 4. Trailer side harness retention tab has been broken off cover which is the result of customer pulling away from trailer without releasing the trailer harness – **Non-Warranty Issue.**

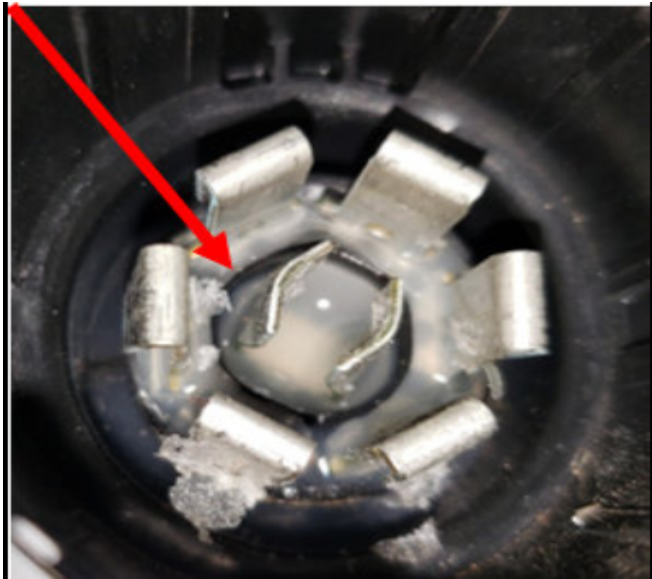
5867998

- 1. Sealant from part on terminals, would cause intermittent connection issues connecting to trailer – **Subject to terms of warranty.**

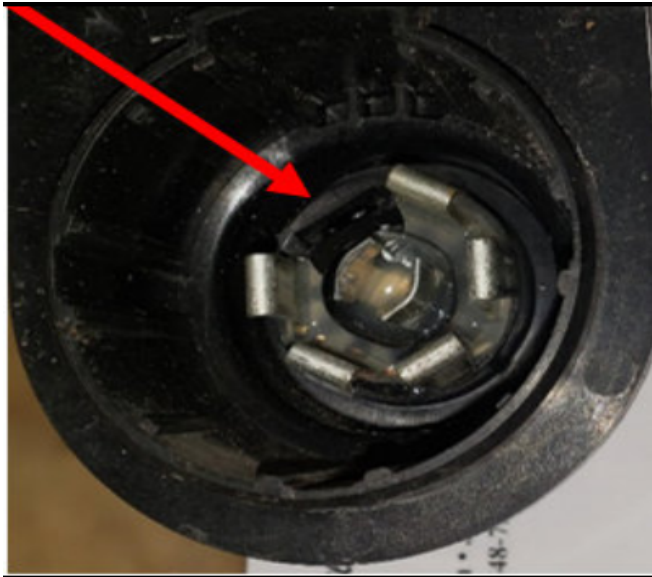
5868000

- 2. Terminal is pushed out – **Subject to terms of warranty.**
