**SIB 51 15 20**

WIND NOISE FROM ENGINE BULKHEAD

E-Series	Model Description
G05	X5 Sports Activity Vehicle
G07	X7 Sports Activity Vehicle

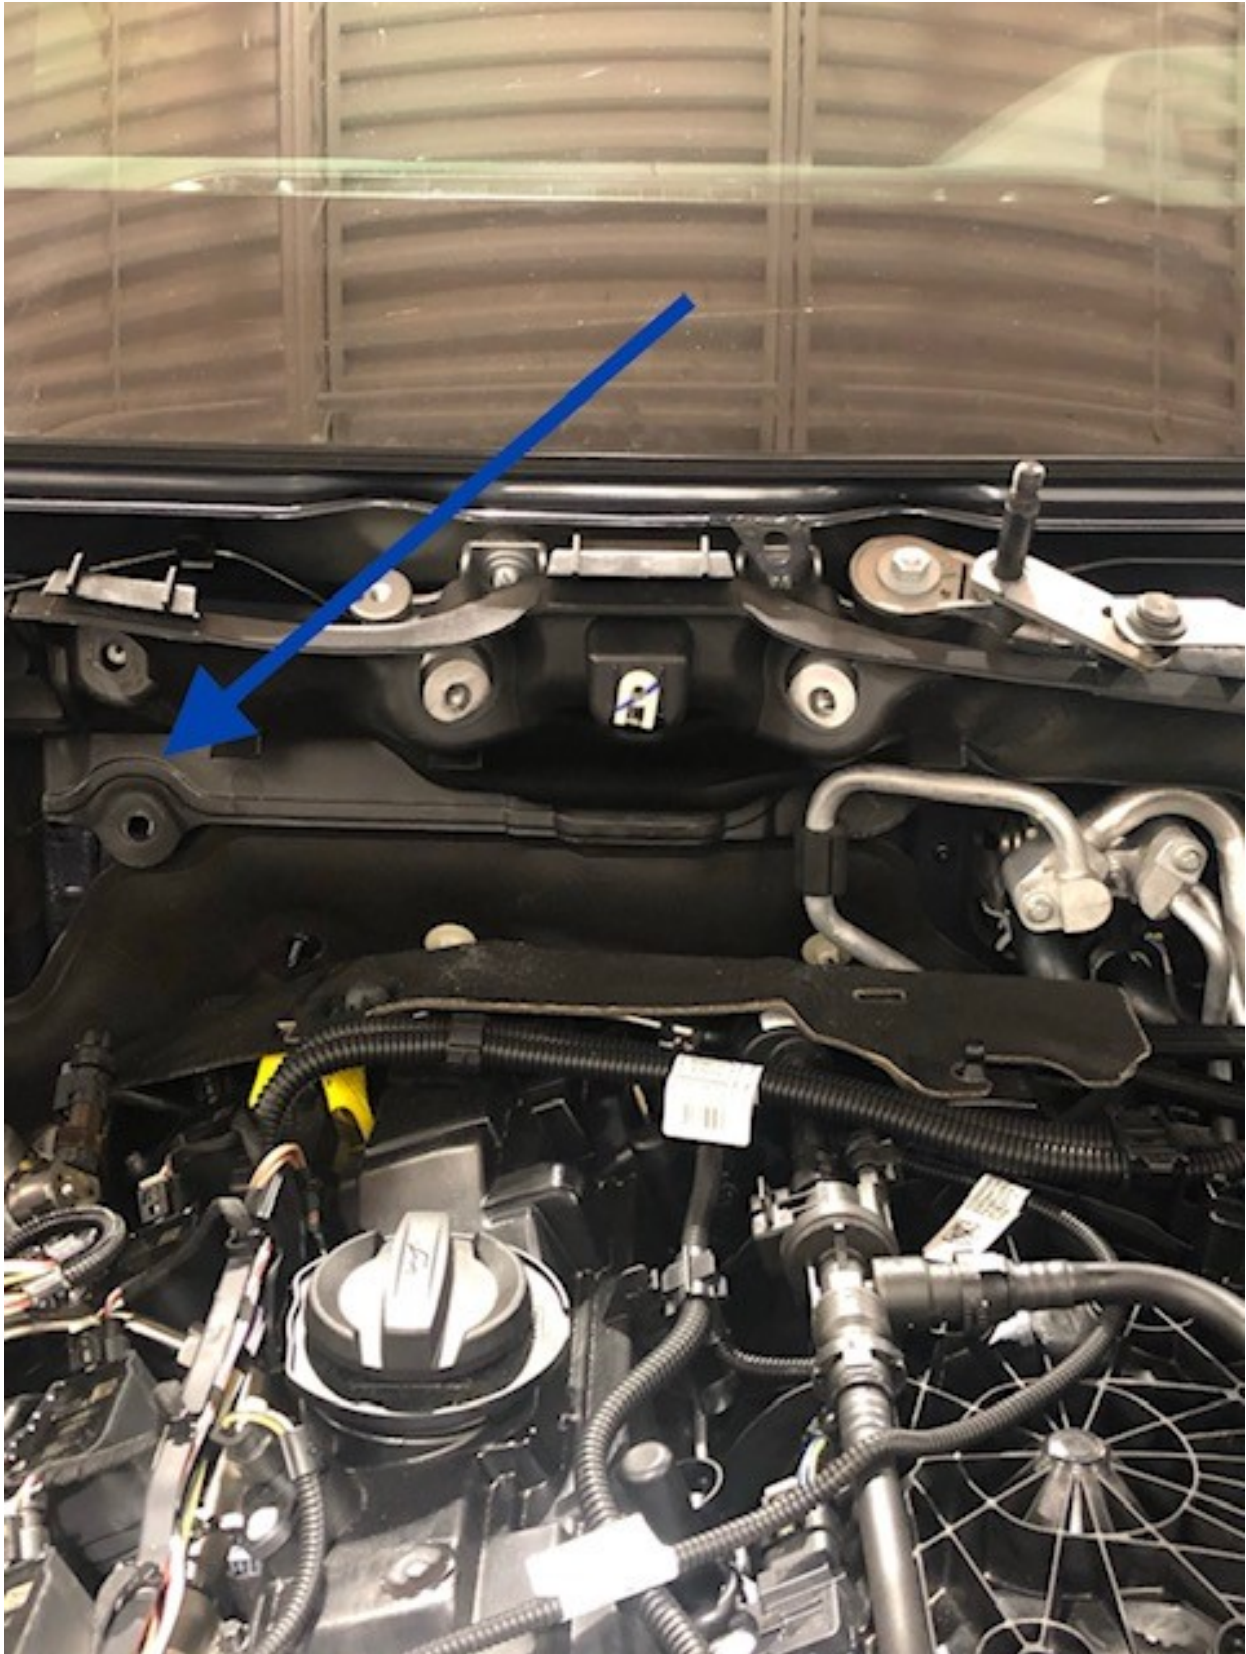
A wind noise can be heard when driving at highway speeds from the area around the lower windshield.

Improper sealing of the engine bulkhead trim.

1. Remove the engine bulkhead trim. Gain access for removal by removing the windshield panel cover, REP 51 13 116 "Removing and installing windshield panel cover".
2. Reference the photo below for the location of potential deformed seal:

3. With bulkhead trim removed, inspect the rubber sealing surface. Is the seal deformed?

4. Using butyl cord, reseal the bulkhead trim and completely reassemble the vehicle.
