NUMBER: 08-031-16

GROUP: Electrical

DATE: March 31, 2016

Hands Free Module Prompts Begin Erroneously

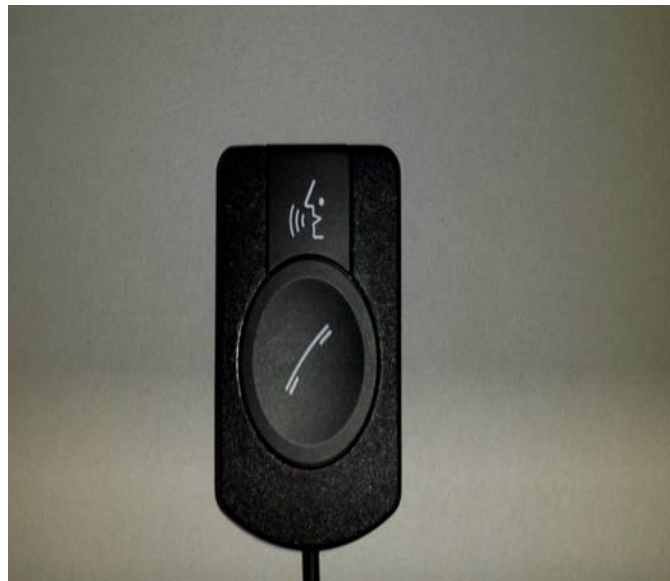
Fig. 1 Stand alone Phone and VR button

NOTE: One way to tell if a HFM kit was added to the vehicle is the presence of a stand alone VR/Phone button. Another way would be the absence of a VR/Phone button on either the steering wheel or on the radio ([Fig. 1](#)).

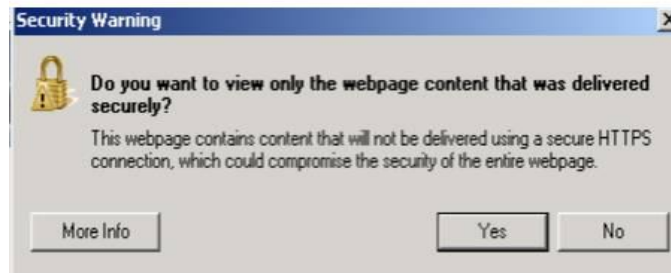
Fig. 2 Pop-up Security Message

1. Has the USB flash drive been created?
 - a. Yes >>> Proceed to [Step #4](#).
 - b. No >>> Proceed to [Step #2](#).
2. Go to DealerCONNECT> Service> UCONNECT Information & Utilities> Uconnect Dealer software downloads to download the files.
3. If a security message appears “Do you want to view only the webpage content that was delivered securely?” see ([Fig. 2](#)). Press **No** to continue.
