Technical product information

Topic	Warning evident within the DIP for the steering system - DTC U103100 evident within diagnostic address 0044
Market area	Russische Föderation (5RU),Australia E04 Bentley rest Asia and Australia (6E04),China 796 VW Import Comp. Ltd (Vico), Beijing (6796),Germany E02 Bentley rest Europe (6E02),Japan E03 Bentley Japan (6E03),Korea, (South) E08 Bentley South Korea (6E08),United Arab Emirates E06 Bentley Middle East and Africa (6E06),United Kingdom E01 Bentley UK (6E01),United States E05 Bentley USA and rest America (6E05)
Brand	Bentley
Transaction No.	2067399/1
Level	EH
Status	Approval
Release date

Bentayga

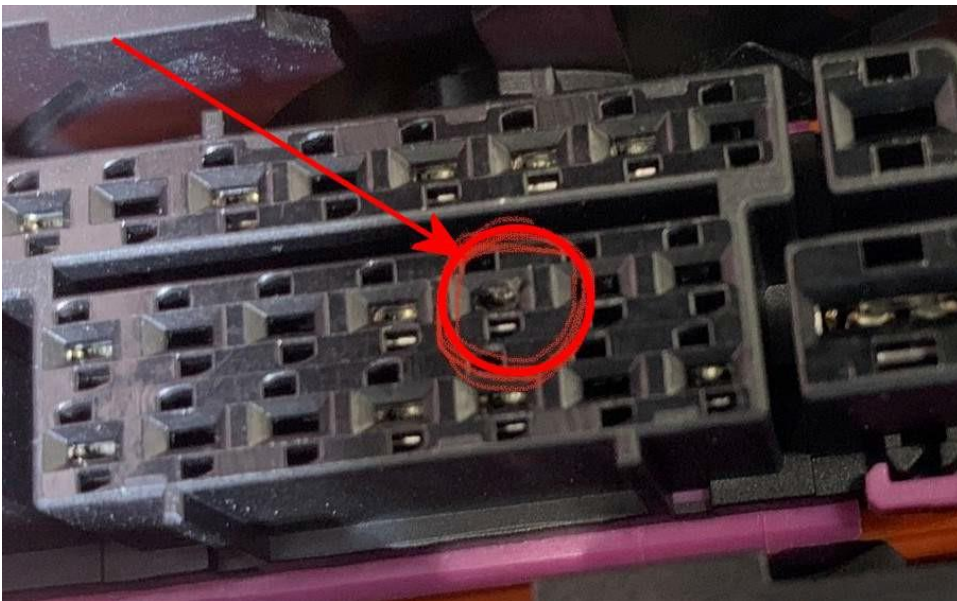
- Referring to the applicable wiring diagram - Conduct a visual check of plug connection for J539, the example in Figure 1 shows damage to pin 14 (Brake servo control unit)

- Referring to Rep.Gr97 - Conduct any applicable wiring repairs
