Technical product information

Topic	Air conditioning not cooling and/or low refrigerant gas
Market area	Bentley: worldwide (2WBE)
Brand	Bentley
Transaction No.	2067385/1
Level	EH
Status	Approval
Release date

New Flying Spur and Bentayga

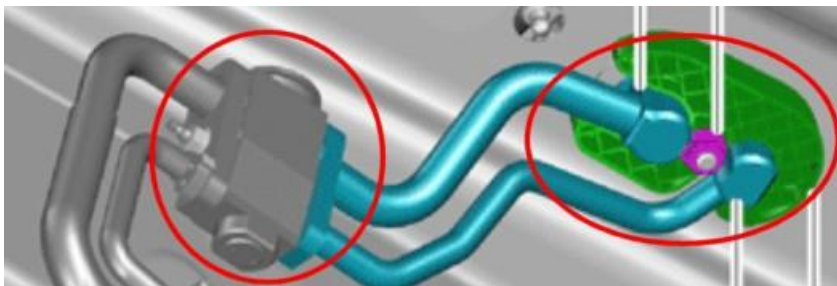
Depending on the model type (see below Figure 1 Bentayga and Figure 2 New Flying Spur) the operative should check the rear HVAC unit expansion valve connections for any HVAC system leaks, in the event a leak is discovered the operative should refer to the applicable Rep.Gr to gain access to the leaking component(s) and replace the applicable parts (O-rings)

- Once the location of the leak is identified all of the applicable O-rings should be replaced

- Once the source of the leak is identified - Refer to Rep.Gr 87 and discharge the HVAC system
- Conduct a visual inspection of all components/mating faces
- Ensuring all components are free of damage/contamination replace all applicable O-Rings (complete sets)
- Refer to Rep.Gr 87 - Charge the HVAC system
- Confirm the leak is no longer evident
