New Trim Codes May Need To Be Reprogrammed Following Engine Replacement With 7/8 Reman Or Complete (Engine With Both New Injectors And Engine Control Module); Possible Uneven Operation/Rough Running At Idle Following EMS Programming With Data Transfe

Service News

То:	General Managers Service Managers Service Technicians Warranty Managers	Region:	⊠U.S. ⊠CAN	Bulletin: SNM19-002 Date: January 28, 2019 Valid to: N/A Action Required? □Yes ⊠No
From: Subject:	Greg Holderfield – Director, Techni AMT Oil filter Housing Corrosion	cal Support	t l

AMT oil filter housing corrosion

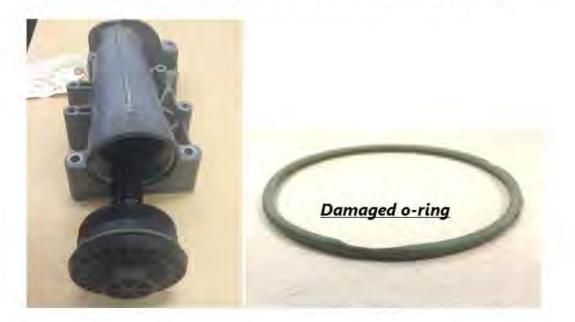
The AMT gearbox oil filter housing has been found to develop debris buildup or corrosion on the filter cover flange.

Failure to inspect and properly clean this area during a filter change can lead to a sealing ring failure during installation of the cap that may not be found during the oil change. The subsequent oil leak can lead to catastrophic gearbox failure due to loss of oil if not detected and corrected.

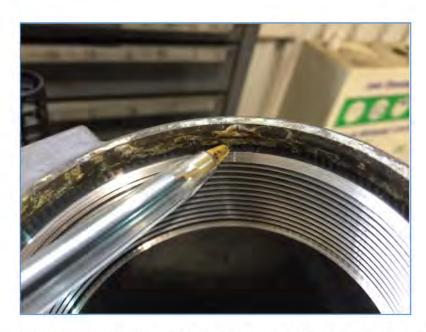
If you detect corrosion on the location shown above do not attempt to clean or reuse this housing. The corrosion is harder than the aluminum. This housing must be replaced.

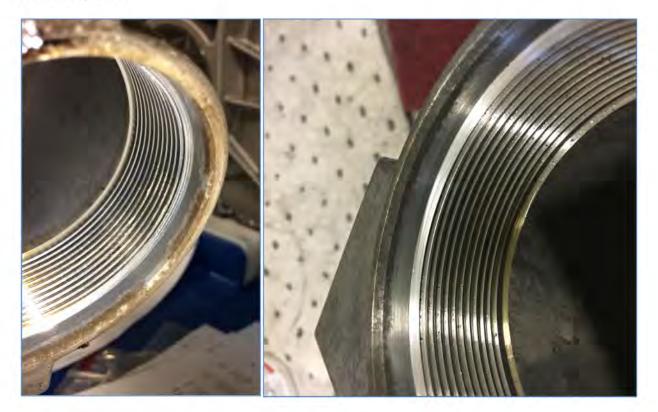
Filter housings that show normal dirt build up (left image) can be cleaned with a Scotchbrite pad or equal. Some residual staining of the aluminum housing (right image) may still be present after cleaning. Clean the threads and sealing surfaces before reassembly. Apply a small amount of silicone grease that meets the specification below on the o-ring, filter housing sealing area and the cap flange below the oring prior to assembly to help seal out moisture and dirt. There must be enough grease present to allow squeeze-out under the flange so the dirt and moisture is sealed out of the area of concern. Clean the filter cap of any excess grease squeeze-out after assembly to prevent giving false impression of a leak.
