Premium Tech Tool (PTT) - Message For Data Mismatch, Product Configuration Mismatch; Instruction To Run An Accessory Kit Displayed When Attempting To Run Diagnostics For Diagnostic Trouble Codes (DTC) Or Programming - US10+OBD13 And Newer Emissions,

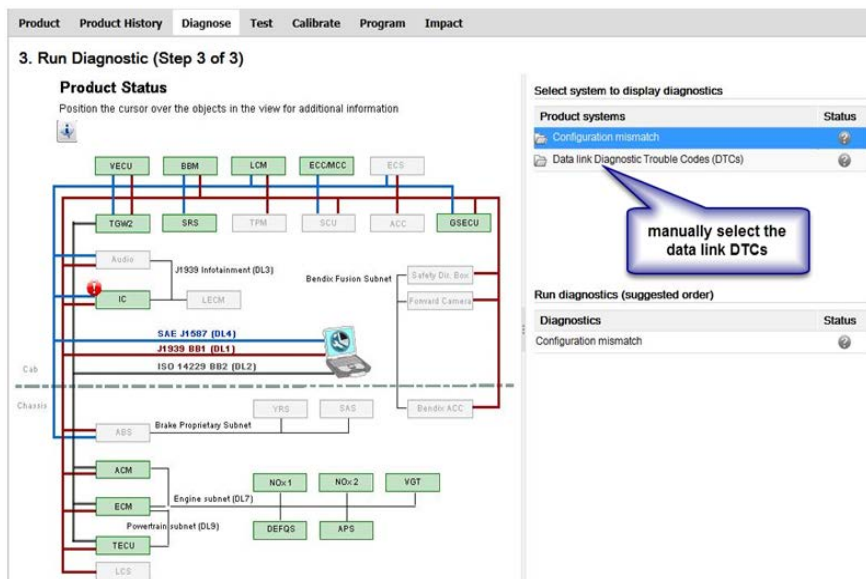
4.1. If both Configuration mismatch and Data link DTCs options are displayed, the Data link DTCs option should be selected **first**.

4.2. The active data link codes that were observed on the readout screen should be selected **first**.
