# Technical Service Bulletin

<b>Subject:</b>  CHECK ENGINE LIGHT ON WITH DTCs P24C6:00, P24C7:00, P24AE:00, P24B1:00 AND/OR P24AF:00	<b>Bulletin No.:</b> 01-005/22
	<b>Last Issued :</b> 06/21/2022

2018-2019 CX-5 SKYACTIV-D 2.2

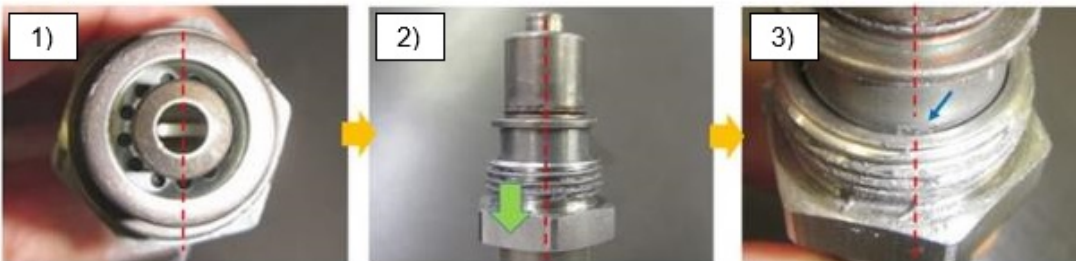
**Procedure (A)** Looking from the sensor element side:

**NOTE:** If the matrix barcode is not found, it may be hidden under the free nut. This may be due to a variation in manufacturing.

- 1) Locate the sensor element plate.
- 2) Push the free nut downward.
- 3) Hold the nut to create clearance, then inspect the area shown below by the arrow.
