(Back Office Only) - Engine Brake Vibration When In High Setting - 13L Engine With Variable Geometry Turbo (VGT) - US17 And Newer Emissions (Common Rail Fuel System)

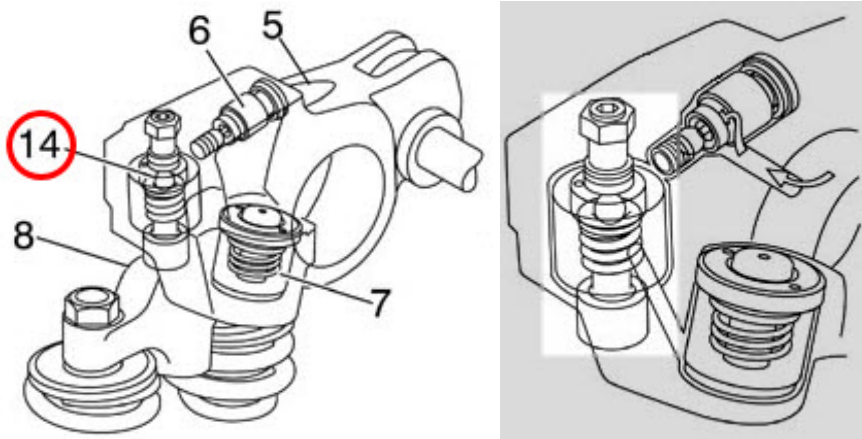
- The power (slave) pistons in the exhaust rockers should be inspected to confirm they are not backing out or loose.

- The slave piston rides on the exhaust valve bridge as shown above (Number 14), and is the only part of the rocker that can be removed.

• **NOTE:** In cases where rocker arms are replaced, it may be found that the part number of the rocker arm in Impact is 22418147. This number is now blocked in Parts Compass and cannot be ordered. When ordering, part number 21406640 is correct.
