Volvo Chassis - Air Leak At Wet Tank - Model VNL

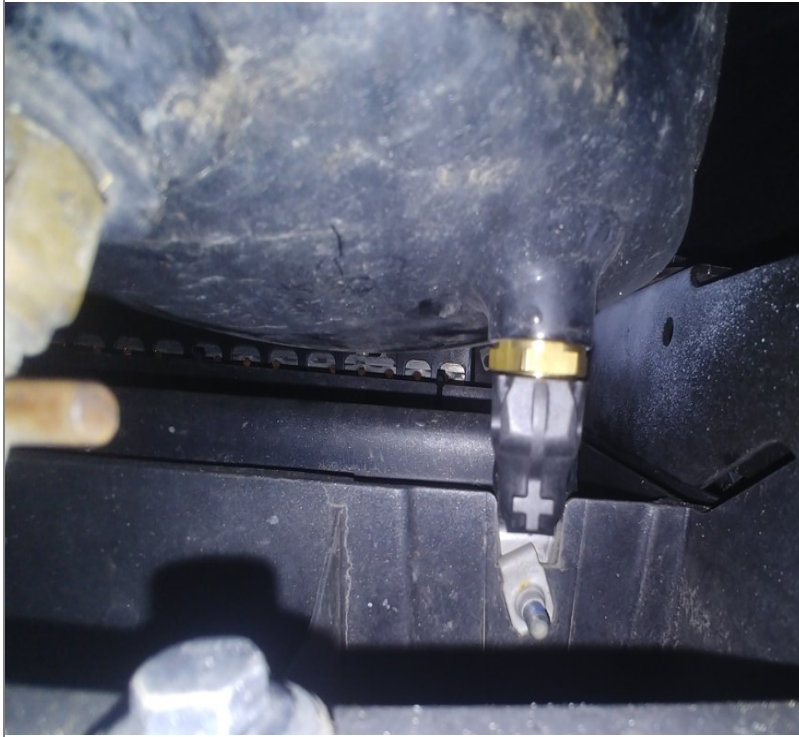
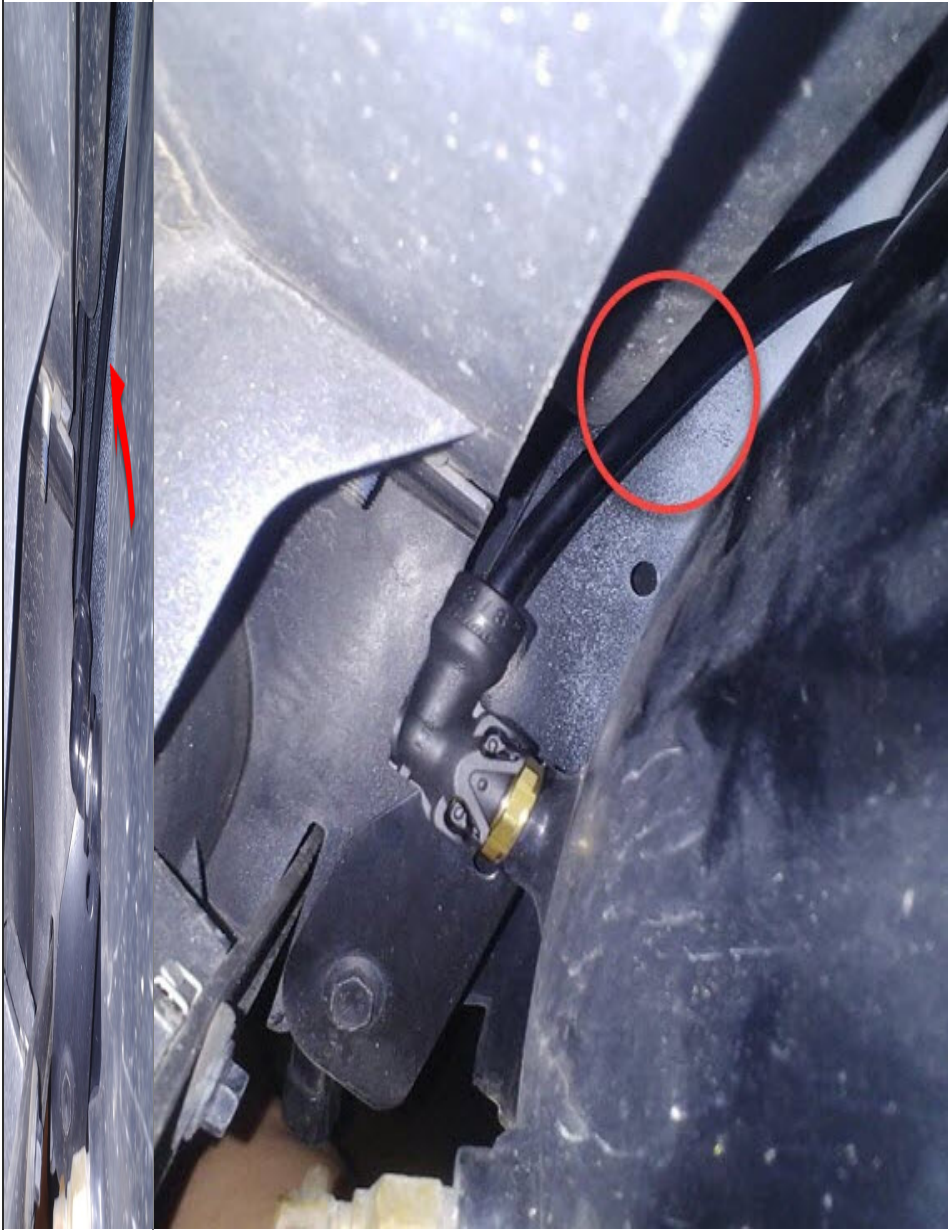
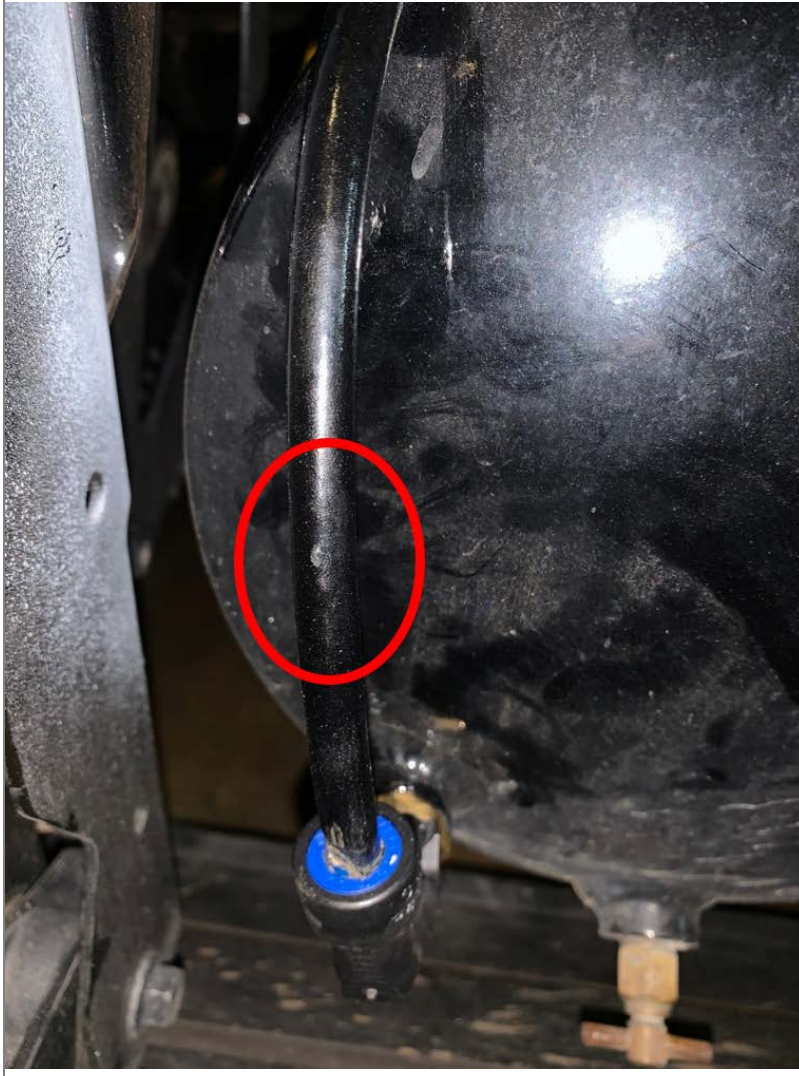
Fitting - 20999390	Global Fitting - 991083 / 991965

Volvo VN models have been reported having the wet tank, located on the front (outside) side of the wet tank, air line rub the chassis fairing. If the truck was built starting March 11, 2019 with air tank 22945941 and air fittings 991083 or 991965, in the front port of the air tank, this issue is possible. To correct this issue, replace fittings 991083 or 991965 with fitting 20999390.
