Charge Air Cooler Revision

M-265-001

All CXU, CHU, & GU Models built before May 2007

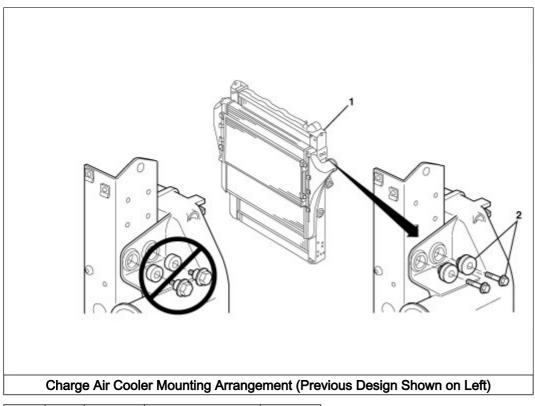
A revised charge air cooler (part Nos. 20956580 and 20956585) was implemented into production on all CXU, CHU and GU model chassis. This revised charge air cooler includes a redesigned upper mounting area, whereby the shoulder bolt and bushing arrangement was changed to sleeved washers and mounting bolts. Should replacement of a charge air cooler on a CXU, CHU and GU model manufactured prior to May 2007 be required, the existing shoulder bolts and bushings must be replaced with the sleeved washers and mounting bolts. An upper mounting hardware kit (part No. 85111312), which contains four sleeved washers and four mounting bolts, is available through the MACK Parts System.

Key	Qty.	Part No.	Description	Replaces
Ī	1	1	20956580	Charge air cooler,	20750095
				long	
		1	20956585	Charge air cooler,	20750102
				short	
ſ	2	1	85111312	Kit, upper	
				mounting

hardware	
	(includes four	
	bolts and four	
	sleeved washers)
