**SERVICE BULLETIN**

**APPLICABILITY:** 2017-18MY Impreza  
 2018MY Crosstrek  
 2018MY Legacy and Outback  
 2018MY BRZ\*

**NUMBER:** 15-211-17R  
**DATE:** 06/13/17  
**REVISED:** 06/27/22

**SUBJECT:** Reprogramming File Availability for Additional Optimization of Harman Gen 3 Audio and Navigation Head Units

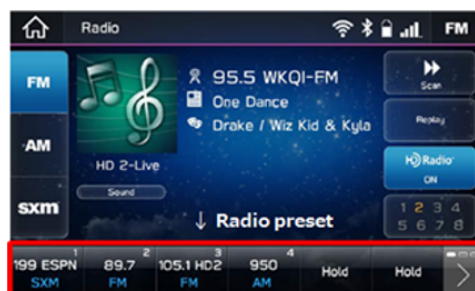
- Update to address some or all AM/FM station presets becoming lost and replaced by “Hold”

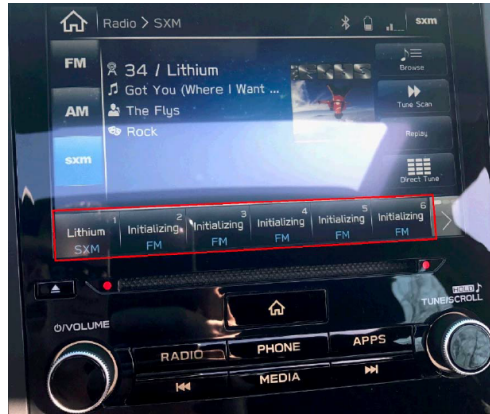
- 1- Radio station presets disappear (touch screen buttons return to “Initializing”).

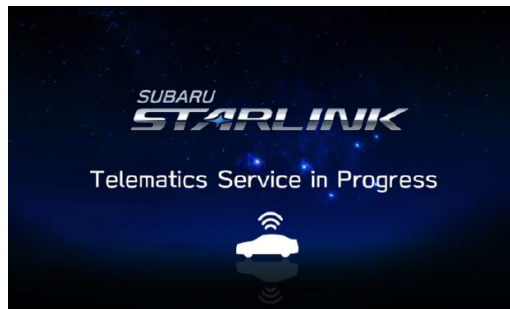
- 2- STARLINK “Telematics Service in Progress” screen freezes.
