RCA-18-22-002-1: Replace Rear Upper Lateral Links and Fasteners

Document Type	Customer Satisfaction Campaign Bulletin
Date	June 8, 2022
Affected Region(s)	USA
Affected Model(s)	R1T
Model Year(s)	2022
Approximate Build Dates	August 2021 - December 2021

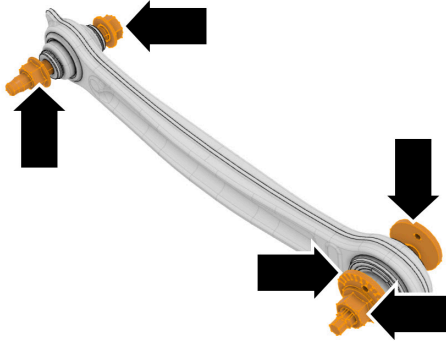
Rivian is initiating a customer satisfaction campaign for some model year 2022 R1T vehicles that may have been built with rear left-hand (LH) and/or right-hand (RH) upper lateral link fasteners that were over-torqued. Over time, this over-torquing may cause the components, including the bolt, mounting bracket and upper lateral link bushing to deform, resulting in a loose joint. The loose joint could result in a loss of wheel camber setting and a noticeable change in handling characteristics and tire wear. The customer may also notice increased noise from the rear of the vehicle. Rivian will replace both the LH and RH upper lateral links and their associated fasteners. Rivian is launching this campaign for customer satisfaction and to ensure the quality of Rivian vehicles.

1. On both sides: Replace: Link, Lateral, Rear, Upper, LH (refer to service manual procedure 183215010).

Note: Replace the highlighted component(s).
