RCA-60-22-001-1: Replace Underbody Panel Fasteners

Document Type	Customer Satisfaction Campaign Bulletin
Date	June 10, 2022
Affected Region(s)	USA
Affected Model(s)	R1T
Model Year(s)	2022
Approximate Build Dates

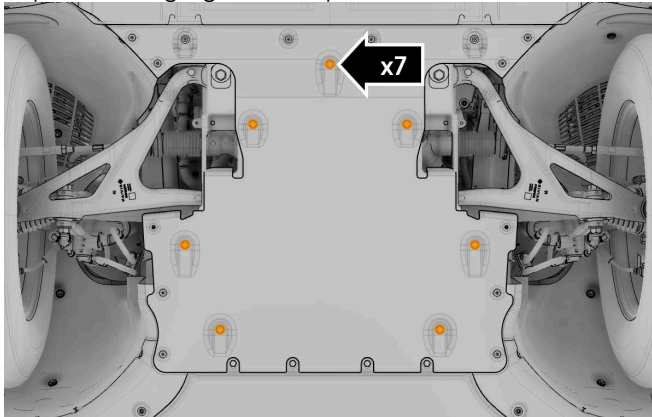
Rivian is initiating a customer satisfaction campaign for some 2022 R1T vehicles that may have been built with weakened fasteners that secure some underbody panels. Heavy impact to the underbody panels could cause the fasteners to shear off and the underbody panels to become loose. If a significant number of the fasteners are broken there is a possibility that the panel could drag on the ground or detach from the vehicle, though this condition has not been observed to date in any customer vehicle. Rivian will replace these fasteners. Rivian is launching this campaign for customer satisfaction and to ensure the quality of Rivian vehicles.

1. Raise and Support Vehicle (refer to service manual procedure 981020017).
2. Replace the highlighted component(s).
