# RCA-78-22-009-1: Trapped Jump Start Wire Harness

<b>Document Type</b>	Customer Satisfaction Campaign Bulletin
<b>Date</b>	June 10, 2022
<b>Affected Region(s)</b>	USA
<b>Affected Model(s)</b>	R1T
<b>Model Year(s)</b>	2022
<b>Approximate Build Dates</b>

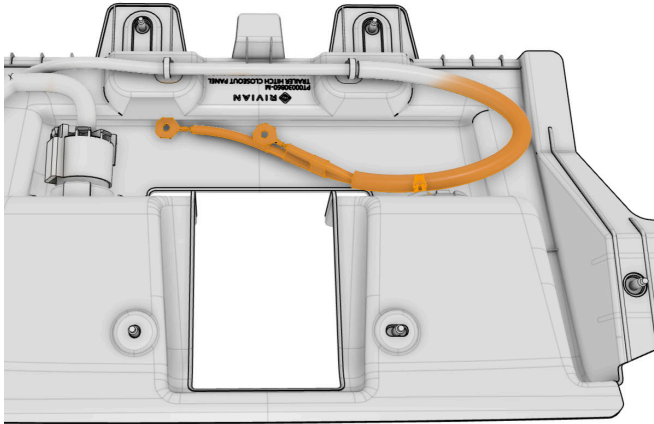
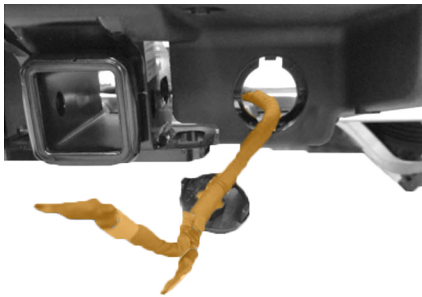
3. Inspect whether the highlighted harnesses are able to be easily pulled out of the vehicle to access the jump start terminals:

**Note:** Shown with components removed for clarity.

- If the harnesses are able to be easily pulled out of the vehicle to access the jump start terminals: No additional work is required. Reinstall all components that were removed for access and replace all non-reusable components.
- If the harnesses are not able to be easily pulled out of the vehicle to access the jump start terminals: Continue to the next step.

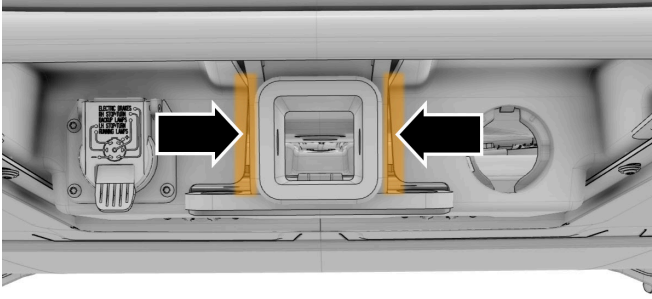
5. Look through the gaps between the trailer hitch and closeout panel.
