Technical product information

| Topic | Bentayga and New Flying Spur Hybrid– DTC P103A00 evident – Engine Oil Fuel Portion Too High |

Bentayga and New Flying Spur Hybrid

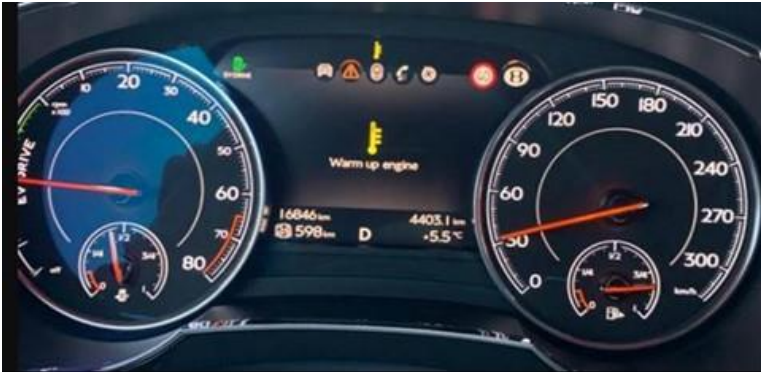
Figure 1

- Warning message within the DIP
- The message asks the customer to 'warm up engine' accompanied by a yellow warning (Figure 1) No other symptoms are experienced.

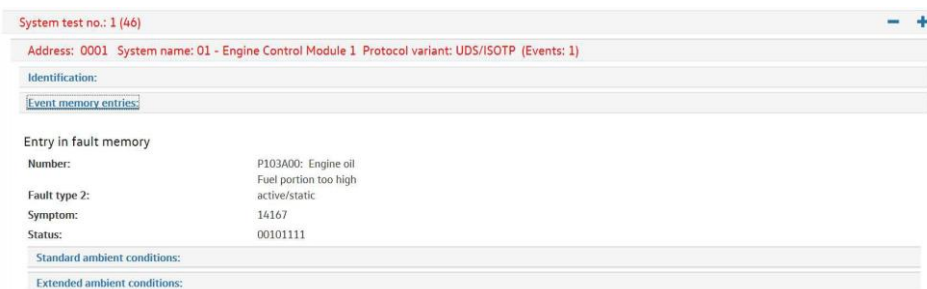
Figure 2

- DTC P103A00 evident - Engine Oil Fuel Portion Too High (Figure 2)

The warning is caused by the level of unburnt fuel in the engine oil. This value is calculated by the Engine Control Module (ECM) and is based on the driver usage pattern

The more cold starts the Internal Combustion Engine (ICE) is exposed to the higher the chance of fuel making its way into the engine oil via the cylinders

When the fuel calculation reaches the pre-programmed amount this then causes the DTC to be triggered

3) Drive the vehicle in SPORT mode for 30 KM (Observing all local speed limits) with enthusiastic driving to reduce the fuel MWB value (IDE04820) to less than 50 grams

- In the event the MWB value (IDE04820) has been successfully reduced (Lower than 50 grams) Erase the applicable DTC's
