## Technical product information

### New Continental GT/GTC and New Flying Spur

Knocking noise from the front (Driving over an uneven road surface) - Front trailing arm bush found damaged/leaking

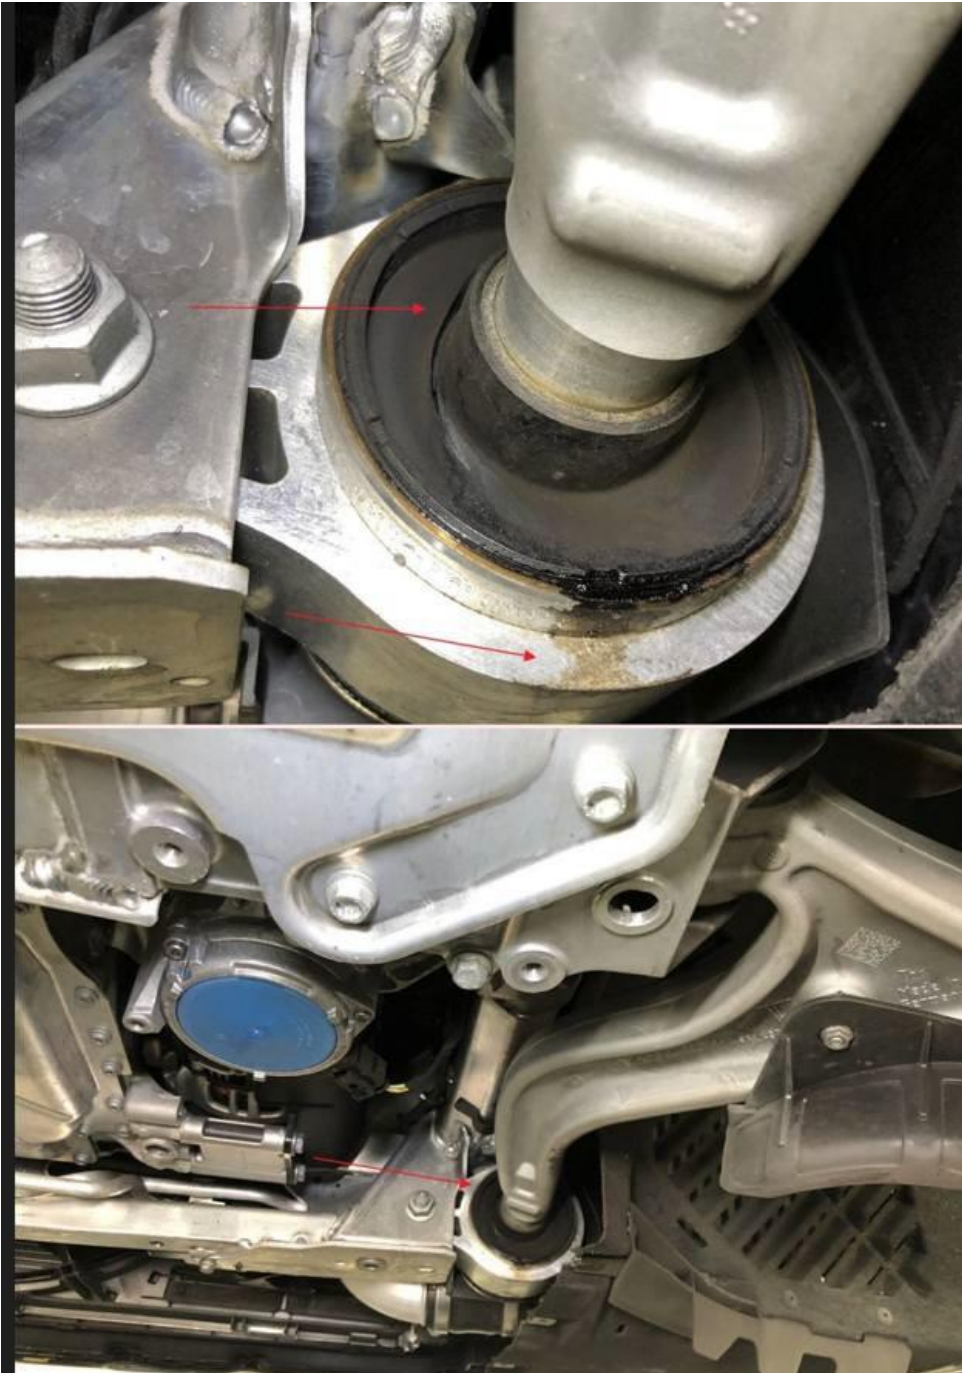
Figure 1

Front trailing arm bush found damaged/leaking as shown in Figures 1 and 2

2) Referring to Rep.Gr 40 - Replace the applicable front lower trailing arm NOTE: The front lower trailing arms should not be replaced in pairs (unless both are damaged/worn) only the damaged trailing arm should be replaced
