TECHNICAL SERVICE BULLETIN

Lack Of Audio And/Or Water Leak In Rear Of Vehicle And/Or Spare Tire Area

22-2262

Ford 2020-2022 Explorer
Lincoln 2020-2022 Aviator

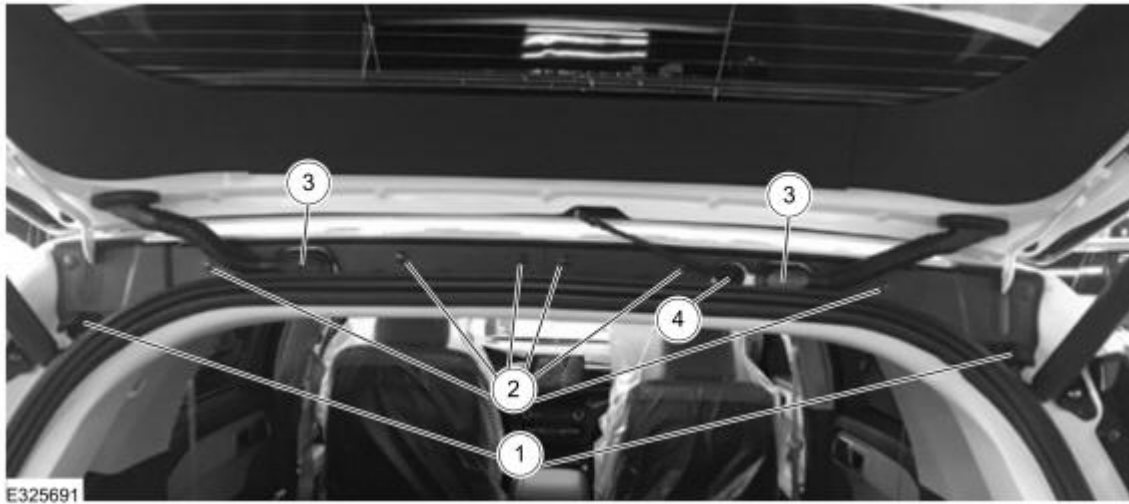
Figure 1

1. Open the rear liftgate.
2. Inspect and make sure the following components are correctly seated by pushing:
 - (1). Power liftgate grommet (if equipped). If not properly seated, replace the affected power liftgate strut. (Figure 1 Callout 1, Figure 2)

(2). Margin seal and margin seal pushpins. (Figure 1 Callout 2, Figure 3 Callout 2)

(3). Electrical wiring grommet. (Figure 1 Callout 3, Figure 3 Callout 3)

(4). Rear washer hose. (Figure 1 Callout 4, Figure 3 Callout 4)

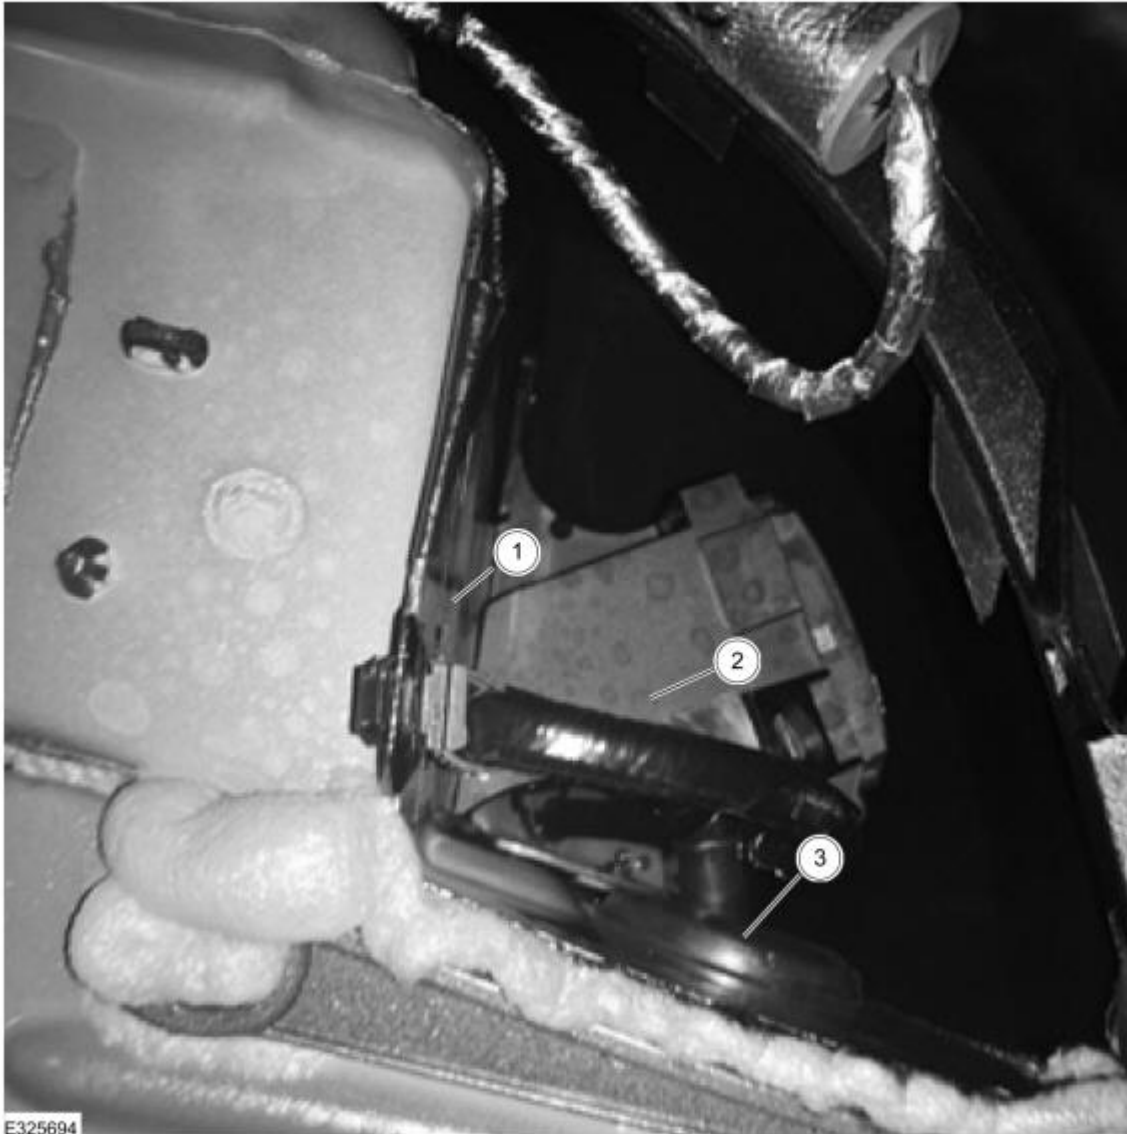
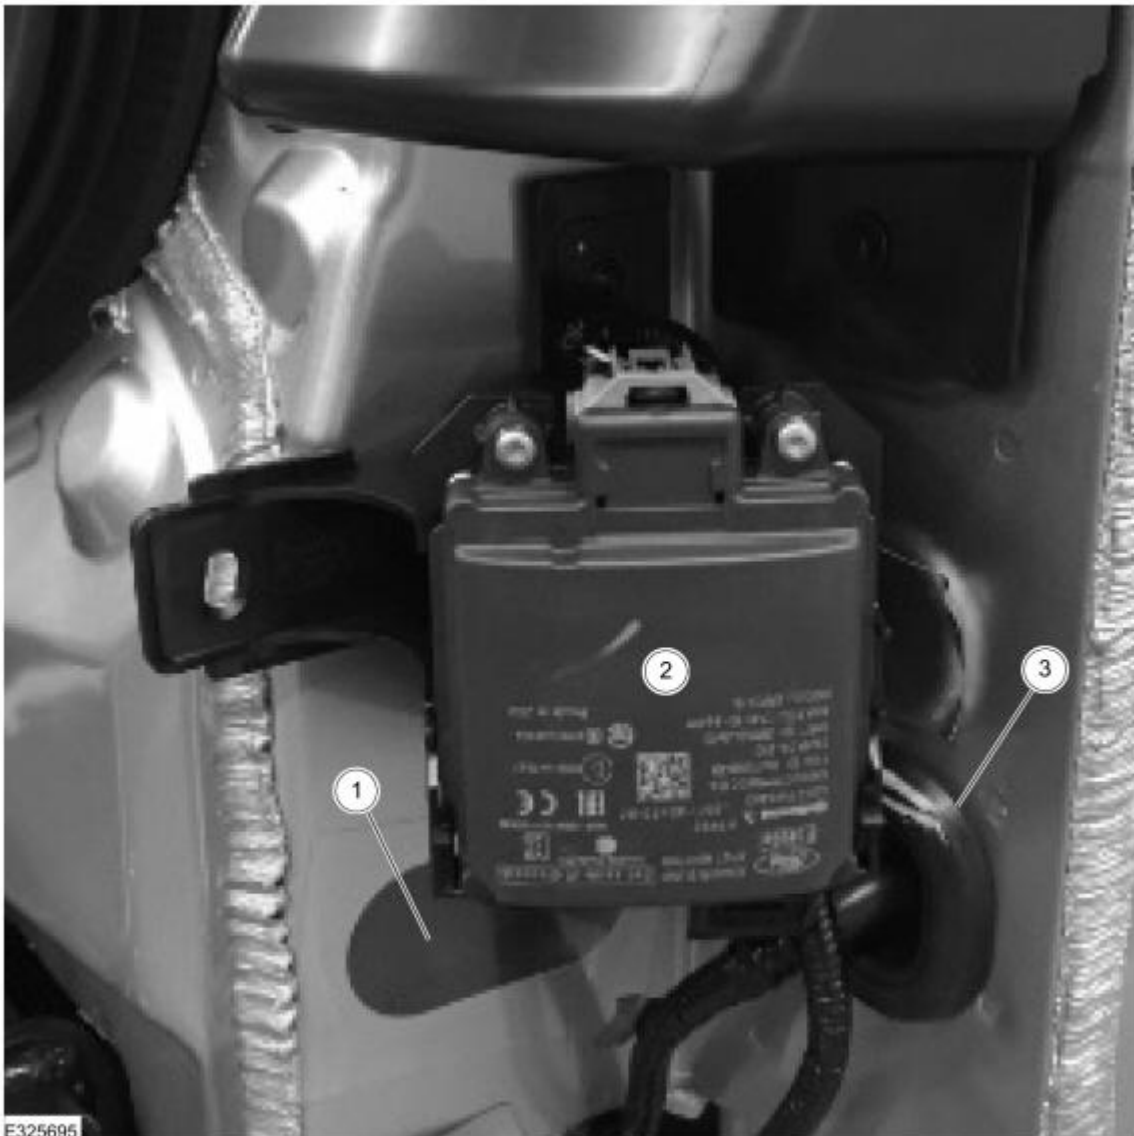
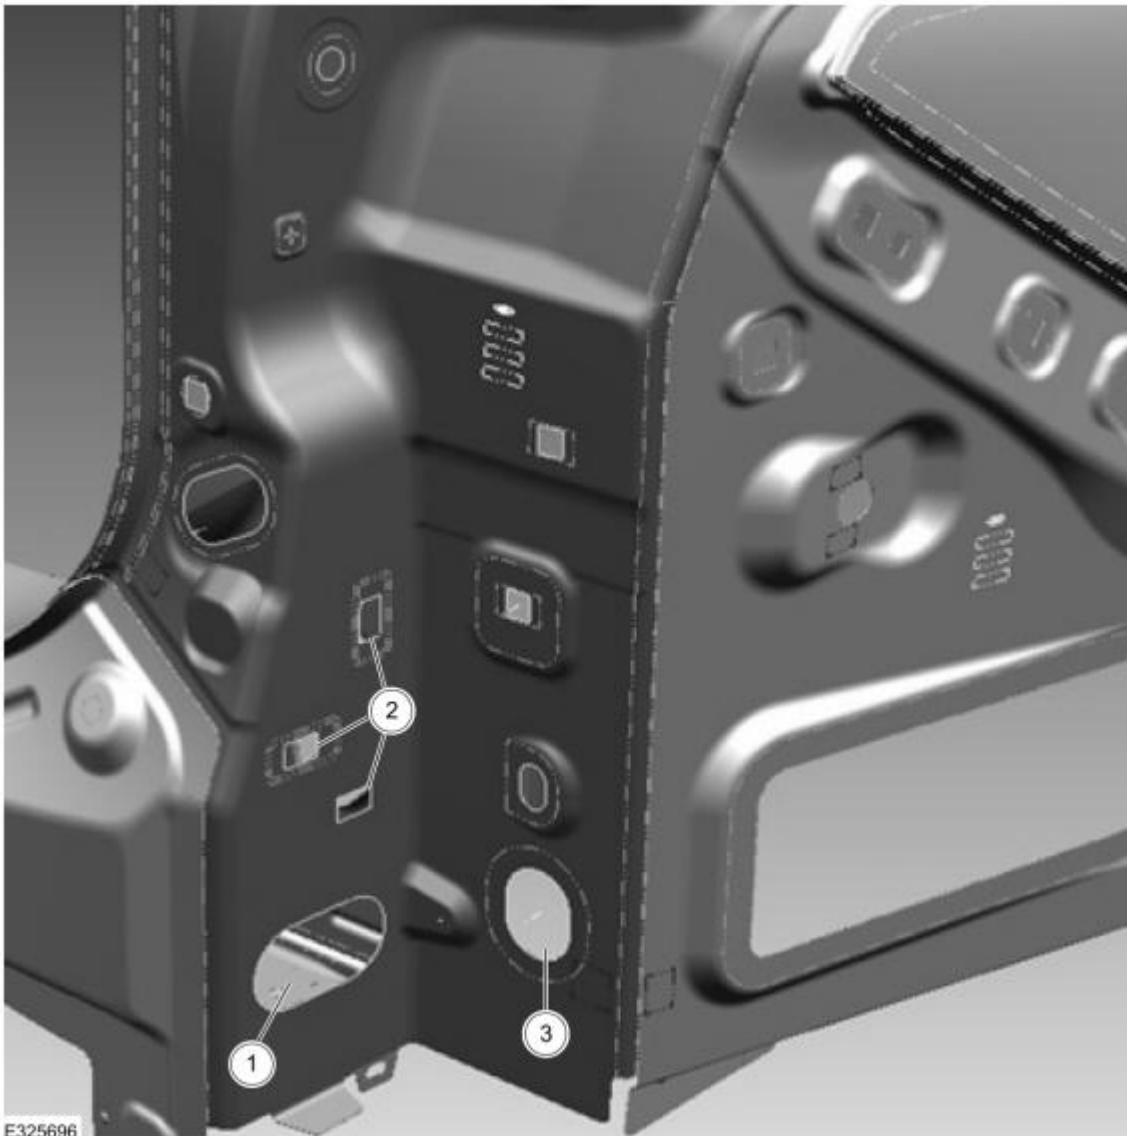
3. If a water leak is present on the right side of the vehicle, replace the audio control module (ACM).
4. Raise the vehicle on a hoist.
5. Inspect the right side rear corner area under the rear bumper cover for the following loose, disconnected, or missing items:
 - (1). Visually inspect for delete tape completely covering the body hole. (Figures 4-6 Callout 1)
 - (2). Press down on the blind spot information system (BLIS) module to make sure the BLIS module is fully seated into the body. (Figures 4-6 Callout 2)
 - (3). Visually inspect the BLIS module harness wire grommet is seated. (Figures 4-6 Callout 3)

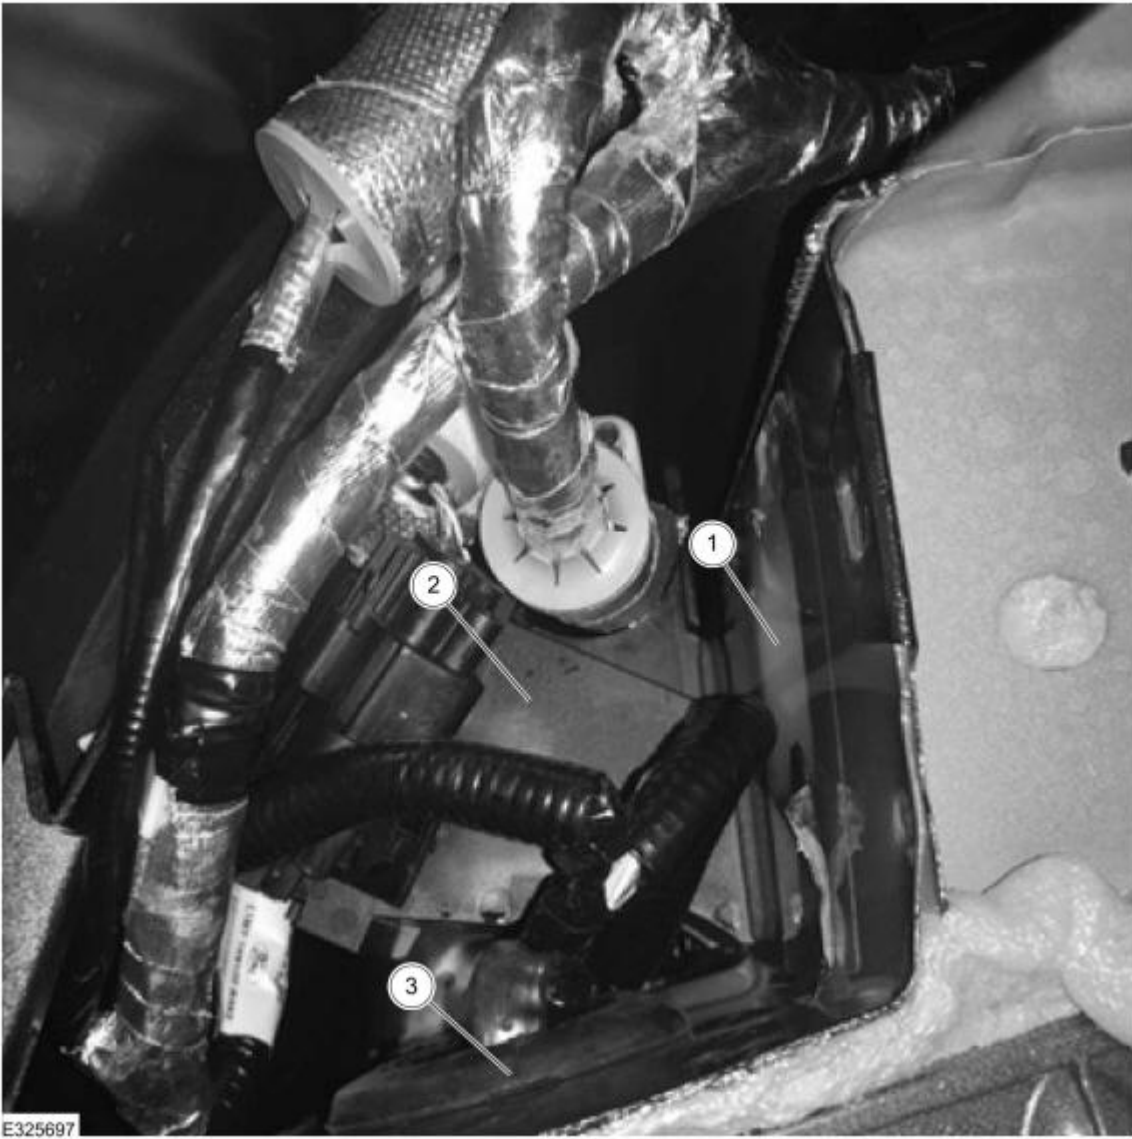
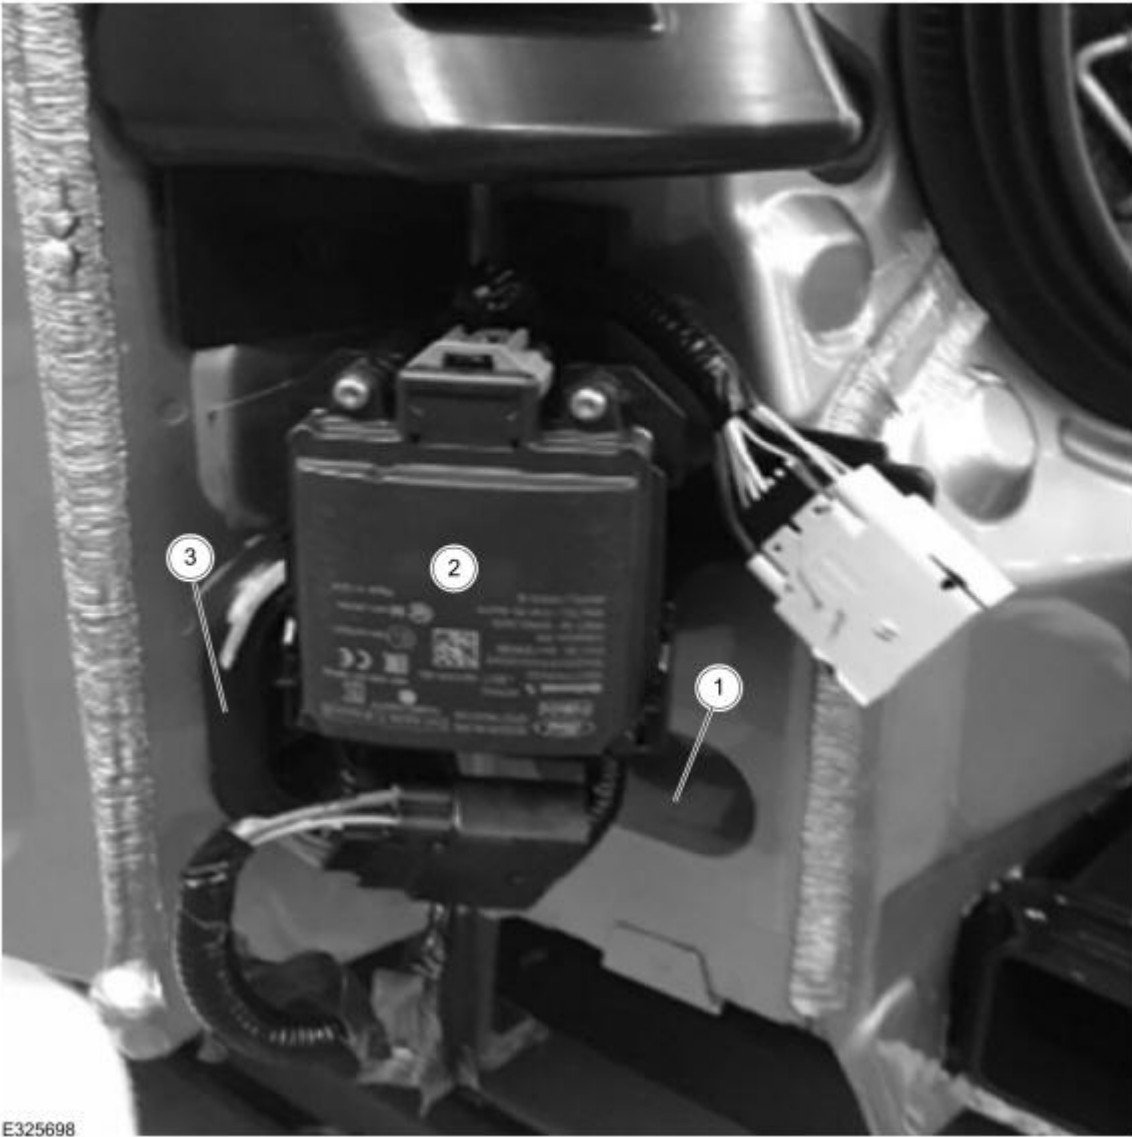
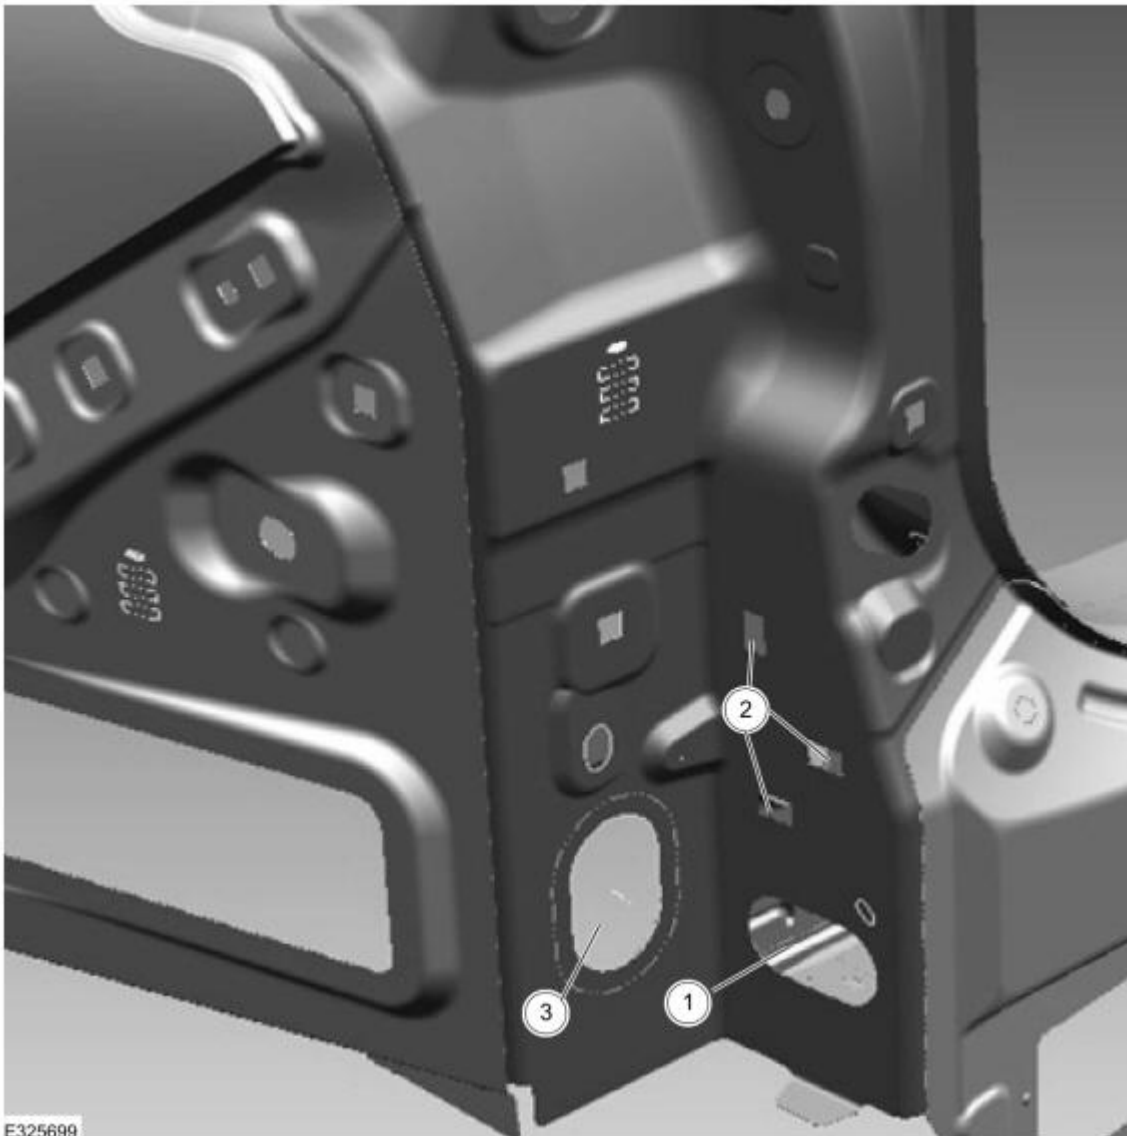
- (1). Visually inspect for delete tape completely covering the body hole. (Figures 7-9 Callout 1)
- (2). Press down on the BLIS module to make sure the BLIS module is fully seated into the body. (Figures 7-9 Callout 2)
- (3). Visually inspect the BLIS module wire harness grommet is seated. (Figures 7-9 Callout 3)

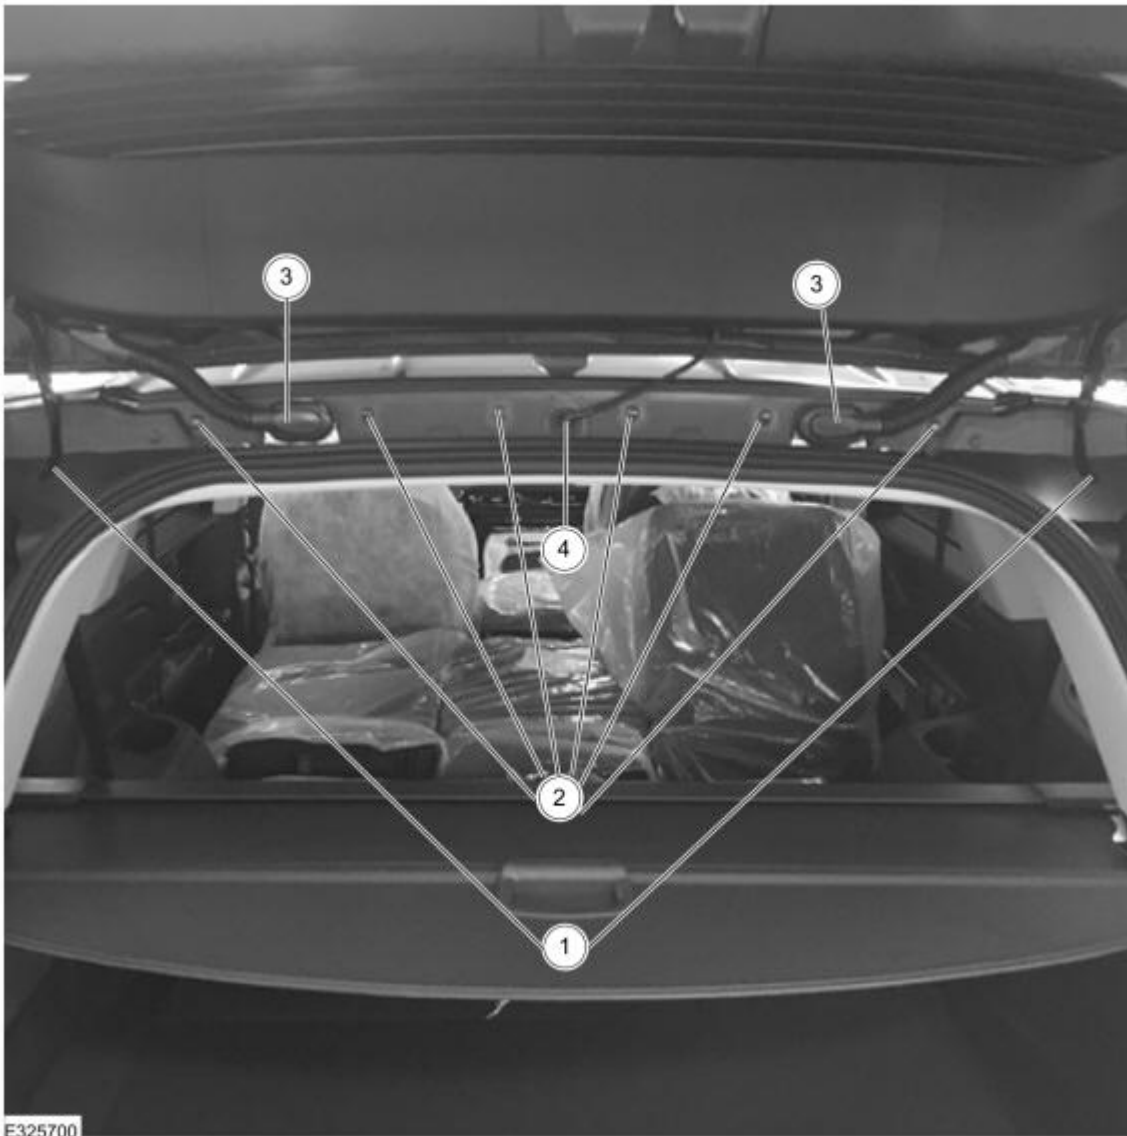
Figure 10

1. Open the rear liftgate.
2. Inspect and make sure the following components are correctly seated by pushing:
 - (1). Power liftgate grommet. If not properly seated, replace the affected power liftgate strut. (Figure 10 Callout 1, Figure 11)
 - (2). Margin seal and margin seal pushpins. (Figure 10 Callout 2)
 - (3). Electrical wiring grommet. (Figure 10 Callout 3)
 - (4). Rear washer hose. (Figure 10 Callout 4)

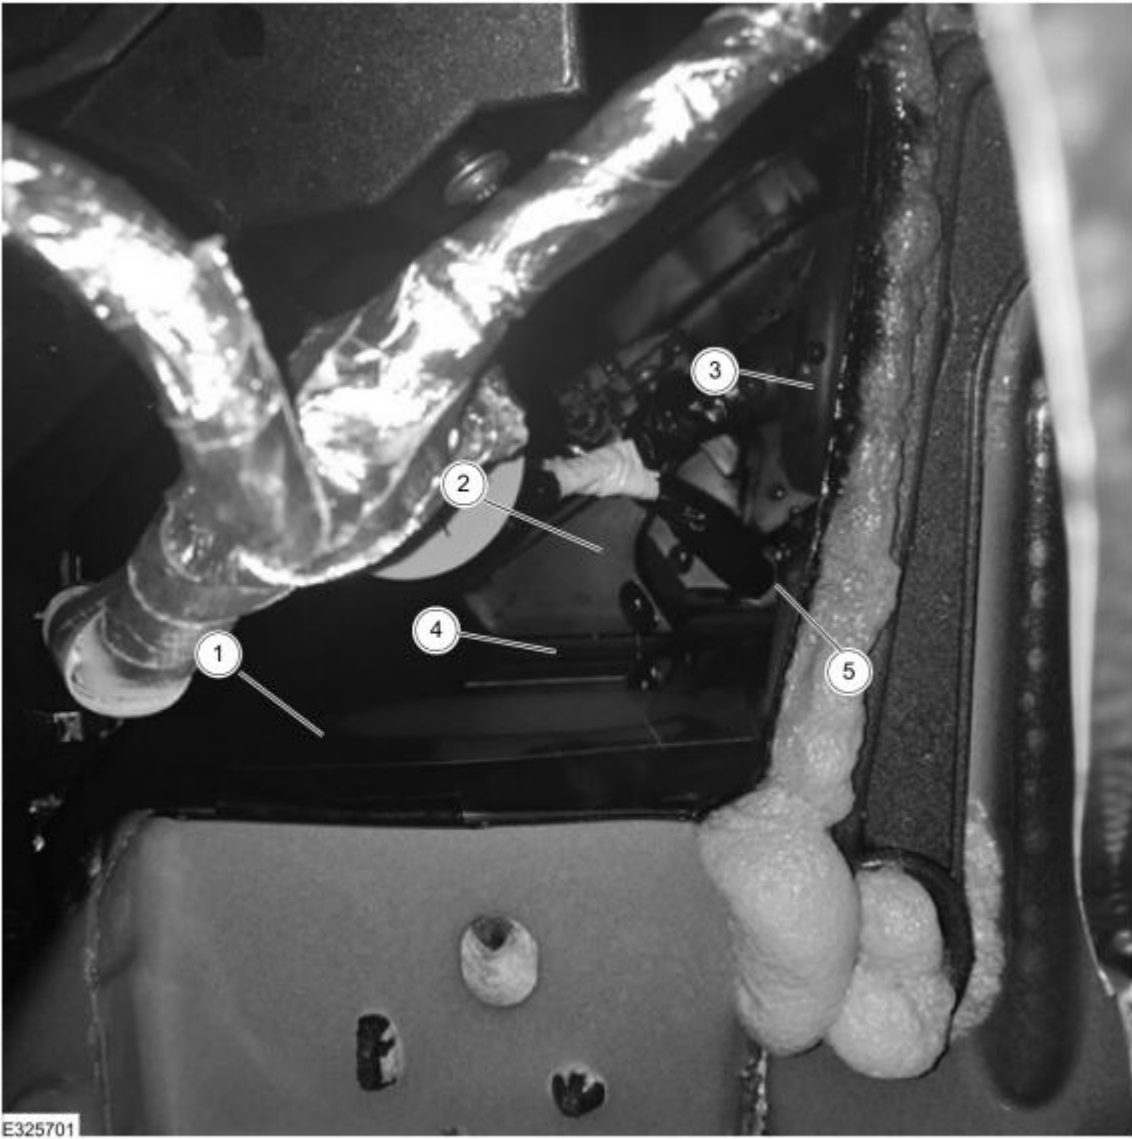
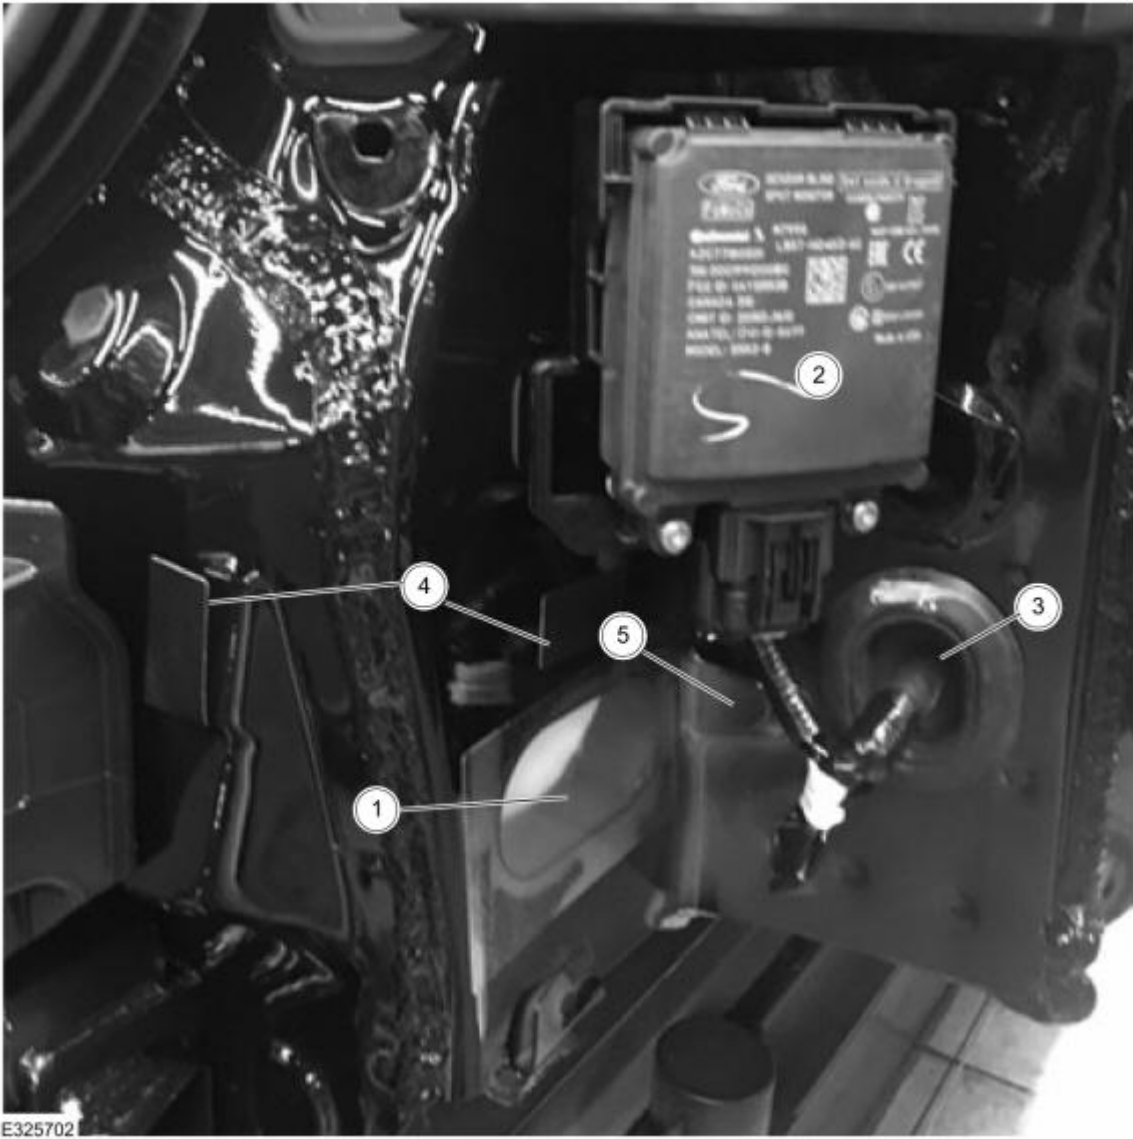
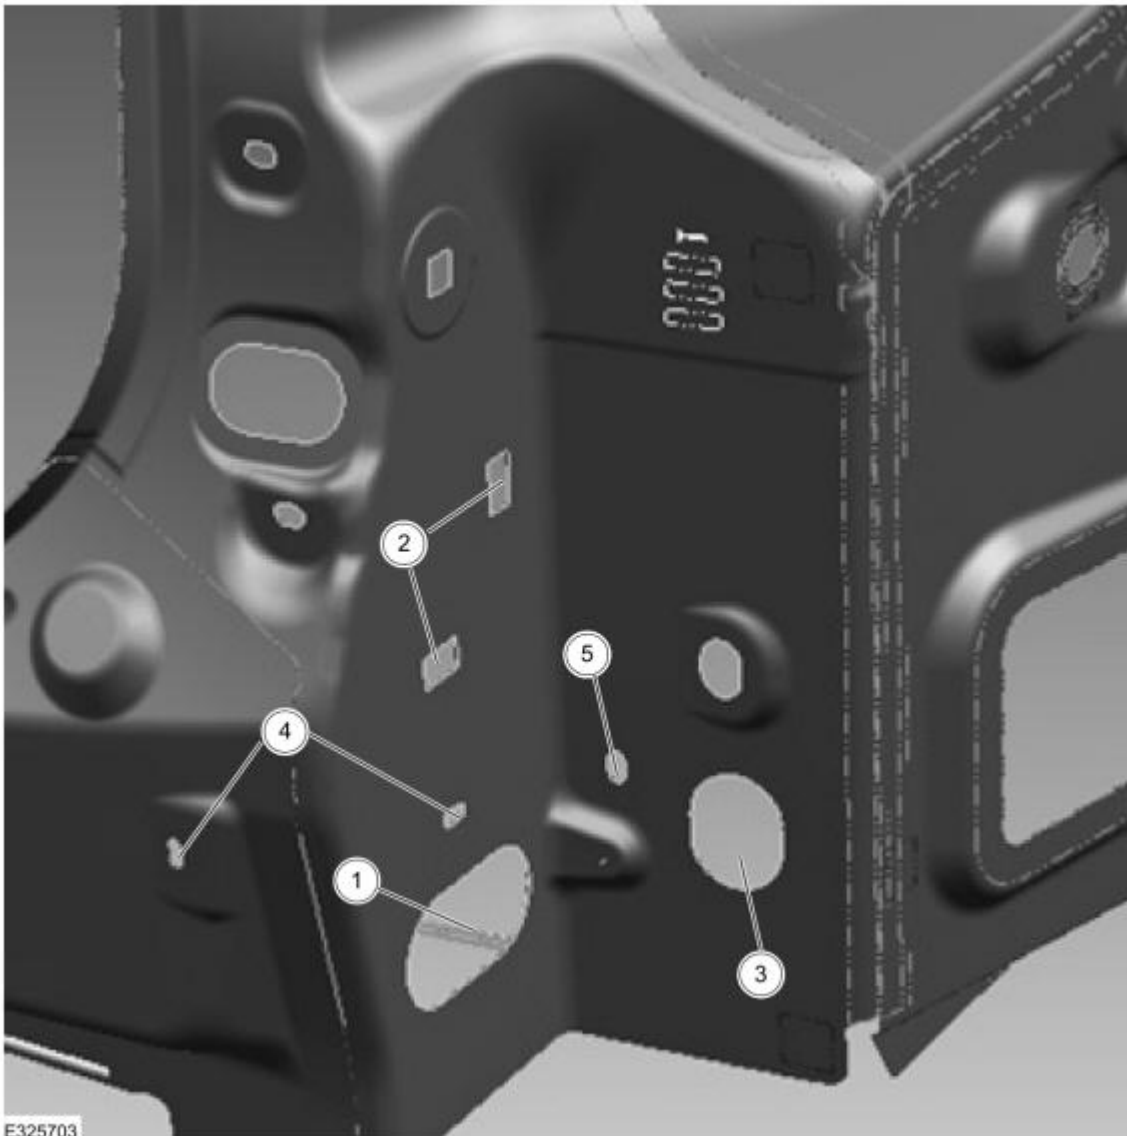
3. If a water leak is present on the right side of the vehicle, replace the ACM.
4. Raise the vehicle on a hoist.
5. Inspect the right side rear corner area under the rear bumper cover for the following loose, disconnected or missing items:
 - (1). Visually inspect for delete tape completely covering the body hole. (Figures 12-14 Callout 1)
 - (2). Press down on the BLIS module to make sure the BLIS module is fully seated into the body. (Figures 12-14 Callout 2)
 - (3). Visually inspect the BLIS module wire harness grommet is seated. (Figures 12-14 Callout 3)
 - (4). Make sure the wire harness grommet for the phone as a key feature is seated or the delete tape is completely covering the body hole. (Figures 12-14 Callout 4)
 - (5). BLIS grommet to module wire. (Figures 12-14 Callout 5)

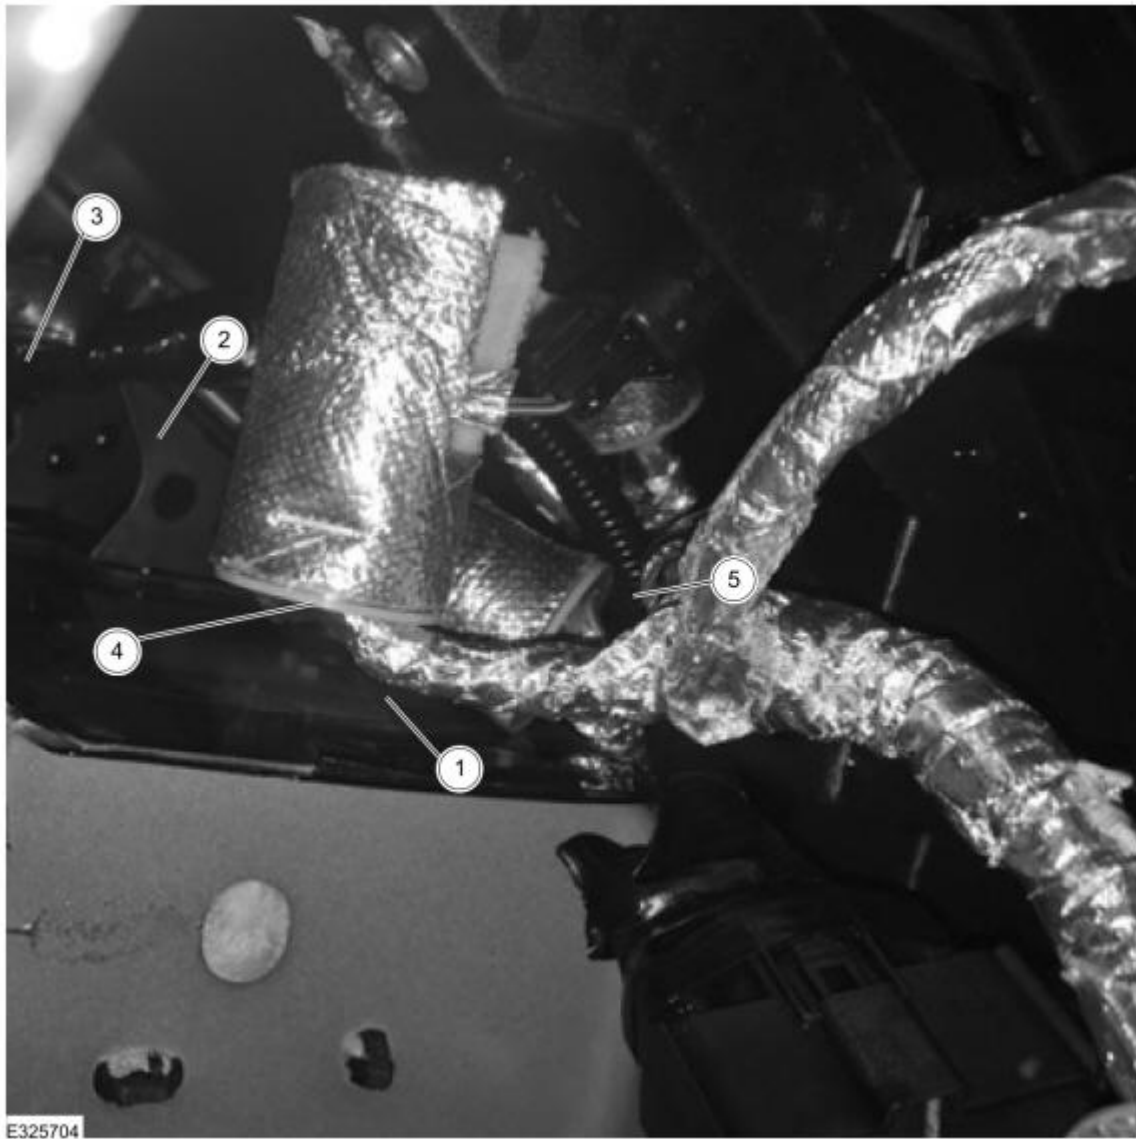
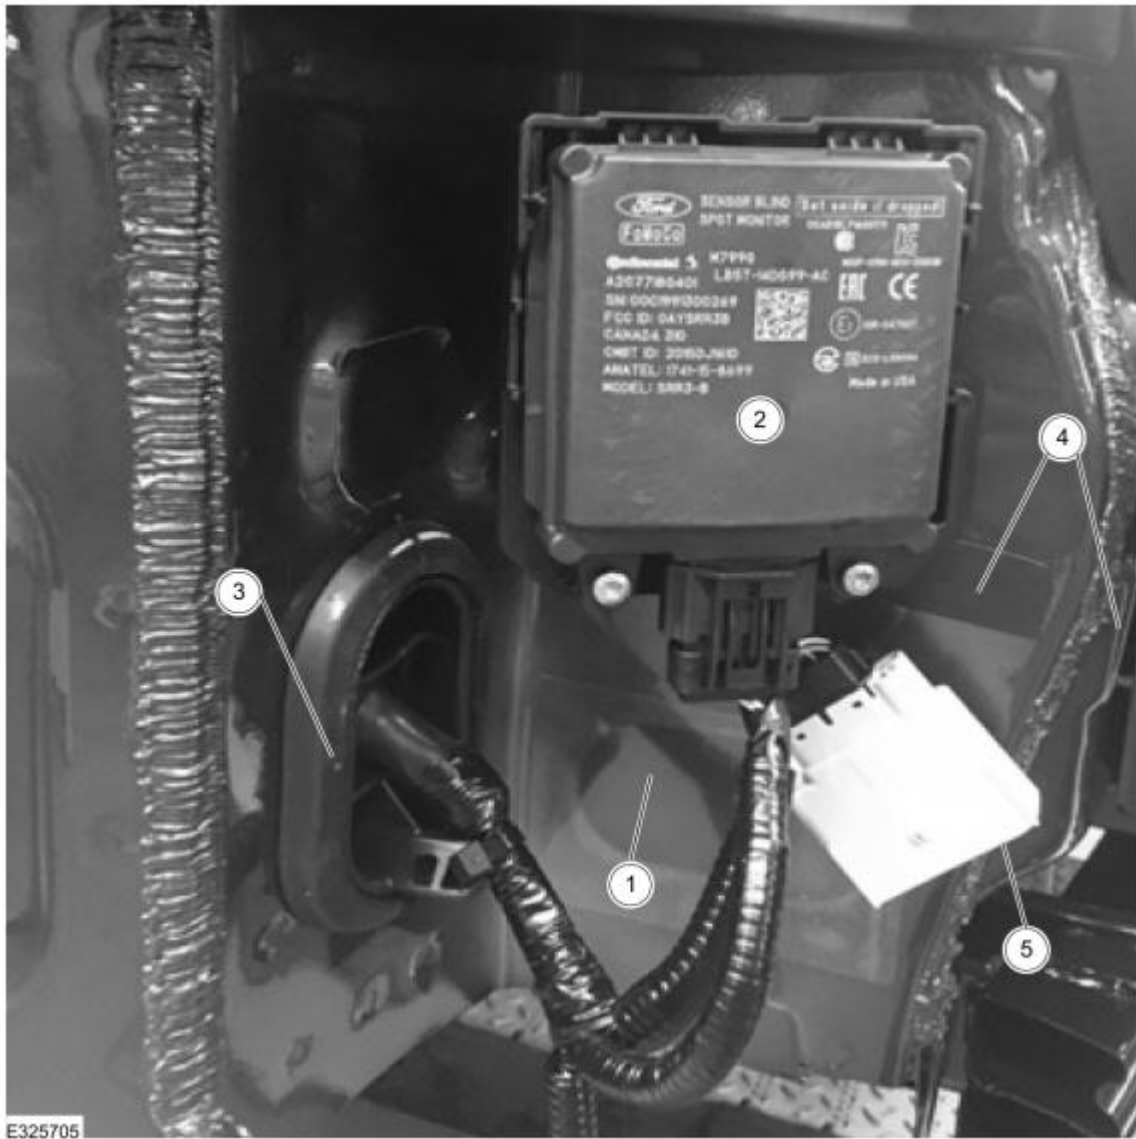
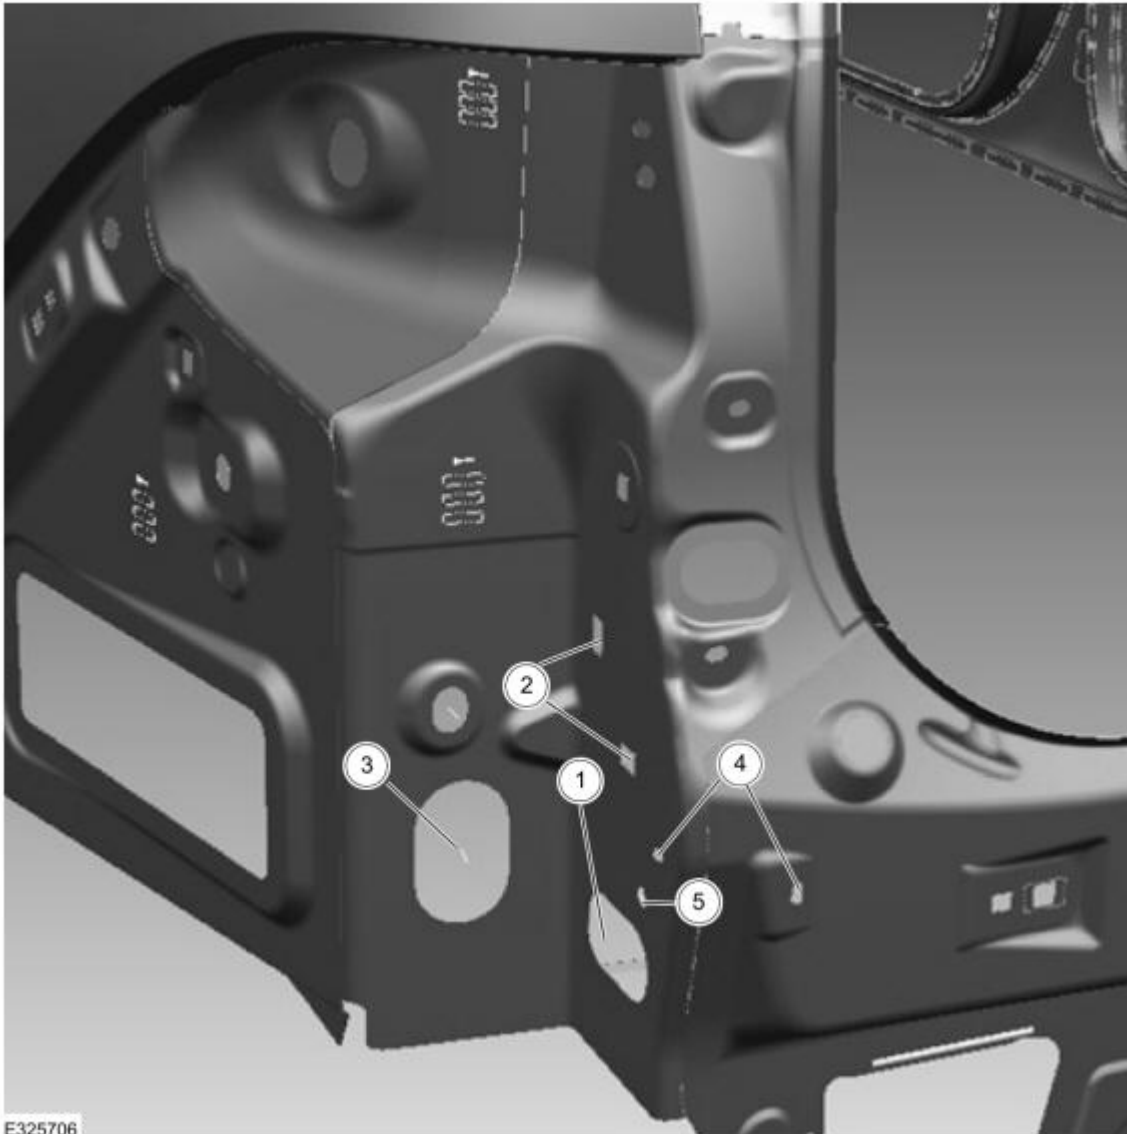
6. Inspect the left side rear corner area under the rear bumper cover for the following loose, disconnected or missing items:
- (1). Visually inspect for delete tape completely covering the body hole. (Figures 15-17 Callout 1)
 - (2). Press down on the BLIS module to make sure the BLIS module is fully seated into the body. (Figures 15-17 Callout 2)
 - (3). Visually inspect the BLIS module wire harness grommet is seated. (Figures 15-17 Callout 3)
 - (4). Make sure the wire harness grommet for the phone as a key feature is seated or the delete tape is completely covering the body hole. (Figures 15-17 Callout 4)
 - (5). Rear fascia wire. (Figures 15-17 Callout 5)
