# Service Bulletin

Bulletin No.: 21-NA-286

**Subject: Rear Hands-free Liftgate Feature Intermittently Inoperable or Difficult to Operate**

Brand:	Model:	Model Year:		VIN:		Engine:	Transmission:
		from	to	from	to		
Buick	Envision	2021	2022

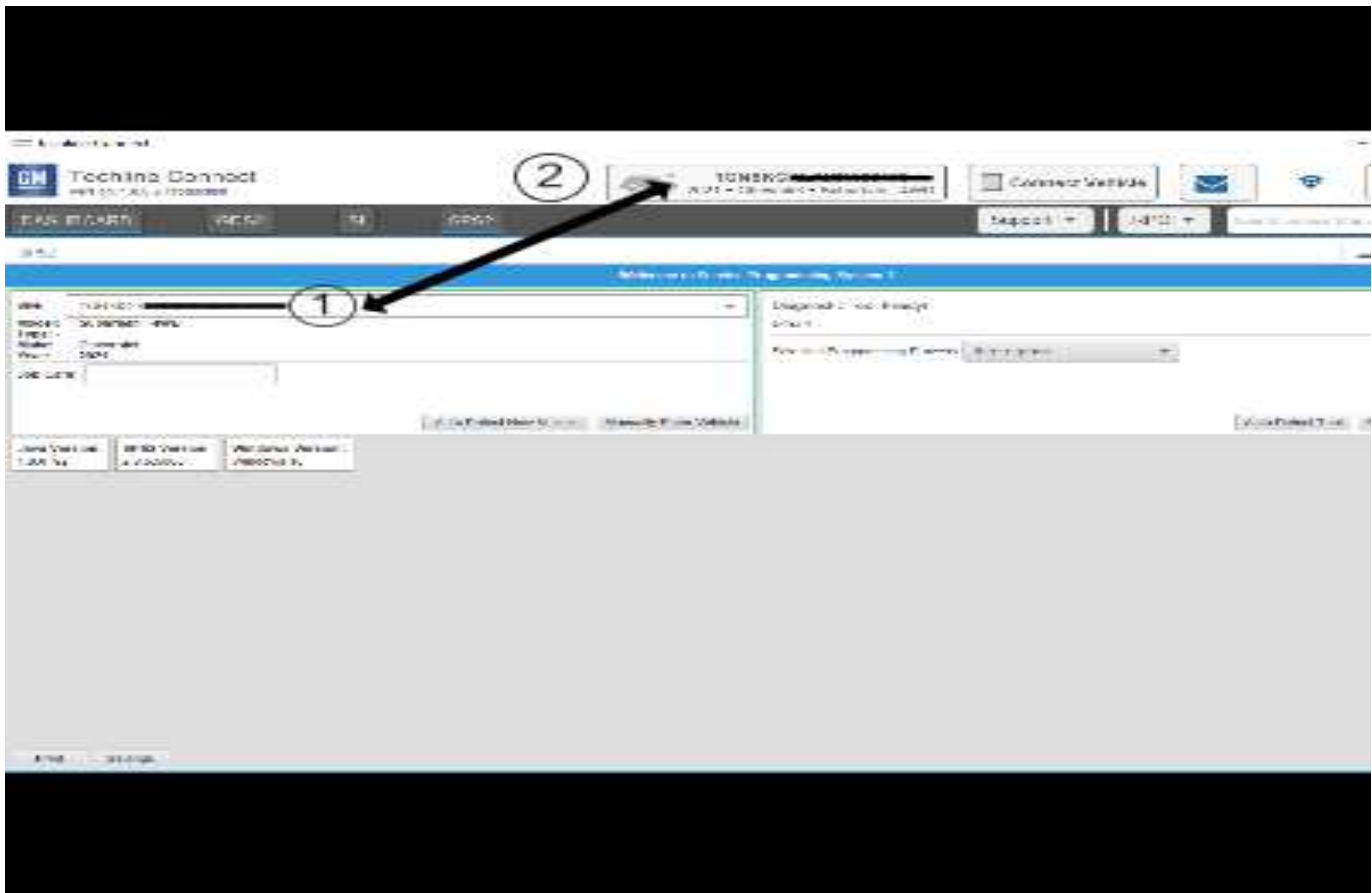
**Caution:** Be sure the VIN selected in the drop down menu (1) is the same as the vehicle connected (2) before beginning programming.

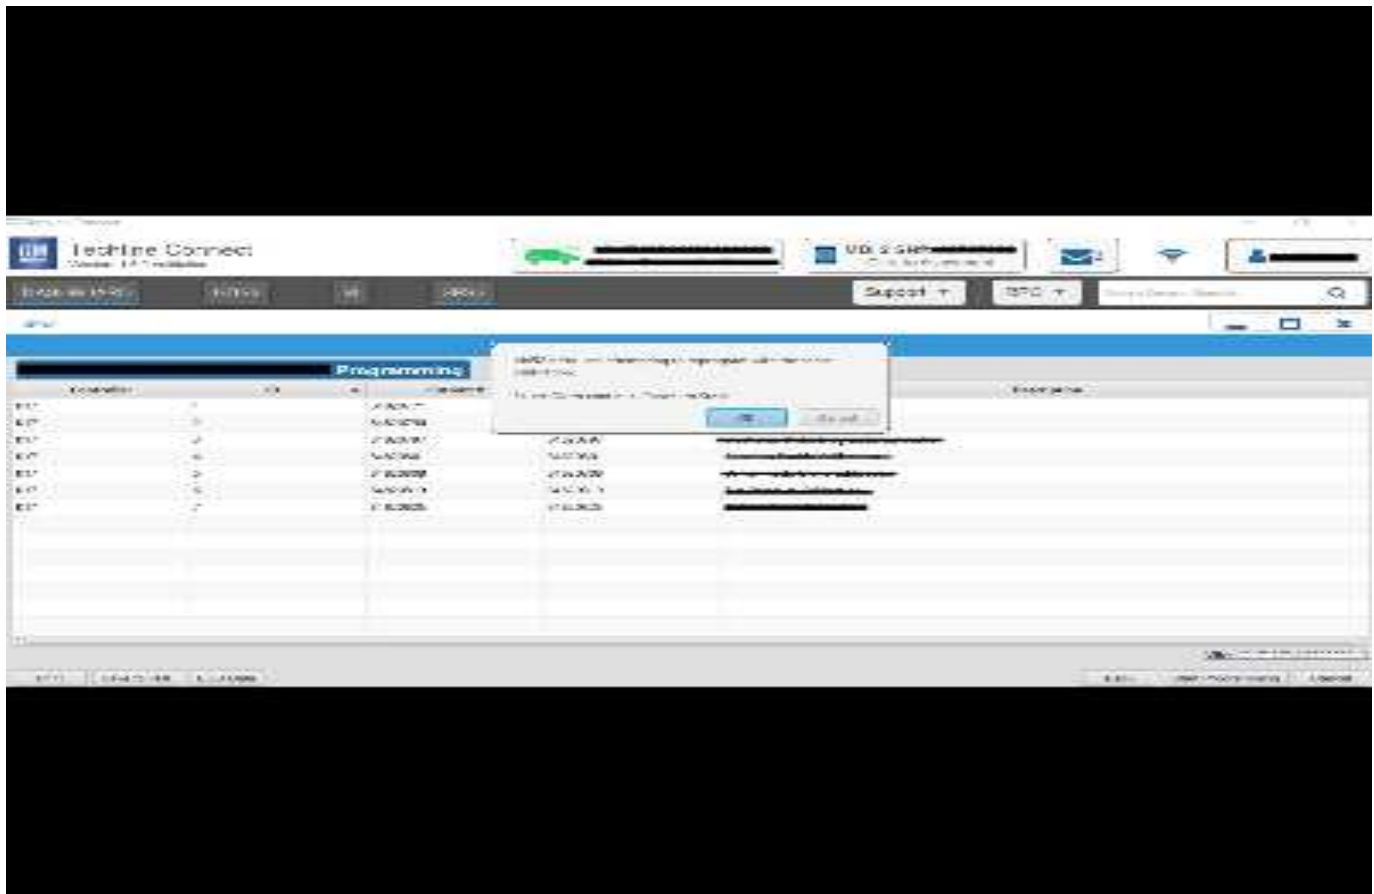
5644477

**Important:** Techline Connect and TIS2WEB screens shown above.
