Technical Service Bulletin

37 Vehicle Does Not Accelerate After Coming To A Stop. SAFE Warning Displayed On Instrument Cluster

37 22 06 2067546/1 July 14, 2022.

Model(s)	Year	VIN Range	Vehicle-Specific Equipment
e-tron GT, and RS e-tron GT	2022 – 2023	All	Not Applicable

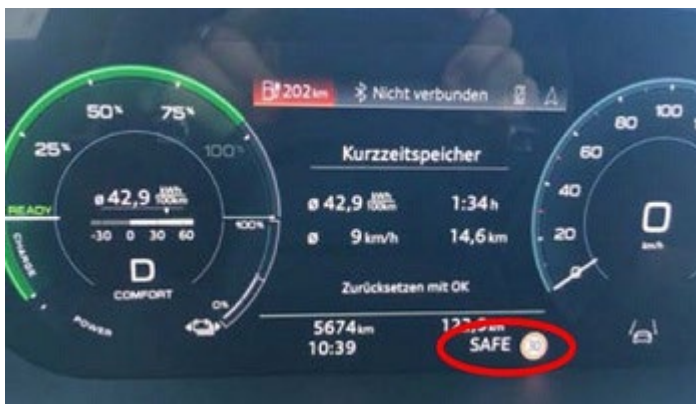
Upon the vehicle resting at a stop, for a period of time greater than 30 seconds, the vehicle will no longer accelerate.

“SAFE” warning is shown by the instrument cluster (Figure 1).

Figure 1: “SAFE” warning is shown by the instrument cluster

If a button on the remote key is pressed and held for longer than 60 seconds while driving, it is possible that a reset of the convenience control module J393 (address word 0046) may occur.

If the convenience control module J393 (0046) performs a reset, the vehicle is prevented from accelerating at the next stand still event lasting over 30 seconds.

Update convenience control unit J393 (DA0046) with SVM. To enter the SVM code, use "Flash" mode on the ODIS tester. The SVM code is **46A032**. Follow the instructions on the tester.
