Technical Service Bulletin

87 Air conditioning does not cool

87 22 28 2063575/2 July 12, 2022. Supersedes Technical Service Bulletin Group 87 number 21-15 dated June 16, 2021, for reasons listed below.

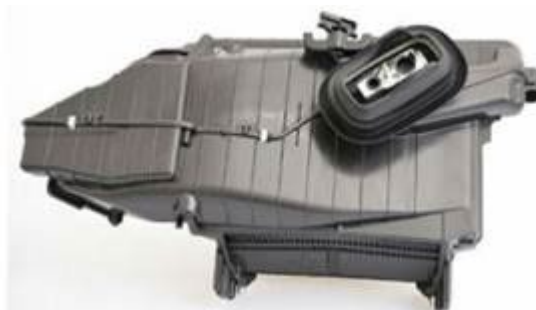
Figure 1. HVAC evaporator and housing.

The refrigerant circuit head pressures are checked, found to be insufficient and after recovering the refrigerant volume the diagnostic finding is determined that the refrigerant volume in the circuit is very low or empty. DTC B10AE21 (High-pressure sensor Lower limit not reached) may be stored in the Heating/Air Conditioning Electronics control module, E87 (address word 0008). Leak identification dye is added to the refrigerant circuit along with a full charge of the refrigerant and the vehicle is test driven. Correct cabin cooling is restored. A visual inspection of the refrigerant circuit is conducted and no obvious leak can be seen under UV lighting. When using an electronic refrigerant leak detector at the central vents and condensate drain it alerts that the evaporator core may be the source of the leak.

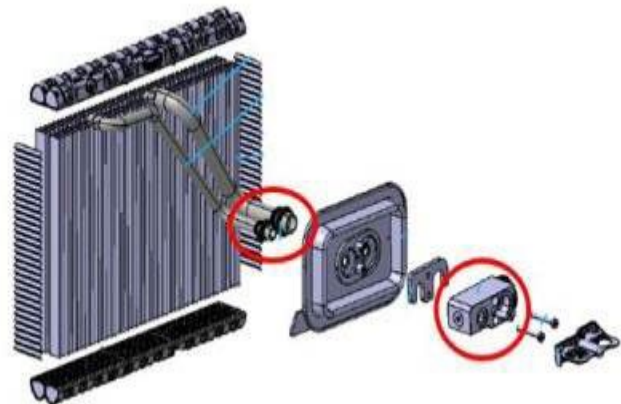
Figure 2. Refrigerant connections in need of closer observation.

1. If, after checking for refrigerant leaks at each component and connection in the refrigerant circuit and systematically excluded as a cause, your diagnostic conclusion is that the evaporator core is the only refrigerant leak in the entire circuit apply a high level of scrutiny to the connection junction at the evaporator core /expansion valve/refrigerant lines for a possibly overlooked leak in these areas (Figures 2 - 3).

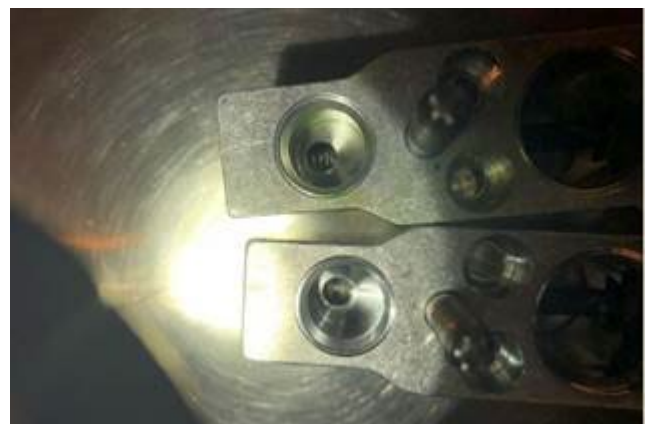
Figure 4. Leak at expansion valve connection evidenced by residue from the contrast agent.

2. If a refrigerant leak is detected from the evaporator core/expansion and valve/refrigerant line junction, take a short video showing the diagnostic confirmation of a leak in this area and post it to Doc-IT. Then, replace the expansion valve and all four O-rings without replacing the evaporator (Figure 4). Re-test to ensure that the refrigerant leak is solved without the replacement of the evaporator core. Photograph any damage to the expansion valve ports, damaged o-rings, or refrigerant line connections and post these to Doc-IT as well.
