TECHNICAL BULLETIN
J038NAS2
10 NOV 2014

SECTION: 303-00

Emissions Recall: Engine Malfunction Indicator Lamp Illuminated

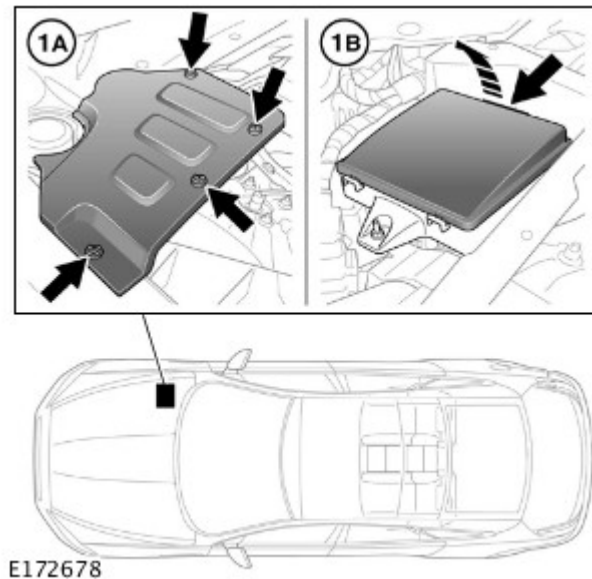
XJ (X351) engine compartment fuse box location.

1. **NOTE: XJ (X351) ONLY.**

CAUTION: XJ (X351) ONLY: when instructed to select the 'tick' to configure the Powertrain Control Module (PCM), the Engine Control Module (ECM) fuse must be removed prior to selecting the 'tick'. The fuse box is located in the engine compartment (see Step 1). The ECM fuse number is F3 - fuse rating 5A. When the software download is complete and SDD states to set the ignition switch to 'OFF' (position 0), switch the ignition 'OFF' and then wait 10 seconds before installing the previously removed ECM fuse. Once the fuse has been refitted, continue with the SDD command prompts.
