TECHNICAL BULLETIN
J020NAS1
15 NOV 2013

Service Action: Instrument Cluster Telltales

XJ Range (X351)

Model Year: 2010-2011
VIN: V00047-V20095

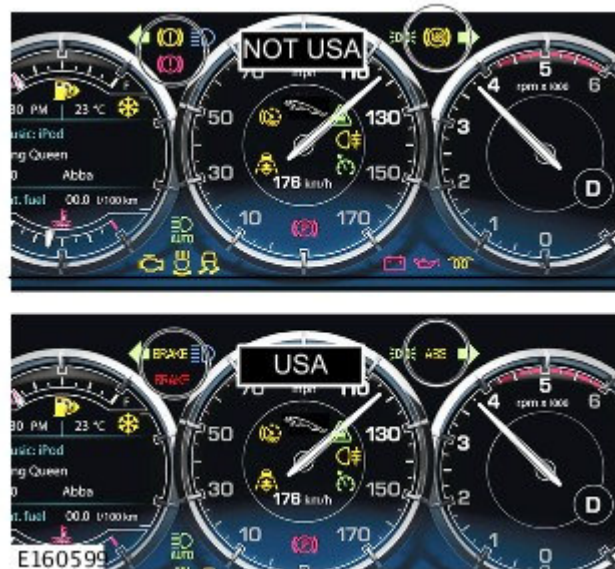
**NOTE: The brake warning lamp text is visible during the Instrument Cluster bulb check.**

After the update has completed, cycle the ignition 'OFF' and then 'ON'; verify that the yellow and red brake warning lamps now appear as text rather than icons.
